JAMES CROSS, Certified Marine Surveyor
19 Nooseneck Hill Rd., West Greenwich, RI 02817
Phone (401) 397-5040
Member Association of Certified Marine Surveyors / ACMS.USA.COM
Check us out on the web at www.jimcross.net

Re: 1977 44' Atlantic Trawler

This letter reports the results of a survey of the above vessel which was inspected on the 20th of August, 2020, at the Prime Marina in Warwick, Rhode Island while hauled. You requested the inspection to establish its condition and value.

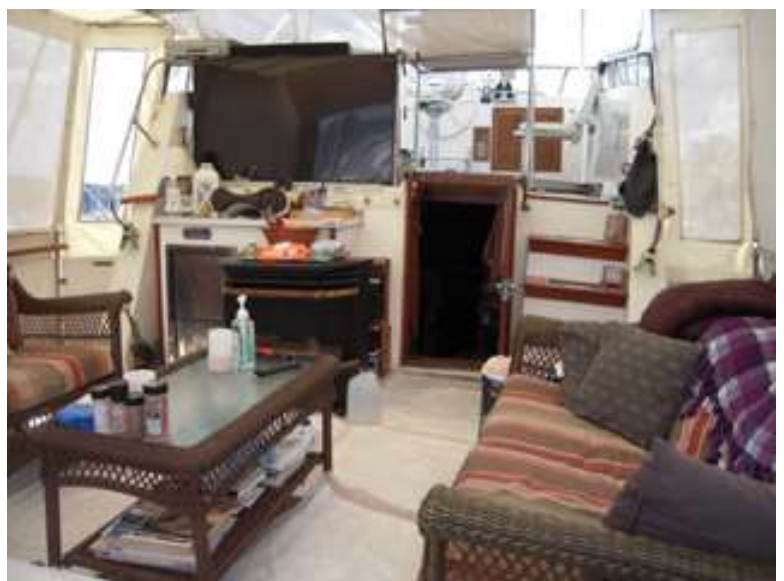
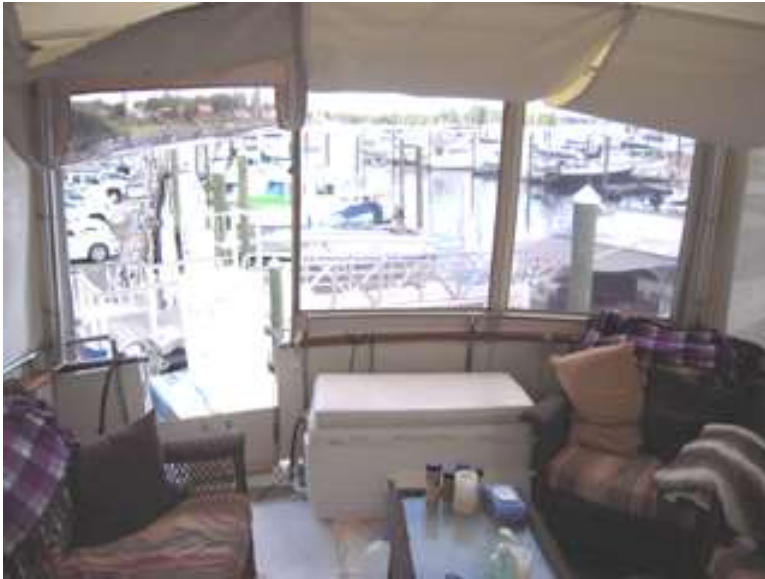
A complete bridge and after deck full enclosure is a recent upgrade. The canvas and supporting stainless structures are well designed and properly installed. All canvas is fairly recent.

Cockpit: Photo on previous page and at left has been converted to a completely enclosed salon.

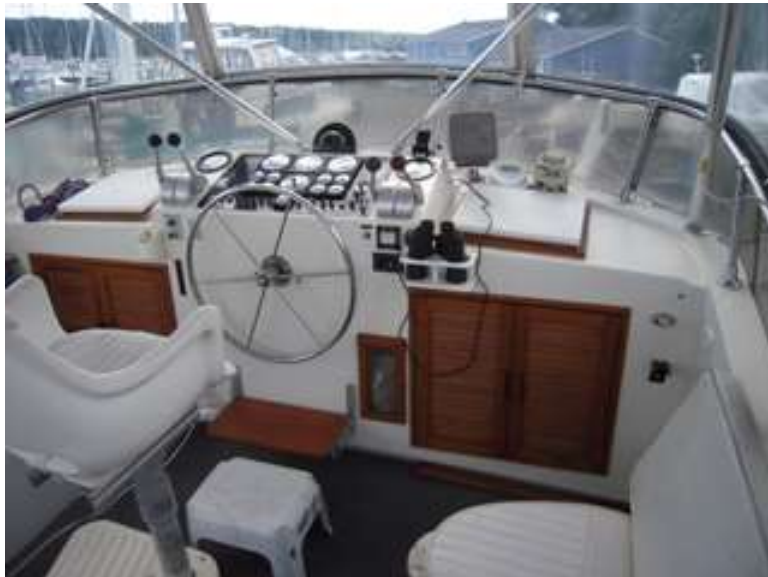
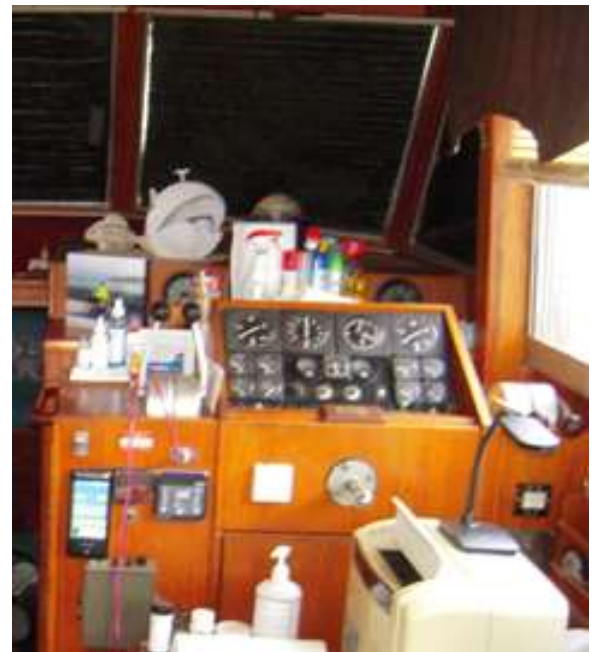
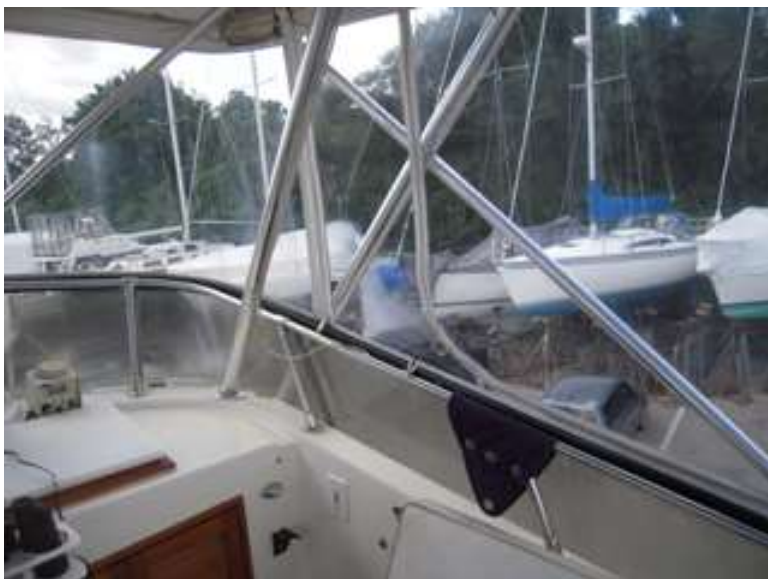
The bridge operating station area is in good clean condition. The deck has been carpeted and is in good condition. The area is self draining , port and starboard, that drain overboard. The upper and lower operating stations are well designed and the controls easy to operate. The Ritchie compasses are accurate on their present heading. The throttles operate smoothly. The shifts and steering are also smooth operating and in excellent condition. Steering is hydraulic and the related lines are in good condition. Access to the engine spaces are gained through two hatches in the deck of the main salon and the foldin stair aft of the galley.

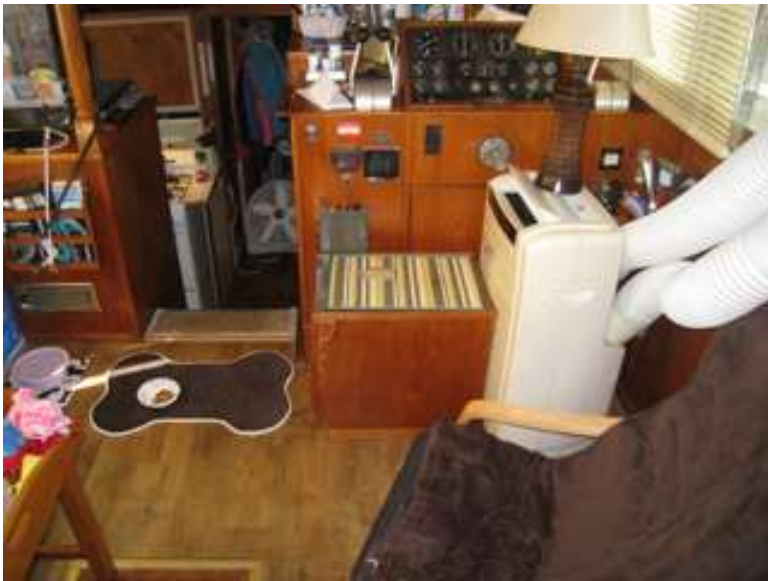
The main cabin houses the salon, galley, and dinette. This area is spacious, nicely finished and in better than average condition. The jointer work is made up of Mahogany, Teak, and vinyl, and for the most part, looks professionally maintained. A new hardwood sole has recently been installed.

The upholstered sections show light use, good care, and maintenance. The doors and ports are in good condition and tight to the weather. The entire interior area is in excellent condition and bright. The overhead suede liner also appears in excellent condition. The entire deck is in sturdy, solid condition and is well supported. All deck supports were checked from below and all are secure. Lighting is good throughout the vessel. The dinette converts to sleep two adults. The vinyl upholstery and new sole show only light use. The main salon, overall, is in excellent condition.

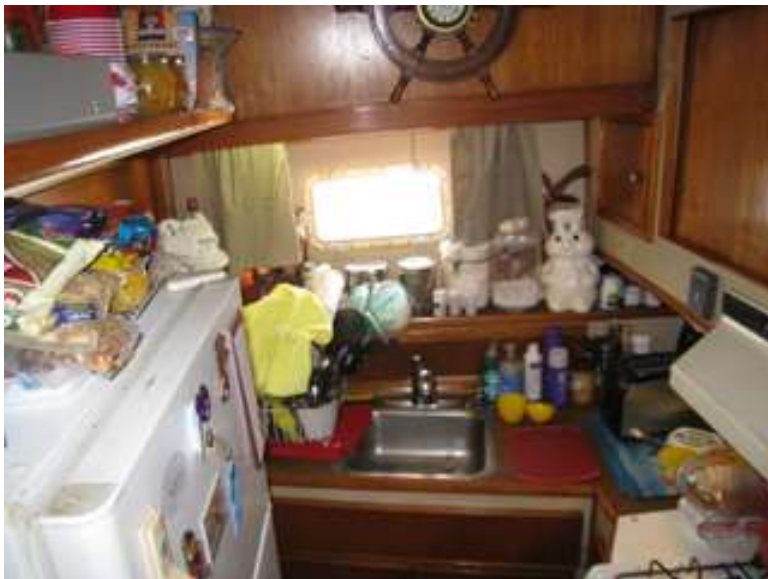
There is a complete inventory of full size galley appliances stove with oven, (recent upgrade full size) refrigerator, microwave oven which is in

lightly used condition. The counter top in the galley is comprised of Formica which is in good shape. There is a large sink located between the stove and refrigerator in the galley area. The sink and its related faucets and over board drain are in good condition and clean. The sole in the galley and forward is also Vinyl (New upgrade) and is in excellent condition and secure. No rot was found in any deck timbers or supports. The galley is located a few steps forward and below the main salon and dinette. The galley and dinette (space for four), overall, is in excellent condition.
