JAMES CROSS, Certified Marine Surveyor
19 Nooseneck Hill Rd, West Greenwich, RI 02817
Phone (401) 397-5040
Member Association of Certified Marine Surveyors / ACMS-USA.COM
Check us out on the web at www.jimcross.net

Re: 2002 Carver 444 Motor Yacht "SARDO"

This letter reports the results of a survey of the above vessel which was inspected on the 1st of July, 2018 for an "in water test" and then again while hauled at Brewers Marina in Warwick, Rhode Island. The inspection was completed to establish its condition and value.

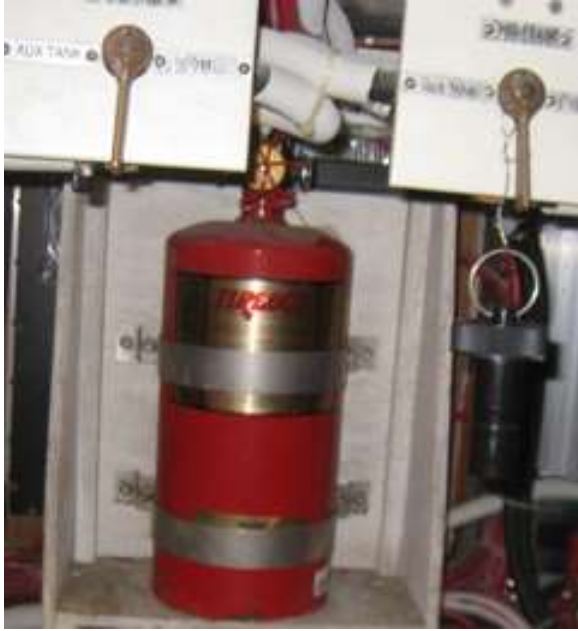
Fire extinguishers and safety equipment on board include: Kidde BC size 10 dry chemical. Automatic Fire Suppression System in Engine Compartment that needs in-

The Auto fire supression system is in need of inspection.

1. Install backup ground tackle.
2. Protect batteries from shorting.
3. Ensure that a complete Coast Guard Safety and Signalling package is aboard.
4. Replace septic hoses as needed.
5. As fuel lines appear original, they should be checked by the yard. Have fire suppression tank inspected.
6. All three engines should have the engine and reduction gear oil changed before heading to Florida.

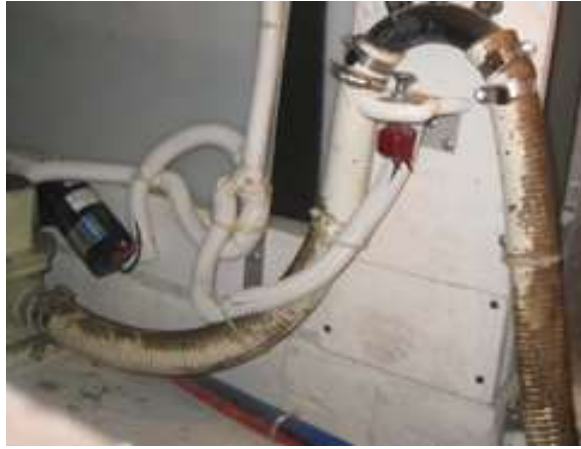
The fuel fills, vents, and feed lines are in good condition and equipped with proper fuel shut-offs. The septic system plumbing hardware is in good shape. Note photo at left indicating some of the septic flexible hose is porous and should be replaced. Septic odor was noted. Air condition and heat systems performed properly.

This image shows wanother septic system hose that is in need of service.

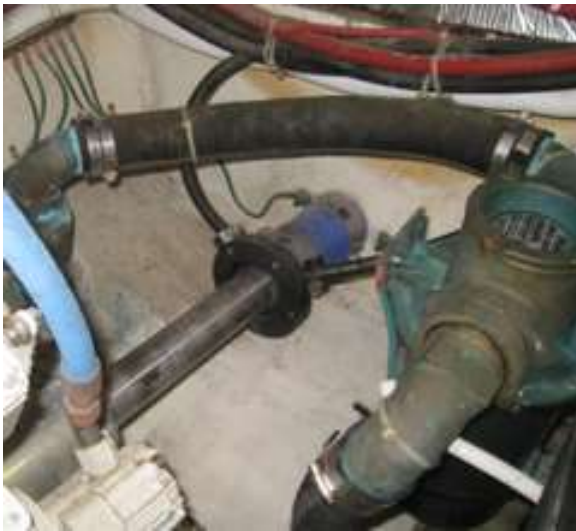
This image shows water cooled shaft log and clean bilge.

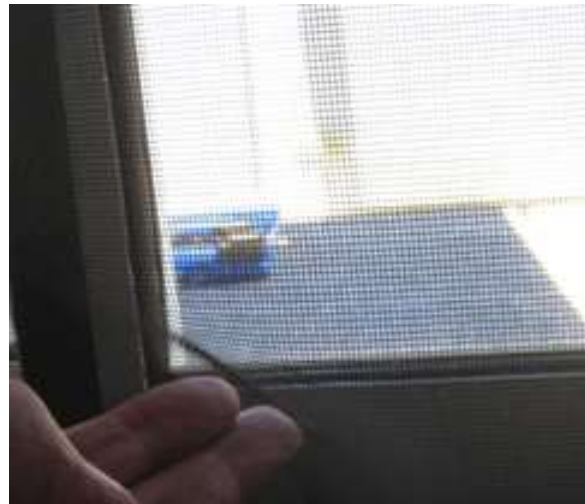
This image shows ripped screen on cockpit entry door that is in need of service.

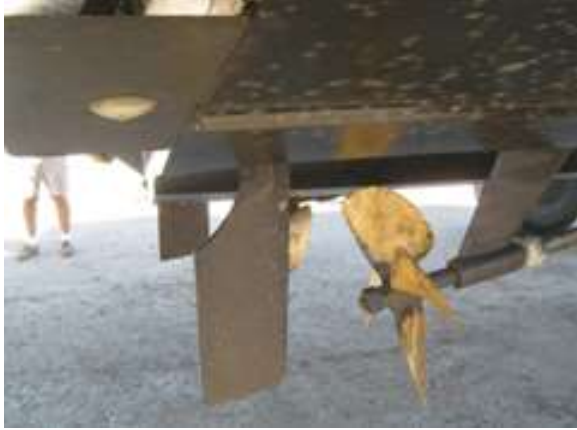
This image shows clean, propeller, strut, trim plane, and shaft.

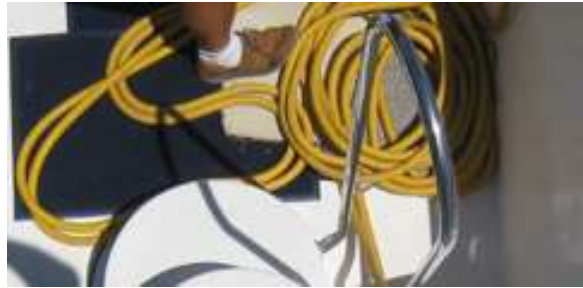
This image shows two 50 amp shore power cables that are in good condition.

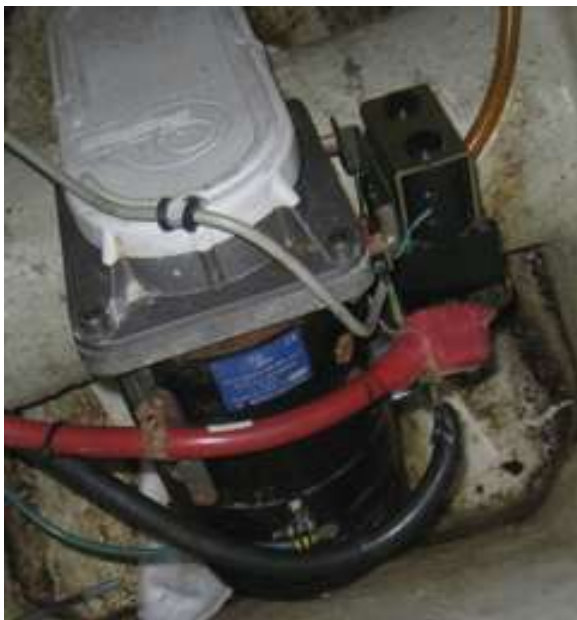
This image shows good working bow thruster.

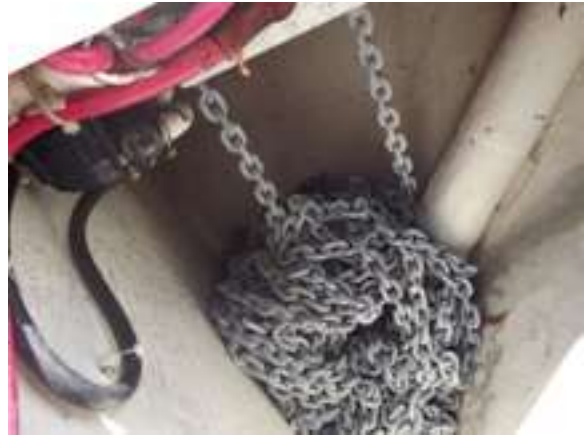
This image shows approximately 200 feet on galvanized anchor chain in the anchor locker.
