**JAMES CROSS, Certified Marine Surveyor**  
 19 Nooseneck Hill Rd, West Greenwich, RI 02817  
 Phone (401) 397-5040  
 Member Association of Certified Marine Surveyors / ACMS-USA.COM  
 Check us out on the web at [www.jimcross.net](http://www.jimcross.net)

Re: 2000 Luhrs 40 Tournament Fly Bridge "TUNA BE WARE"

This letter reports the results of a survey of the above vessel which was inspected on the 7th of June, 2018 while hauled and afloat for an "in water test" at Petis Marina in Warwick, Rhode Island. The inspection was completed to establish its condition and value.

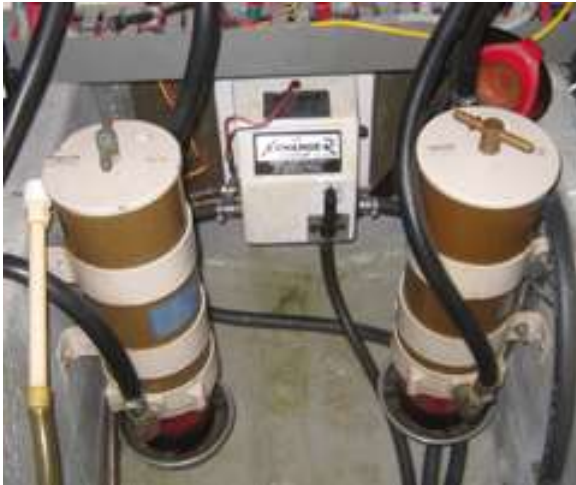
*The auto oil change gear.*

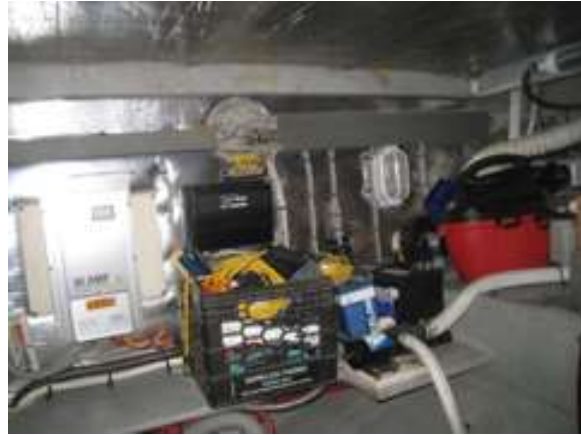
*This image shows wanother septic system hose that is in need of service.*

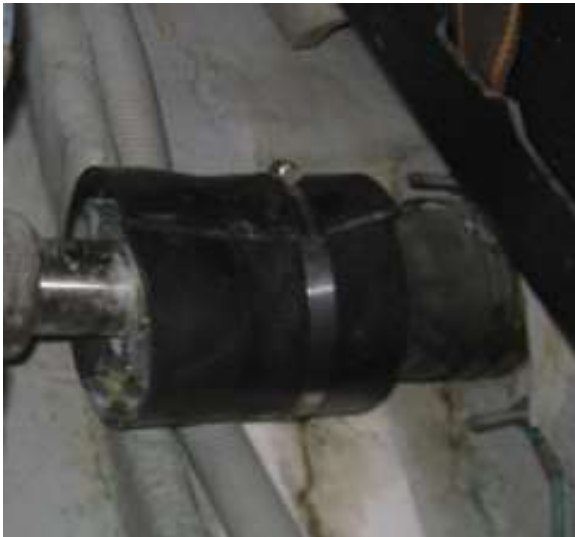
*This image shows water cooled shaft log and clean bilge.*

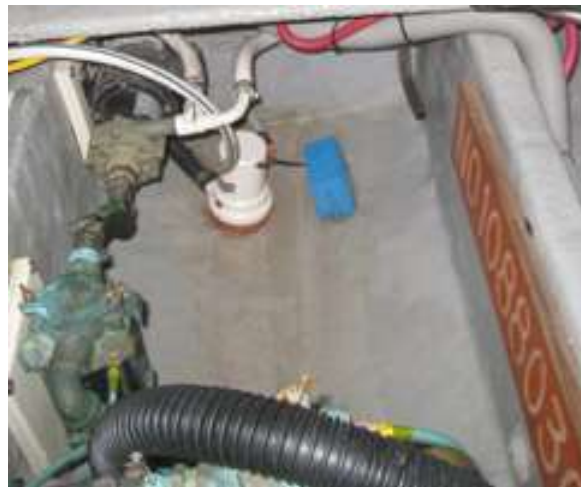
*This image shows clean bilge and sea water strainer.*

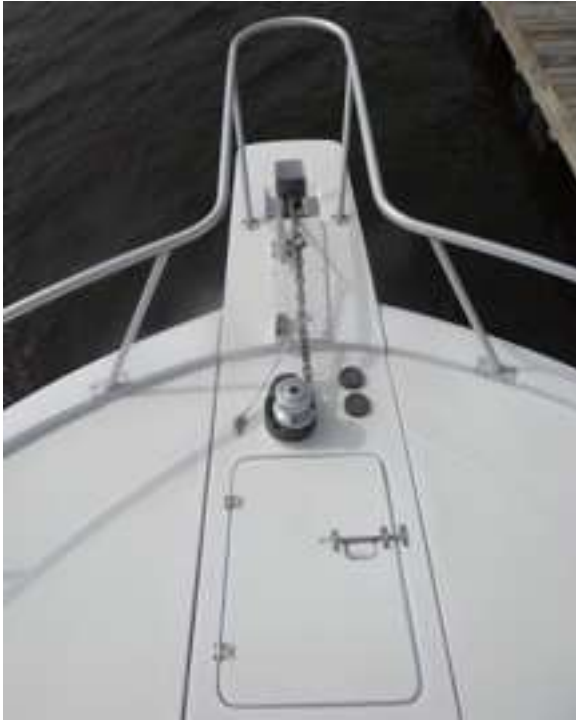
*This image shows clean anchor pulpit and windlass.*

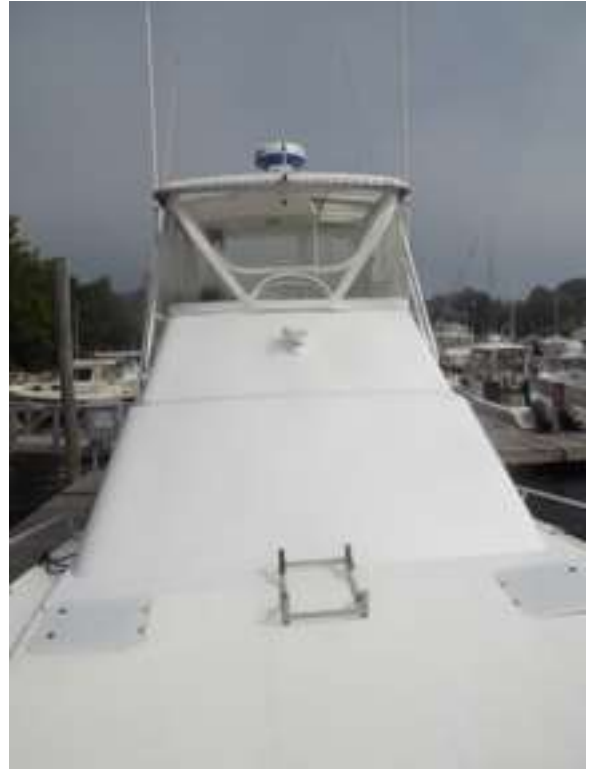
*This image shows front view of bow deck and bridge.*

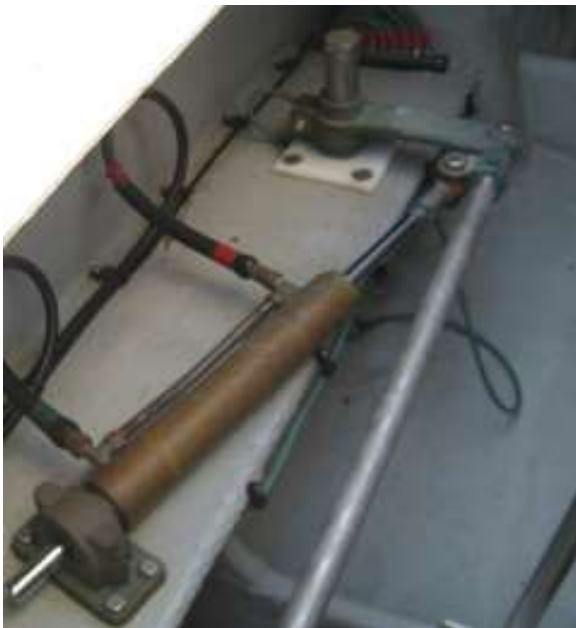
*This image shows good working hydraulic steering gear*

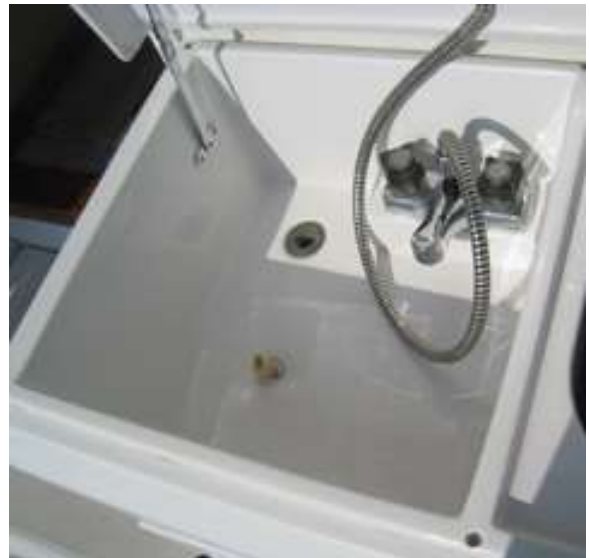
*This image shows a fish cleaning basin in the cockpit.*
