Re: 1997 SeaRay Express Bridge 44

This letter reports the results of a survey of the above vessel which was inspected on the 8th of August 2020, at Silver Spring Marina in Narragansett, Rhode Island while afloat. You requested the inspection to establish its condition and value and to provide information helpful to you in selling the vessel.

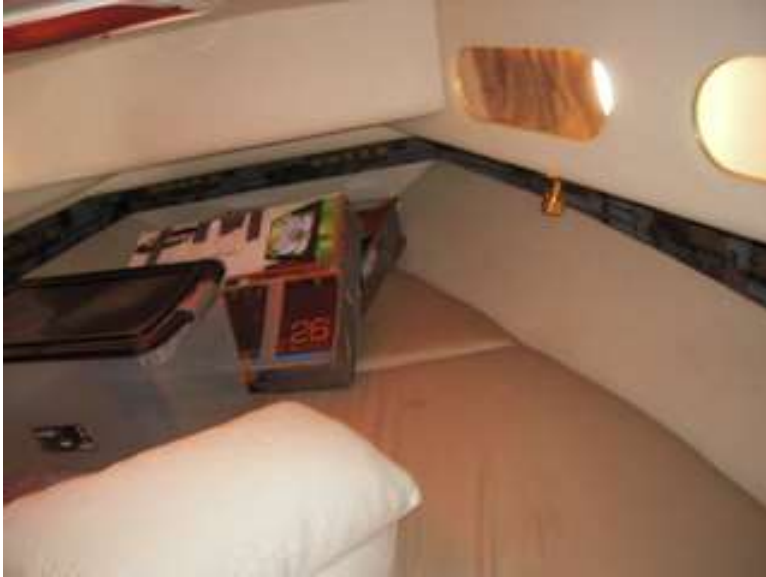
*Forward berth*

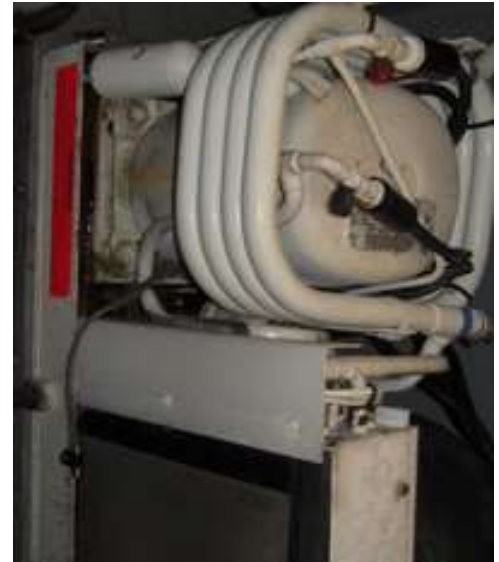
*One of two air/heat units*

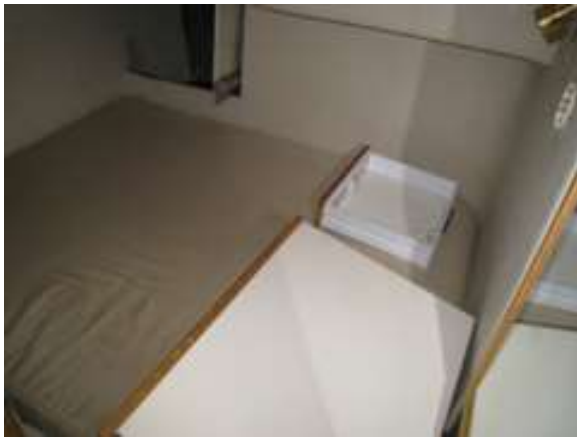
*Guest Aft berth*

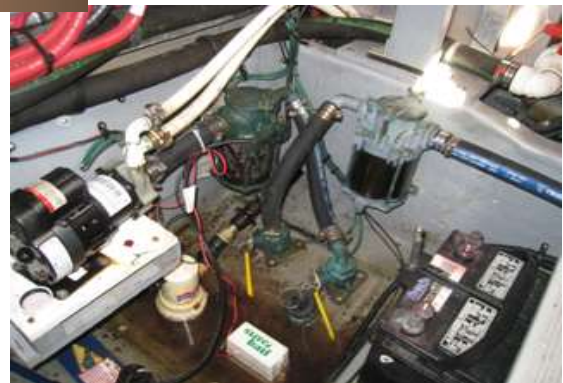
*Potable water pump and misc equipment*

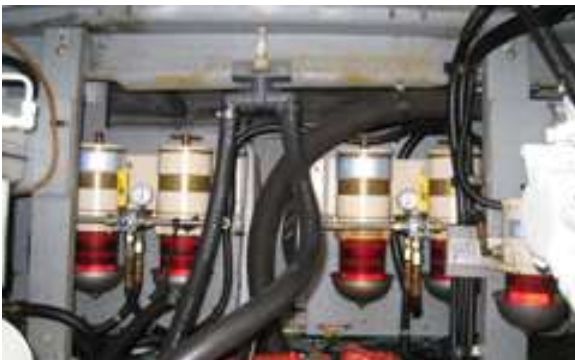
*Fuel supply and filters*

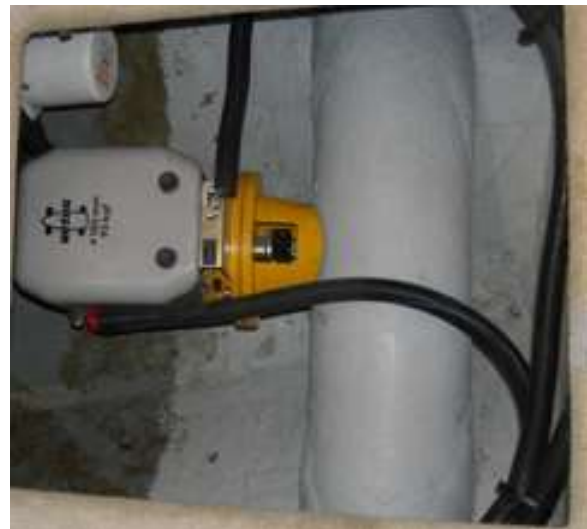
*Fairly new Bow Thruster*

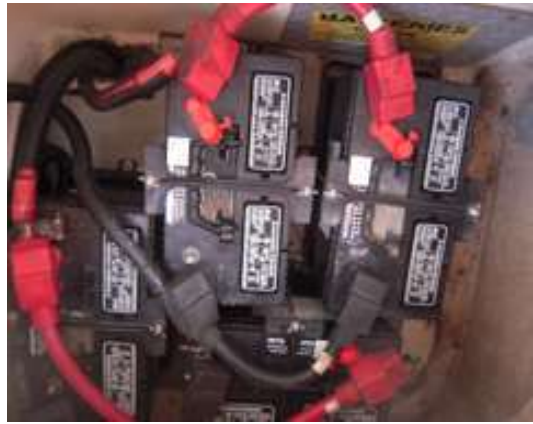
*Batteries, secured and protected*

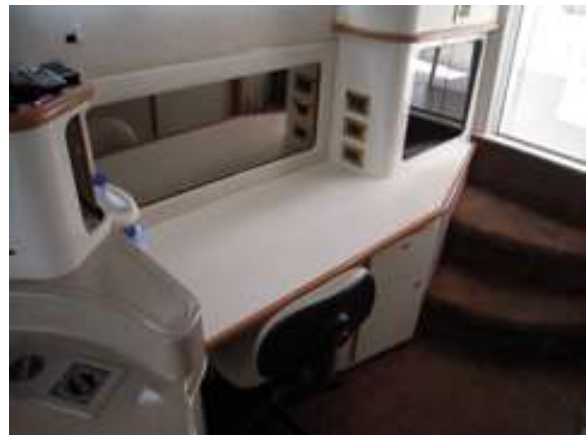
*Navigation station*
