**JAMES CROSS, Certified Marine Surveyor**  
 19 Nooseneck Hill Rd., West Greenwich, RI 02817  
 Phone (401) 397-5040  
 Member Association of Certified Marine Surveyors (ACMS) USA/COM  
 Check us out on the web at [www.jimcross.net](http://www.jimcross.net)

Re: 2016 Beneteau Oceanis 45 Sloop

This letter reports the results of a survey of the above vessel which was inspected on the 15th of October, 2019, while afloat at the Newport Shipyard in Newport, Rhode Island. You requested the inspection to establish its condition and value.

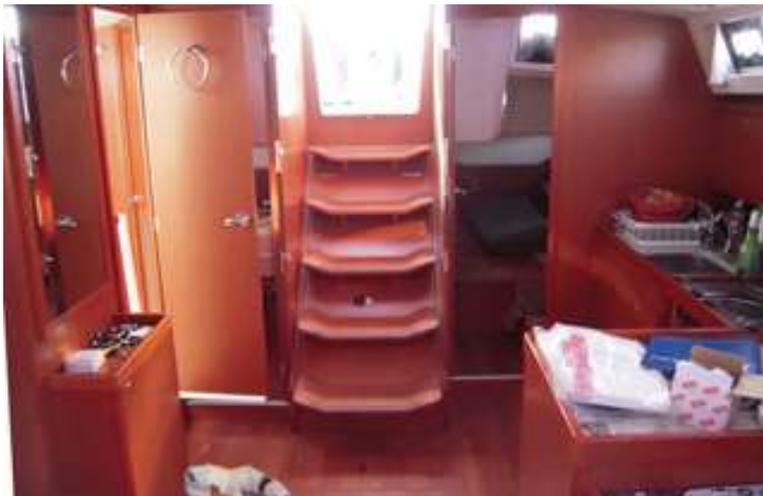
Photo at left is a view of the companionway entry ladder to the main cabin, The entire unit folds upward for easy access to the engine compartment.

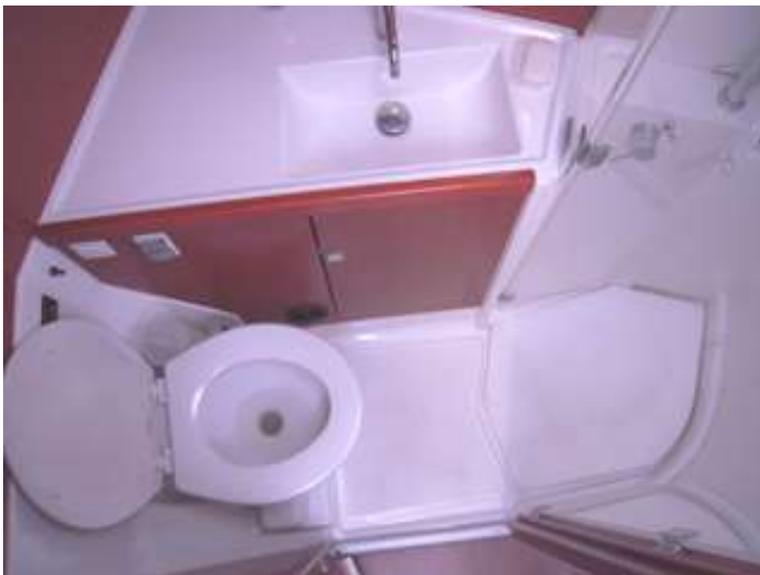
Pictured at left are the two head areas, one forward with shower and one aft.

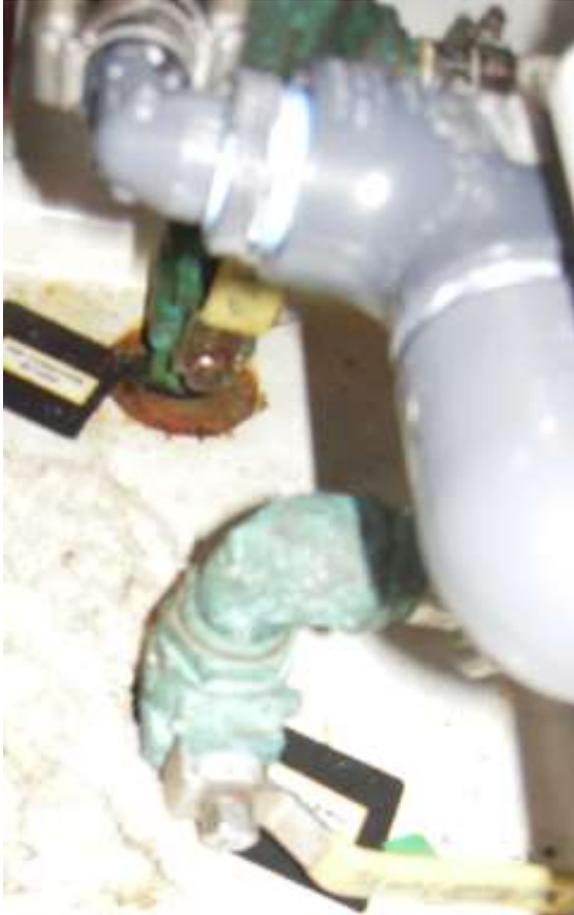
Note photo at left: A rusted fitting you may not be aware of.

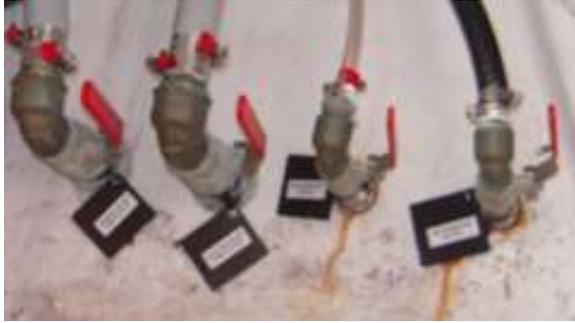
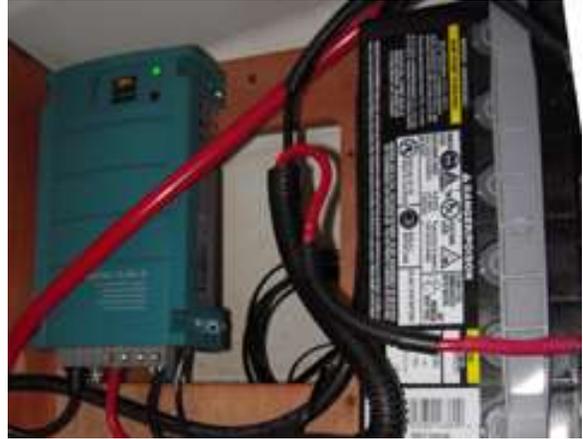
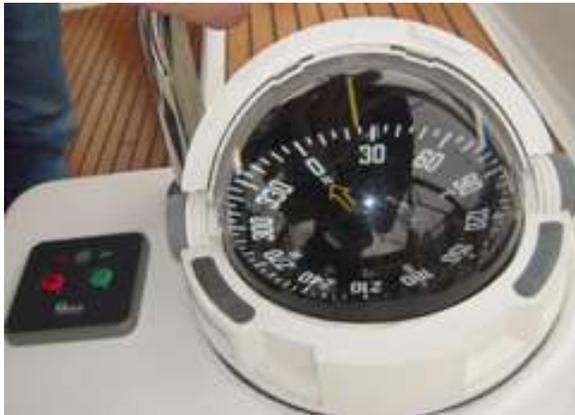
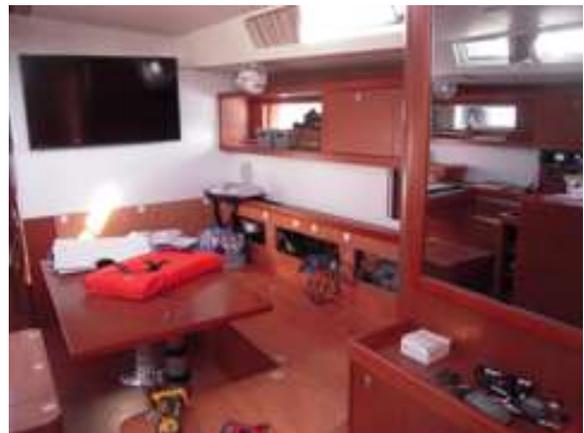
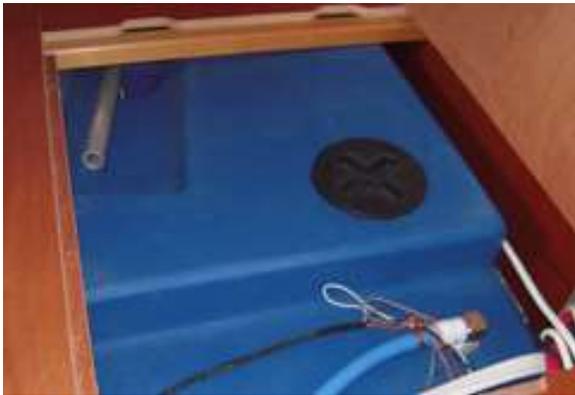
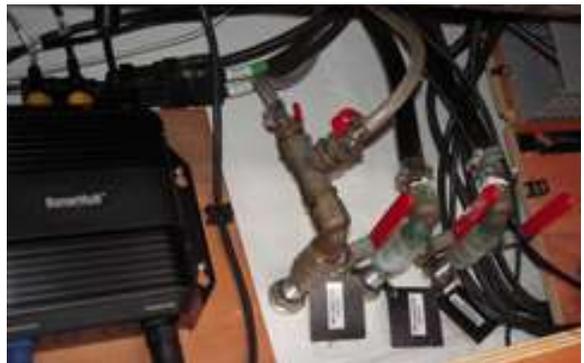
*Other photos page*

*On this page are samples of equipment and their very neat installation. All wiring observed is properly routed and harnessed. Terminals are well protected at the AC level and DC terminals at the batteries are well protected and secure.*
