**JAMES CROSS, Certified Marine Surveyor**  
 19 Nooseneck Hill Rd, West Greenwich, RI 02817  
 Phone (401) 397-5040  
 Member Association of Certified Marine Surveyors / ACMS-USA.COM  
 Check us out on the web at [www.jimcross.net](http://www.jimcross.net)

Re: 2005 Beneteau Oceanis 523 Cutter

"Flying High"

"Survey for Insurance, only, not pre-purchase"

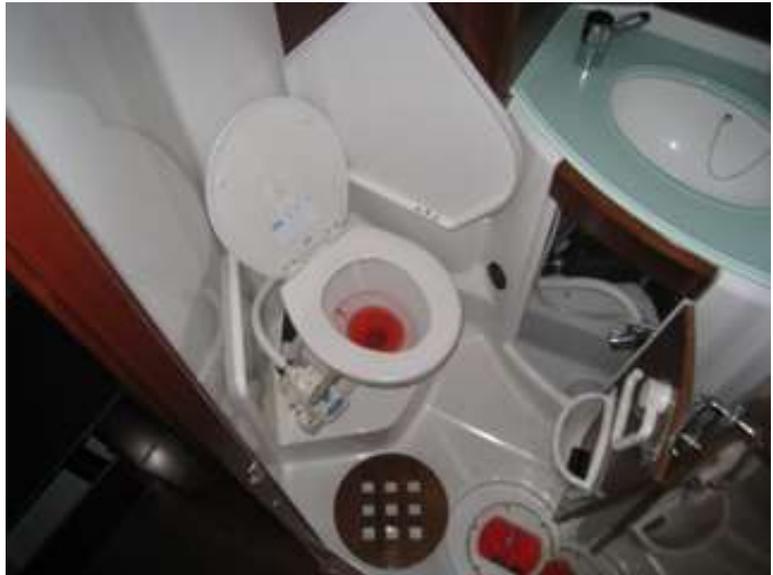
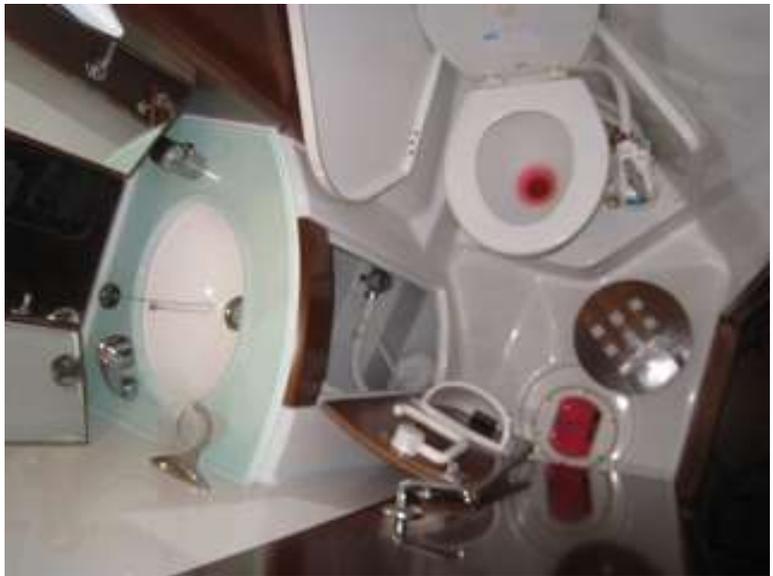
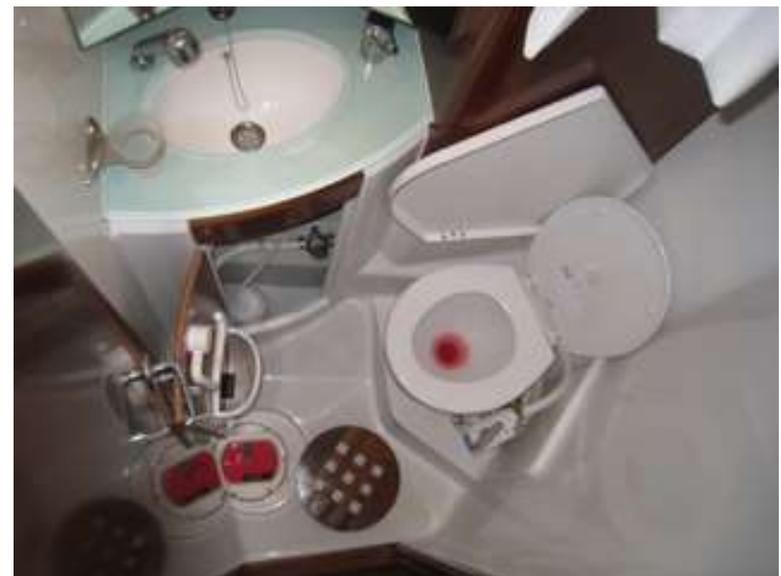
Pictured at right are the three head areas, one forward with shower and two aft.

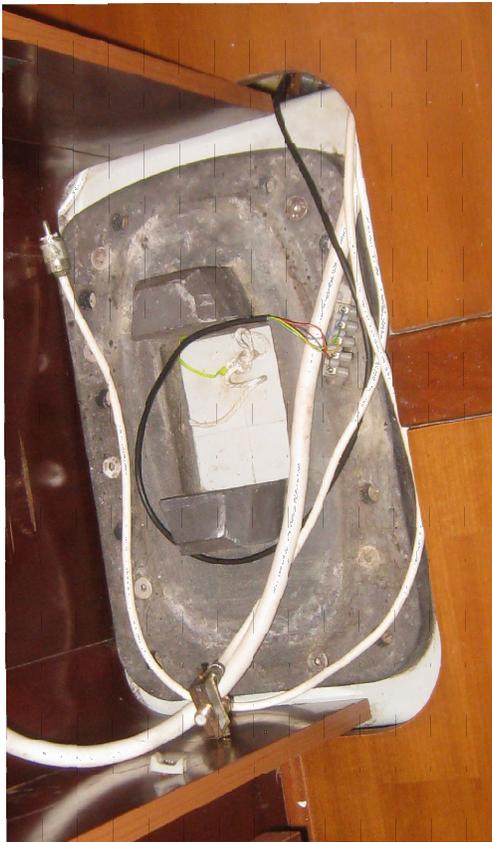
Pictured below is the well secured mast step. No oxidation noted.

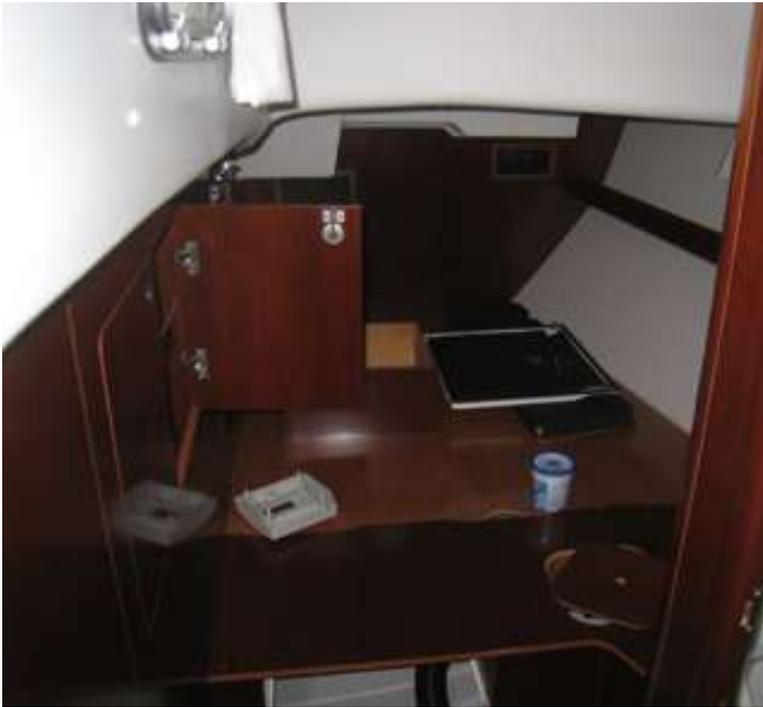
There are two Aft-Berth compartments located beneath the after deck. (one shown at left) These areas will sleep four. These areas are clean and nicely upholstered. There is adequate lighting and locker space in these area. The escape deck hatches to these areas are tight to the weather and in good condition.

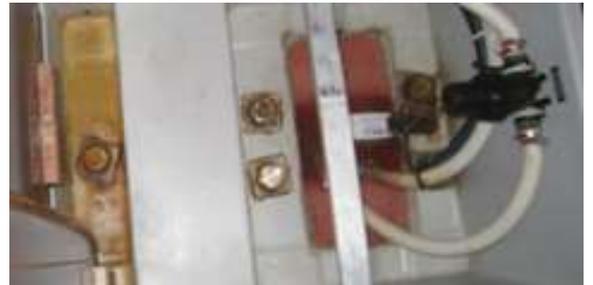
Pictured are a clean bilge, and heavy duty stainless keel bolts

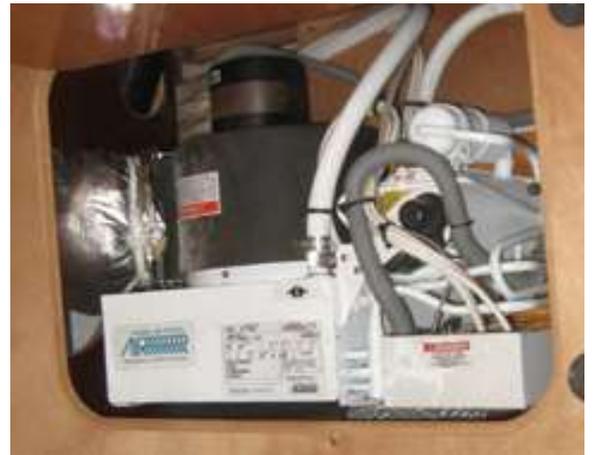
One of three Heat/Air units
