JAMES CROSS, Certified Marine Surveyor
 19 Nooseneck Hill Rd., West Greenwich, RI 02817
 Phone (401) 397-5040
 Member Association of Certified Marine Surveyors/ACMS-USA.COM
 Check us out on the web at www.jimcross.net

Re: 2001 Bruckman Blue Star 29.9 "NO NAME"

This letter reports the results of a survey of the above vessel which was inspected while hauled on the 15 of May, 2018 at Wickford Marina in Wickford, Rhode Island. You requested the inspection to establish its condition and value in order to purchase insurance. Present during the inspection were you, myself, and my associate, Mr. Rob Nutt, MS.

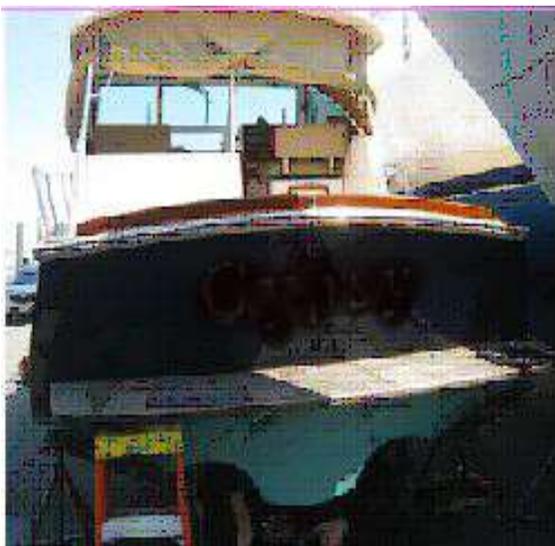
Hull and Structures

The hull is a typical polyester laminate reinforced with fiberglass matt and woven roving in a deep V configuration with no keel. The freeboard finish is factory applied blue epoxy paint with boot and cove trim, and is in excellent condition. I was unable to locate any delamination or separating of glass, including the engine bearers. The bottom is freshly painted with green antifouling paint, and is in good condition. The bottom was sounded and no soft spots or repairs noted. The topside (deck is cored and reinforced) is also epoxy white and in flawless condition, no soft spots were noted. All through hulls are nylon or bronze and are in good condition with properly working ball valves. The vessel is equipped with a large Teak swim platform. The

platform is in good condition and is secure. There are bow and anchor pulpits, and they are in good condition and secure. All of the deck hardware is properly backed and secure. The rudder shaft logs are in good secure condition. The internal structure is well attached to the main structure. The hull/deck joint is mechanically secure and there are only a couple of very small dings in the rub rail. The overall mechanical condition of the hull and attachments is Bristol. The hatches and ports are all in very good condition and tight to the weather. The cockpit is secure and blemish free. A very comfortable operating station with plenty of guest seating is built in. The cockpit is blemish free and sturdy.

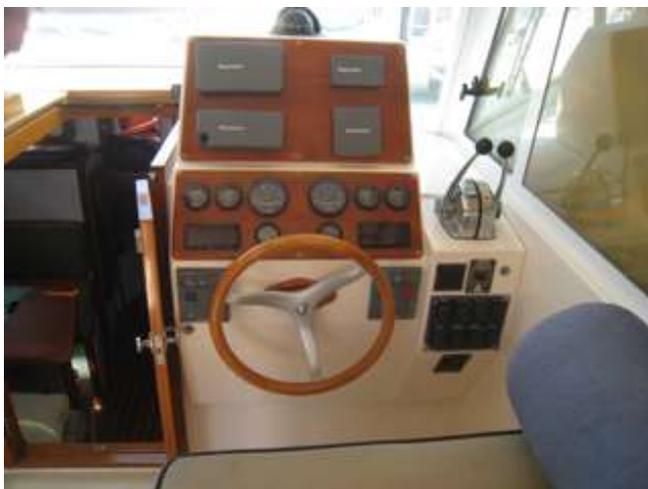
Operating Stations

The operating station area, including the upholstery, is in lightly used condition. The upholstery appears lightly used. The epoxy finish coat does not have the usual crazing and season cracks. The full enclosure canvas including vinyl hard top also shows light use.

The operating station is well designed and the controls easy to operate. The compass is accurate on the present bearing. The control panels including all gauges were not checked out while operating. The operating station area is larger than most and overall in excellent condition.

The supporting structure components for the hard top and weather enclosure are secure, properly backed and in excellent condition.

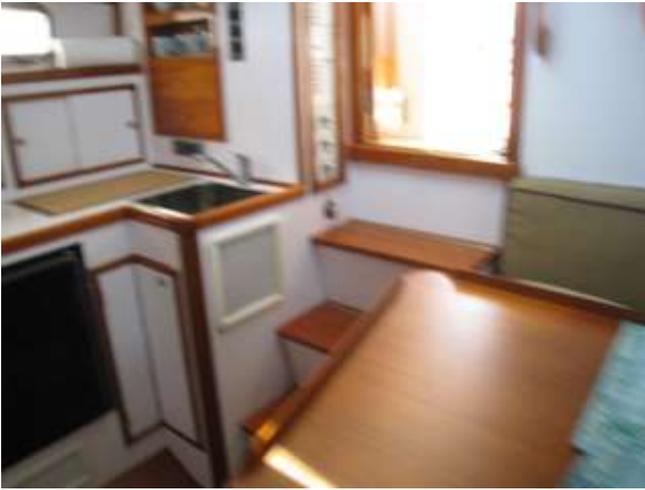
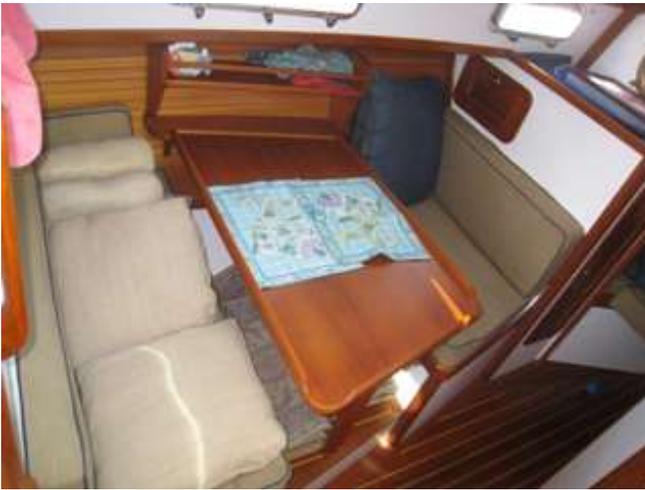
Main Salon

The main cabin houses the salon, galley, and dinette. This area is spacious, nicely finished and also in Bristol condition. The jointer work is made up of solid Cherry, plastic, and vinyl, and for the most part, looks professionally maintained.

The upholstered sections show light use, good care, and maintenance. The doors and ports are in good condition and tight to the weather. The entire interior area is in excellent condition and bright. The overhead vinyl liner also appears in excellent condition. The entire deck (sole) is in sturdy, solid condition and is well supported. The deck surface covering is Teak and Holly and is in very good, clean condition. All deck supports were checked from below and all are secure. Lighting is good throughout the vessel. The dinette converts to sleep two adults. The vinyl upholstery also shows only light use. The main salon, overall, is in excellent condition.

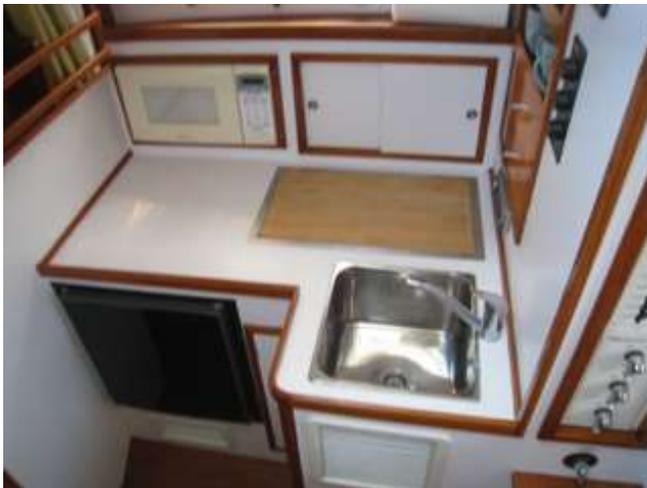
Galley

There is a complete inventory of good size galley appliances stove with built in Microwave oven, refrigerator with freezer, which is also in lightly used condition. The counter top in the galley is comprised of Corian which is in good shape. There is a large stainless sink located as shown. The sink and its related faucets and over board drain are in good condition and clean. The sole in the galley and forward is also Teak and Holly and is in excellent condition and secure. No rot was found in any deck timbers or supports. The galley is located a few steps aft of and below the operating station. The galley and dinette (space for four), overall, is in excellent condition.

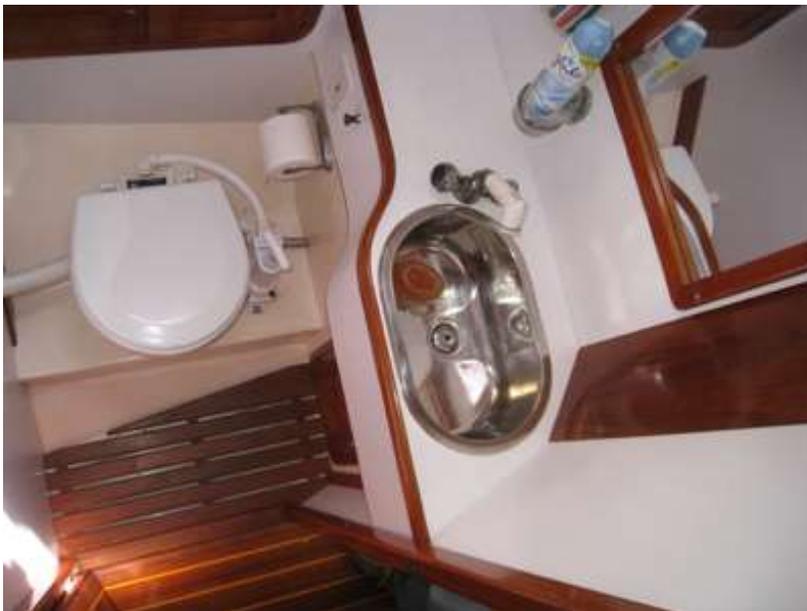
Head and shower

The head is also a multi piece laminate enclosure with built in shower. It is properly secured to the hull and forms an integral part of the hull unit. It houses a vanity with hand basin, manual flush marine toilet and shower. The shower pump out device is in good, clean condition. There is a macerator unit installed. This unit appears in good condition.

Dockside pump out was not checked out. The overall condition of this forward area is very good and is in the same Bristol condition as the other

areas. No septic odor was noted. The entire septic system (below deck) appears in original condition.

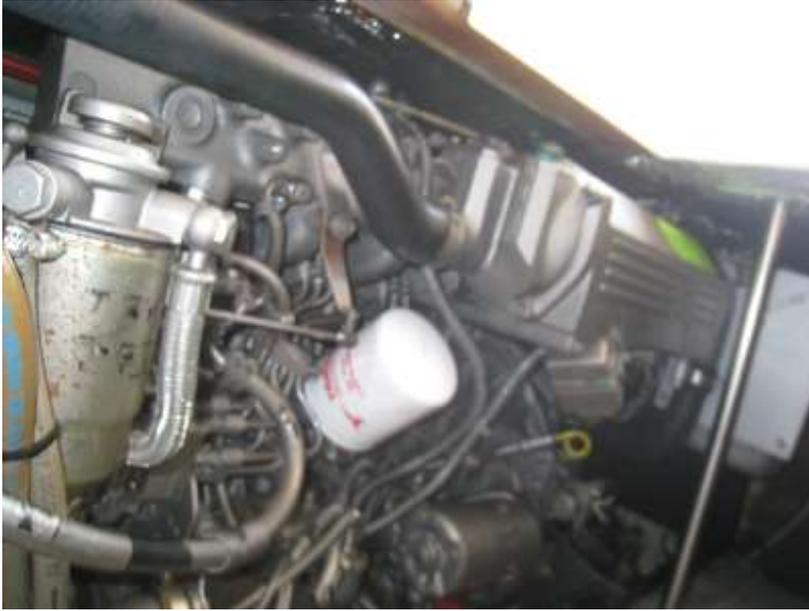
Engines and engine spaces

Propulsion is by a pair of fresh water cooled counter rotating eight cylinder Yanmar Turbo charged Diesel engines with Hurth reduction gears. Approximately 250 HP each. The stainless shafts and bronze shaft logs are in good condition. Visual inspection of the engines, oil, filters, coolant, and related connections show that a good maintenance regime is in effect. Approved bilge blowers and hoses are installed. There are two bilge pumps mounted in the bilge. One bilge pump mounted aft near the steering gear is cracked and probably not functional.

8. Carburetor back fire flame arrester..... NA-Diesel engines
9. Exhaust system.....US Coast Guard Approved type rubber, appropriate silencers, in serviceable condition, with original supports in place.
- 9a. Exhaust system risers.....All good
10. Engine mounts..... stringers are secure, motor mount severely rusted and should be checked by the yard
11. Engine shaft logs..... secure, properly clamped.

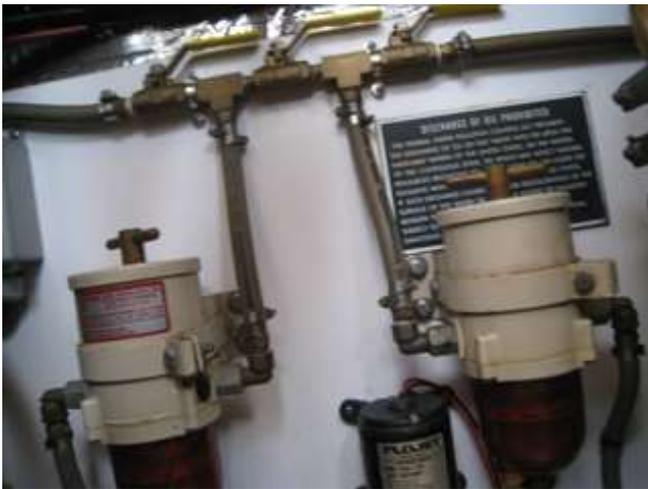
The stainless fuel tanks, (there are two), approximately 220 gallons, is in good condition, as can be inspected. There are proper fuel shut-off valves on all feed lines. Shut-offs are in good clean condition. All fuel lines and valves appear original and have been well maintained. There is no trace of oil in the bilge, and the bilge is clean overall.

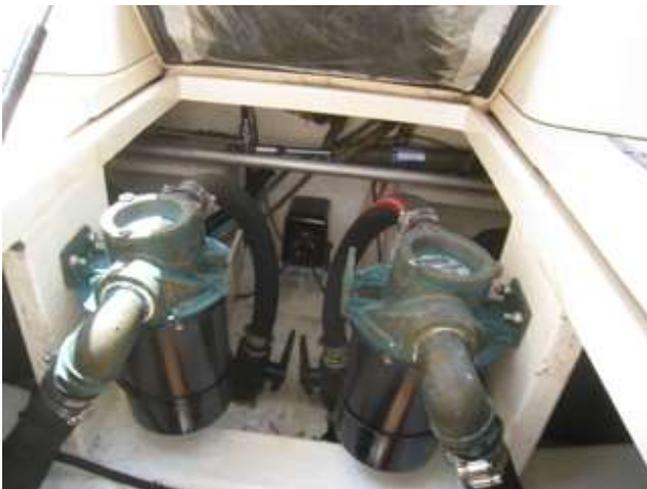
The exhaust systems including the silencers are also in good condition. All bronze valves and salt water devices in the engine compartment are in good condition and properly bonded.

The engines were not checked while running but do appear in excellent, well maintained condition. The intake and exhaust systems, including the silencer and sea water strainer are in good condition and secure.

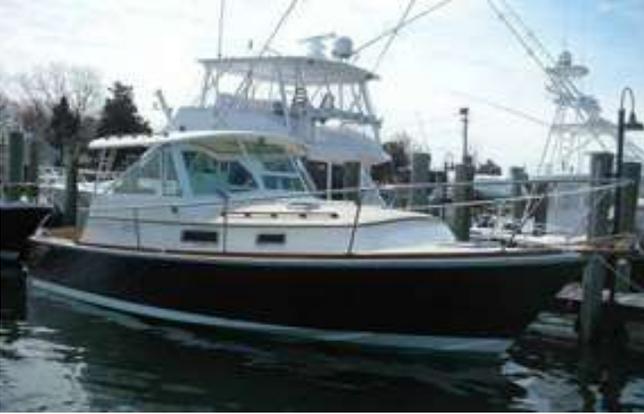
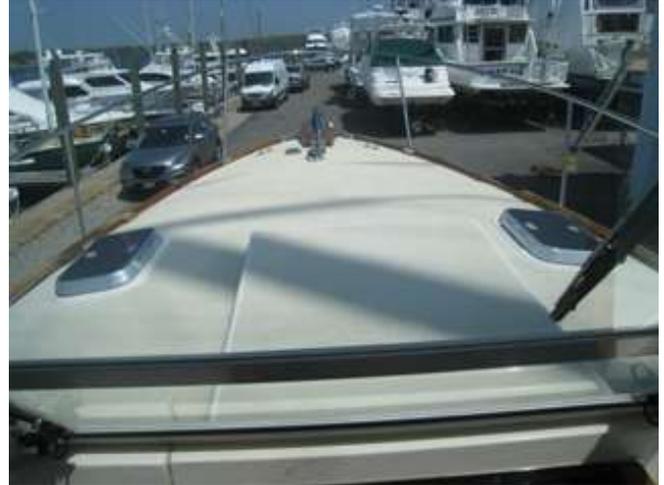
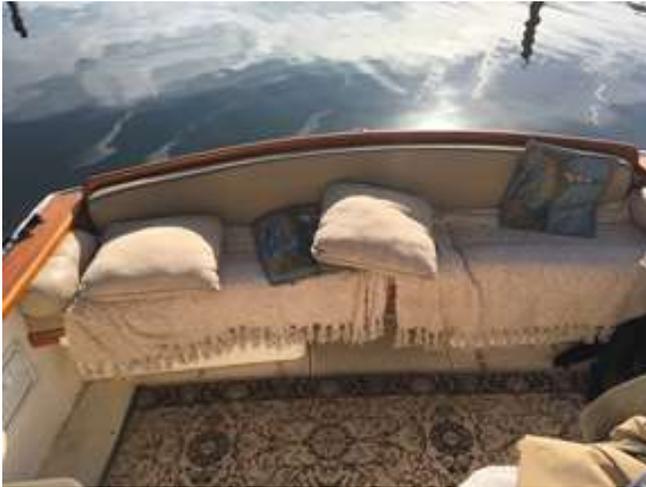
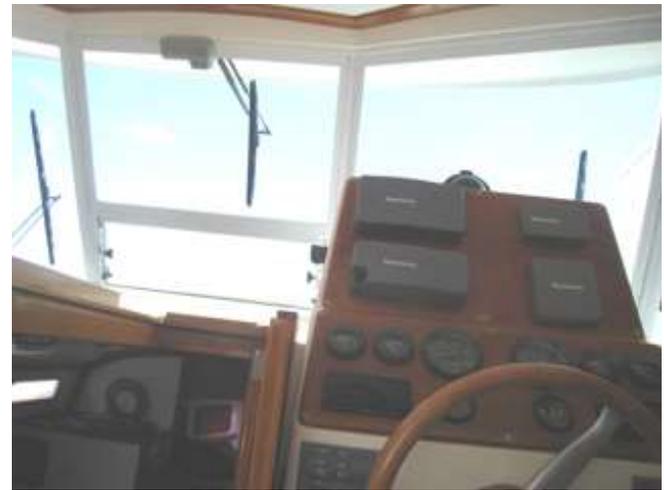
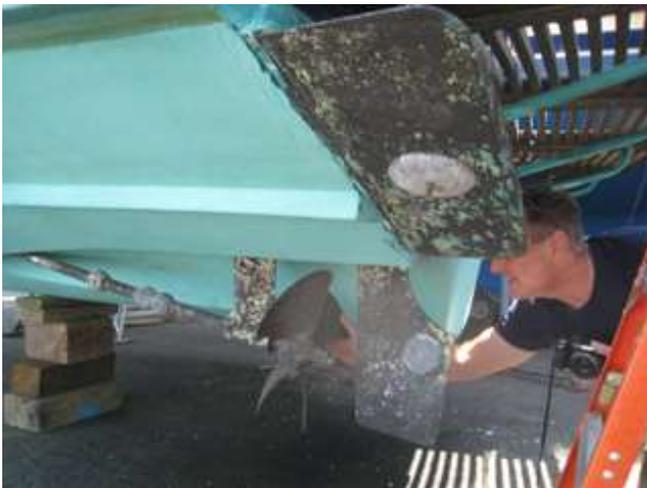
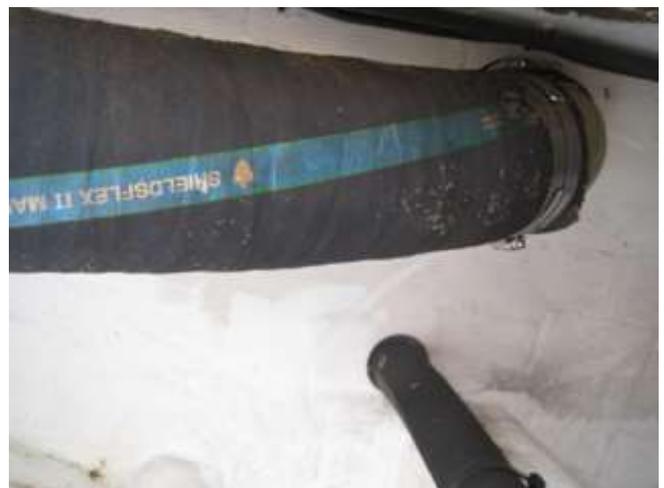
Other Photos Page

The above photos show: view while vessel was afloat, last season, the fore deck, cockpit, operating station, shaft, propeller, strut, and trim plane, and exhaust to overboard at transom. These photos also indicate a well maintained vessel.
