JAMES CROSS, Certified Marine Surveyor
 19 Nooseneck Hill Rd., West Greenwich, RI 02817
 Phone (401) 397-5040
 Member Association of Certified Marine Surveyors/ACMS-USA.COM
 Check us out on the web at www.jimcross.net

Re: 1995 Catalina Islander 34 "FIRST ONE"

This letter reports the results of a survey of the above vessel which was inspected while hauled and afloat on the 18th of July, 2018 at Milford Boat Yard, Milford Connecticut.

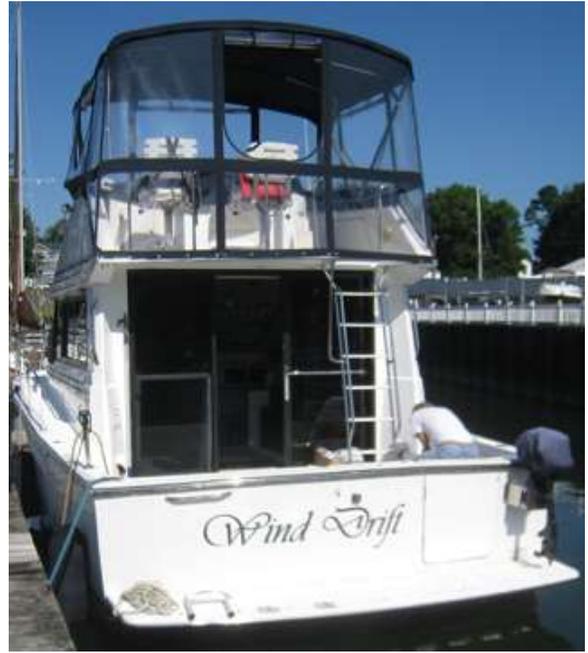
The hull is a fiberglass composite structure reinforced with various fiberglass material, resins, and core materials in a modified deep Vee configuration, with no keel. The freeboard finish is white gel coat with boot and cove trim, and is in excellent condition. I was unable to locate any delamination or separating of glass, including the engine bearers. The bottom is painted with black antifouling paint, and is in good condition. The bottom was sounded and no soft spots or repairs noted. The topside (deck is cored and reinforced) is white and in good, sturdy condition, no soft spots were noted. All through hulls are nylon or bronze and are in good condition with properly working ball valves. The vessel is equipped with a large swim platform with attached stainless boarding ladder. The platform and swim ladder are in good condition and are secure. There are bow and anchor pulpits, and they are in good condition and secure. All of the deck hardware is properly backed and secure. The rudder shaft logs are in good secure condition. The bridge and super structure are properly attached to the main structure. The hull/deck joint is mechanically secure and there are only a couple of very small dings in the rub rail. The overall mechanical condition of the hull and attachments is good. The hatches and ports are all in very good condition and tight to the weather. The cockpit is secure and blemish free. The stainless ladder the bridge is secure. The cockpit is blemish free and sturdy. The cockpit entry door from the swim platform is in good shape.

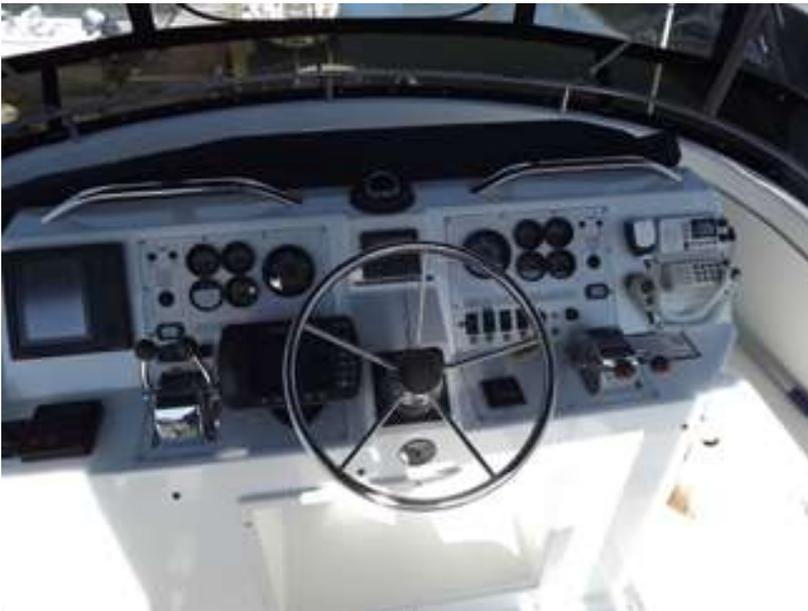
Bridge and Operating Stations

The fly bridge area, including the upholstery, is in excellent condition. The upholstery appears lightly used. The gel coat does not have the usual crazing and season cracks. The full enclosure canvas including vinyl hard top shows light use.

The operating station is well designed and the controls easy to operate. The compass is accurate on the present bearing. The control panels including all gauges were checked out while operating. The fly bridge area is larger than most and overall in excellent condition. There is a stainless life rail installed, properly backed and in secure condition.

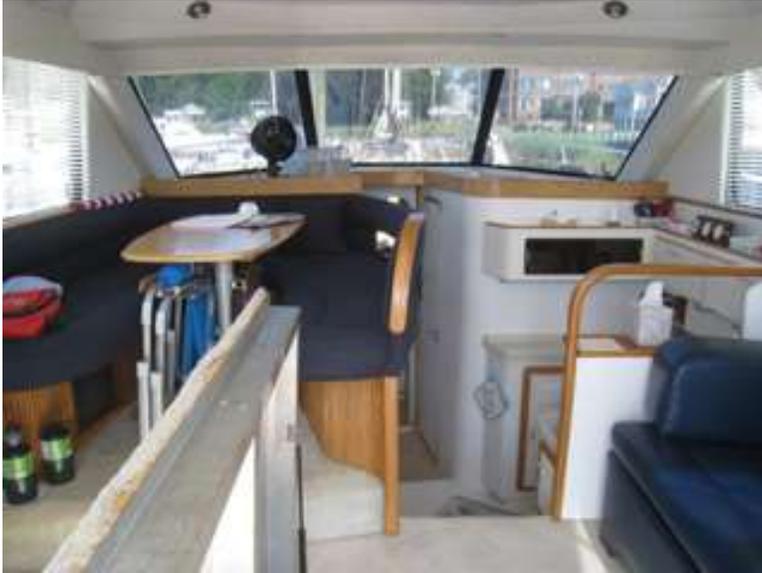
Main Salon

The main cabin houses the salon, galley, and dinette. This area is spacious, nicely finished and also in Bristol condition. The jointer work is made up of solid Cherry, plastic, and vinyl, and for the most part, looks professionally maintained.

The upholstered sections show light use, good care, and maintenance. The doors and ports are in good condition and tight to the weather. The entire interior area is in excellent condition and bright. The overhead vinyl liner also appears in excellent condition. The entire deck is in sturdy, solid condition and is well supported. The deck surface covering is mold resistant nylon carpet and is in very good, clean condition. All deck supports were checked from below and all are secure. Lighting is good throughout the vessel. The dinette converts to sleep two adults. The vinyl upholstery also shows only light use. The main salon, overall, is in excellent condition.

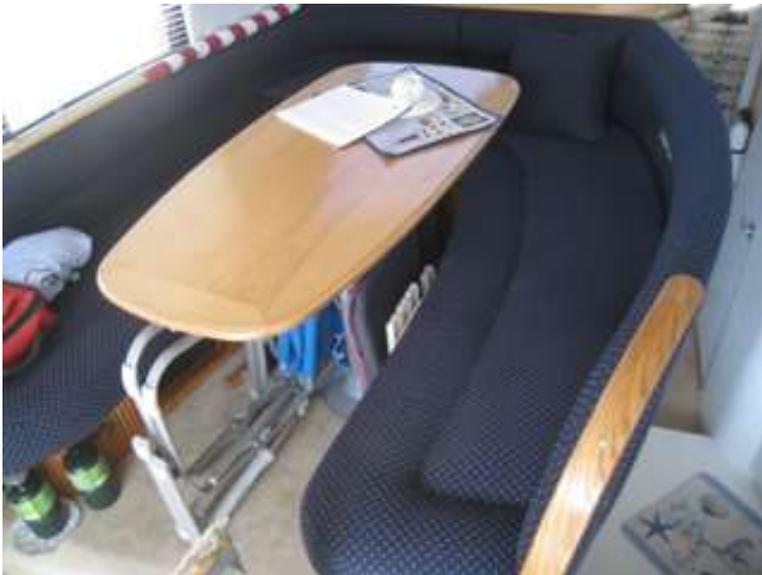
Galley

There is a complete inventory of full size galley appliances stove with built in Microwave oven, refrigerator with large freezer, which is also in lightly used condition. The counter top in the galley is comprised of Corian which is in good shape.

There is a large moulded in sink located as shown. The sink and its related faucets and over board drain are in good condition and clean. The sole in the galley and forward is also hard wood and is in excellent condition and secure. No rot was found in any deck timbers or supports. The galley is located a few steps forward of the main salon and dinette. The dinette (space for four), overall, is in excellent condition.

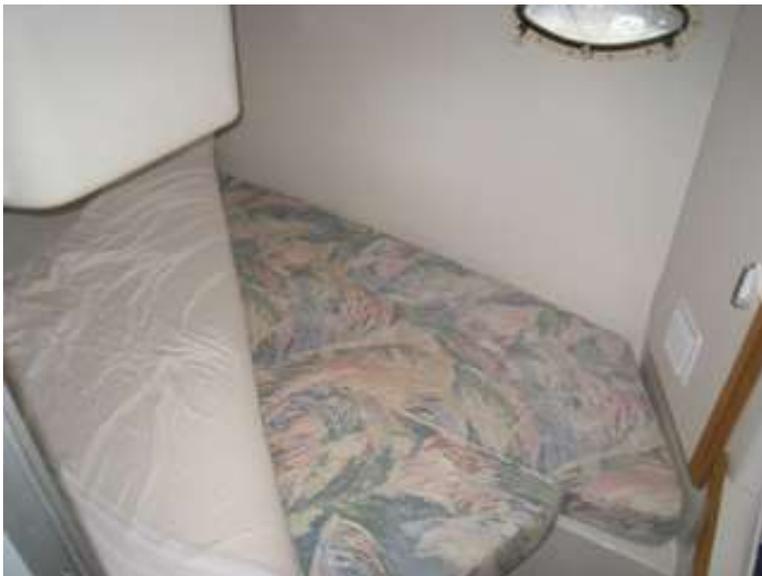
Second forward berth area

A second large berth area is located just aft of the v-berth. These spaces are in excellent condition and are well maintained.

The second stateroom is also located forward of the main salon dinette deck with entries to the head and main passageway. This area is also equipped with an oversized bed. This berth area is clean, nicely upholstered and carpeted. There is adequate lighting and ventilation in these areas. Also, housed in this area are several lockers and other storage. The PVC septic and potable water tanks are secured just under the deck.

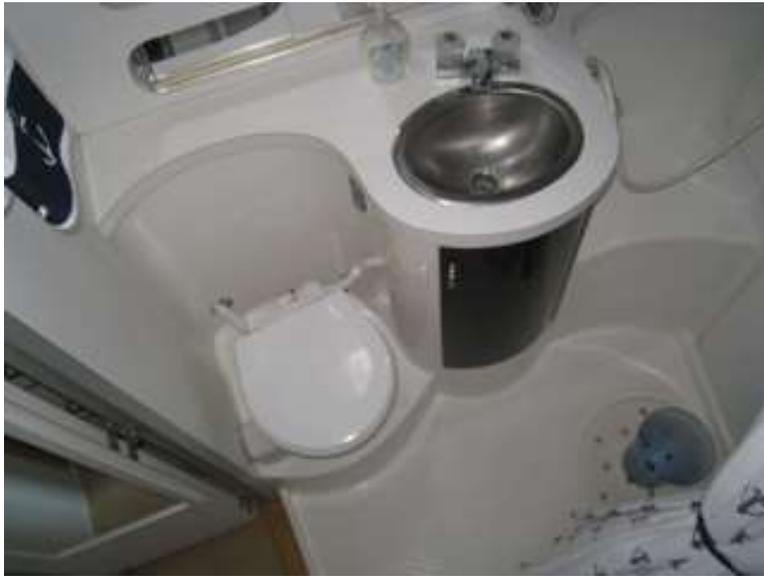
Head and shower

The head is also a multi piece laminate enclosure with built in shower. It is properly secured to the hull and forms an integral part of the hull unit. It houses a vanity with hand basin, electric flush marine toilet and shower. It is in good condition. There is a macerator unit installed. This unit appears in good condition.

Dockside pump out was not checked out. The overall condition of this aft area is very good and is in the same condition as the forward areas. No septic odor was noted. The entire septic system (below deck) appears in original condition

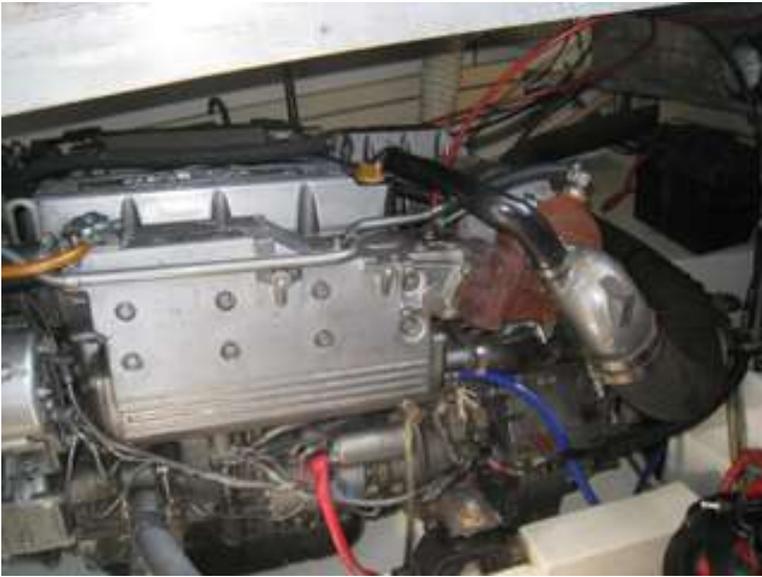
Engines and engine spaces

Propulsion is by a pair of fresh water cooled counter rotating four cylinder Yanmar Diesel engines , Model 4LHDTE with Borg Warner Velvet Drive reduction gears. Approximately 170 HP each. The one and one half inch stainless shafts and bronze shaft logs are in good condition. Visual inspection of the engines, oil, filters, coolant, and related connections show that a good maintenance regime is in effect. The exhaust systems, including the risers and turbos are secure and in good shape. Approved bilge blowers and hoses are installed. The bilge pump, (properly secured and wired) is in good shape.

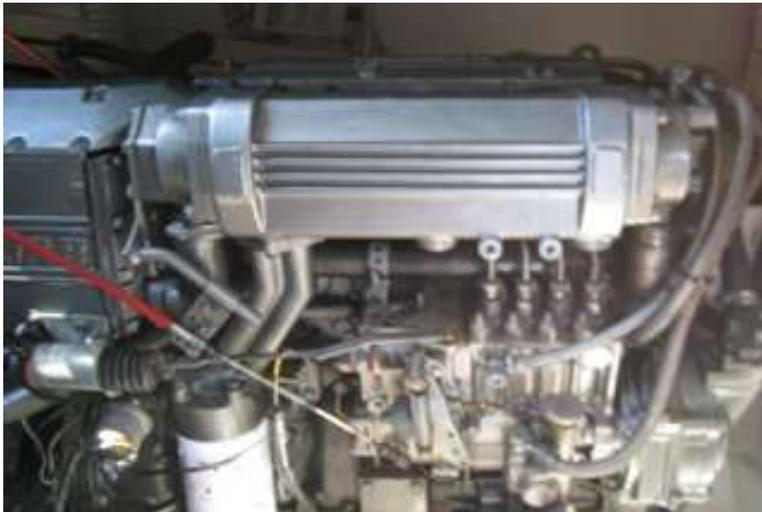
The stainless fuel tank, approximately 300 gallons, is secured aft of the engines and can not be inspected completely. Parts that can be seen show no signs of corrosion. There are proper fuel shut-off valves on all feed lines. Shut-offs are in good clean condition. All flexible fuel lines appear to be recent upgrades. There is no trace of oil in the bilge, and the bilge is clean overall.

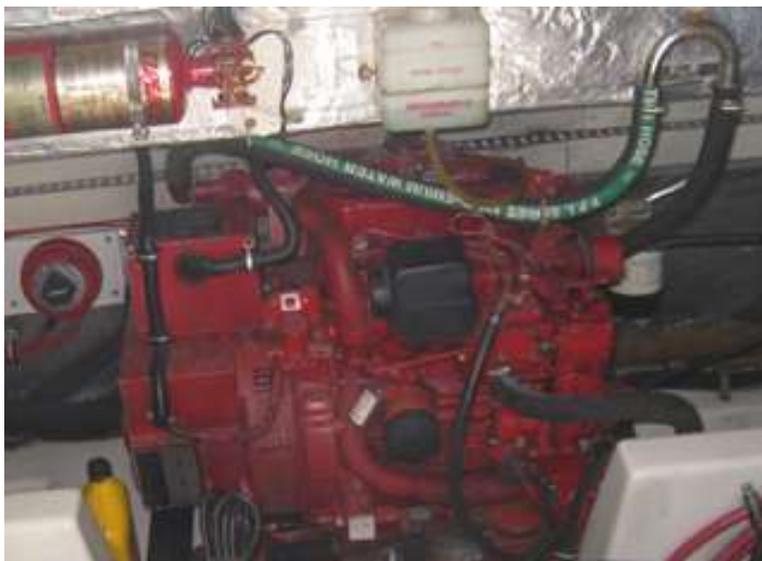
The exhaust systems including the silencers are also in good condition. All bronze valves and salt water devices in the engine compartment are in good condition and properly bonded.

The Westerbeke five KW AC generator was checked while running and operated properly under various loads and is in good condition. The intake and exhaust systems, including the silencer and sea water strainer are in good condition and secure.

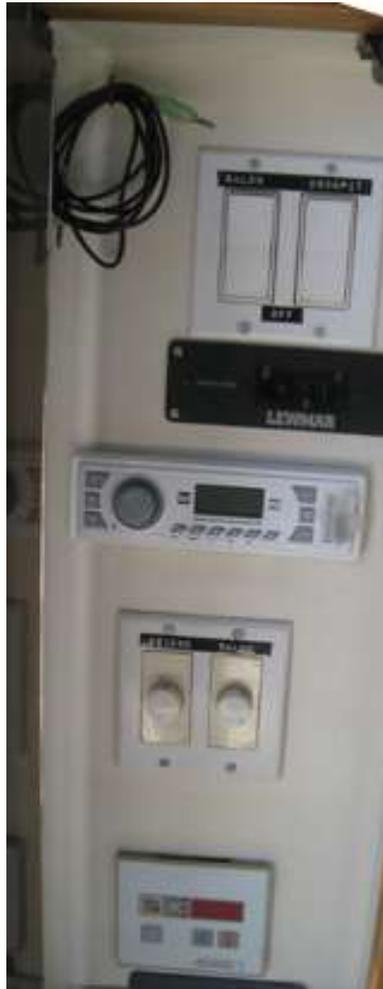
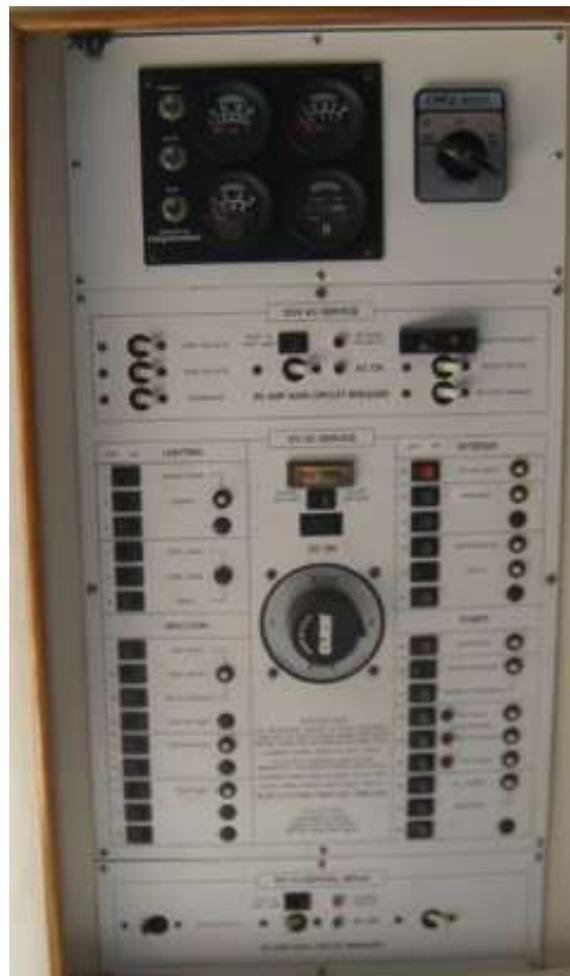
Electrical and Electronics

The main electrical panel is a combination 120 volt AC and 12 volt DC board. The 120 volt section is breaker protected and the 12 volt section is breaker and fuse protected. The electrical panel (120 volt AC and 12 volt DC) is in good shape. The AC/DC refrigerator was checked out while running. There is a 120 volt 30 amp converter-battery charger which appears in good, clean condition. The marine type batteries on board are recent upgrades . All of the batteries are properly secured, but not protected.

The 120 volt 30 amp 50 foot shore power cable is in condition. There is an complete bonding system installed. The running lights conform to the CFR. The electrical wiring, overall is in good secure condition and appears original with proper harnessing in place. I did not notice any modifications to the electrical systems. The electric windlass is properly installed and powered.

Recommendations: Ensure that a complete Coast Guard Safety and Signalling Package is back aboard.
Add backup ground tackle. Add protection to batteries to prevent shorting.
Service & Tag engine room Auto Halon System.
Remove any unessential material from engine room.
Repack port rudder shaft log.

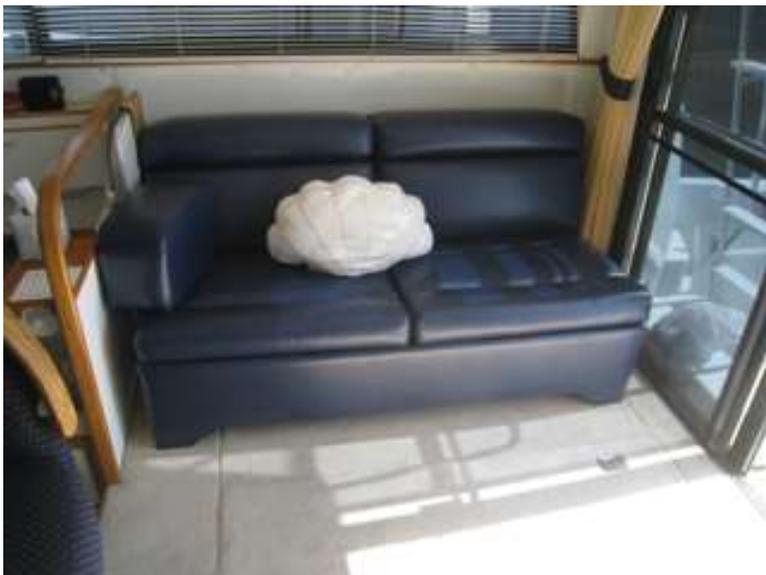
View of main saloncouch that opens to a double berth

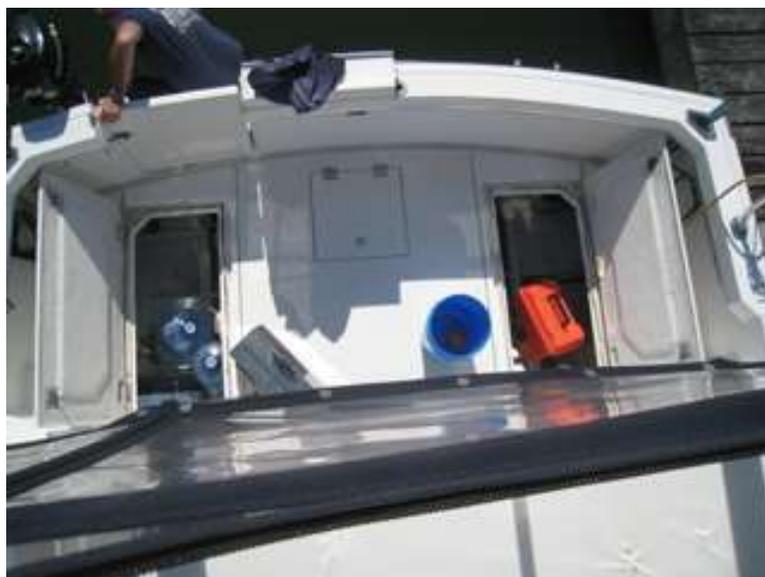
View of cockpit from bridge

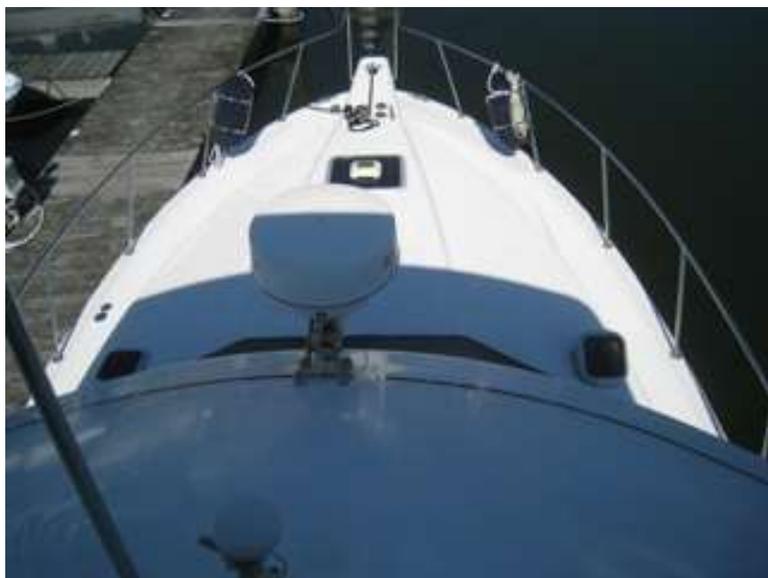
View of bow deck, life rail and anchor pulpit

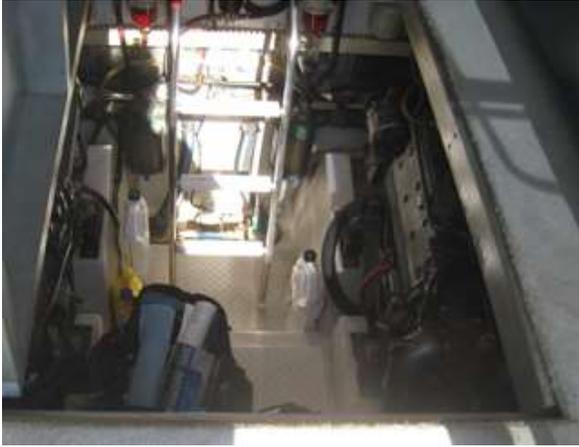
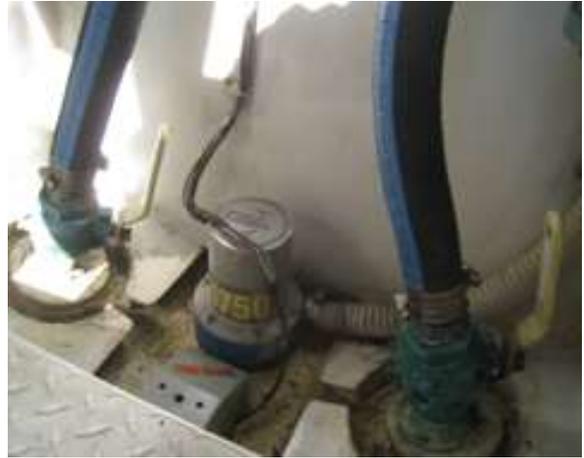
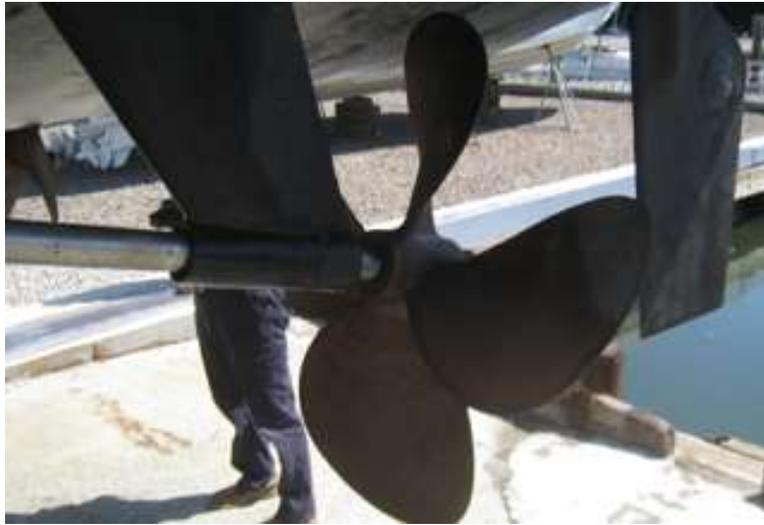
Other Photos Page 2

The above photo show: the main salon ladder to engine room.

Starboard side, propeller, shaft, rudder & strut. Raw water intake valves and bilge pump.

These photos also indicate a well maintained vessel.
