Re: 1985 Chris Craft Commander Sport 442

"MARTOONI"

This letter reports the results of a survey of the above vessel which was inspected while afloat, covered, and winterized on the 27th of February 2018, at the East Greenwich Yacht Club in East Greenwich, Rhode Island. You requested the inspection to establish it's condition and value.

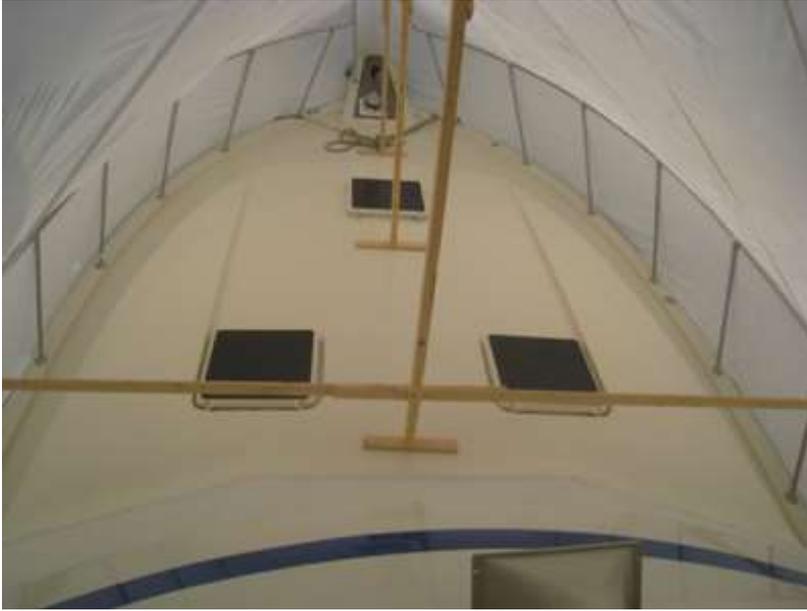
The hull is a hand laid-up polyester, laminate reinforced with fiberglass matt and woven roving in a modified deep vee configuration with a large skeg (keel). The hull is solid fiberglass laminate. (No core). A balsa and plywood the core used in the topsides and superstructure. The pilot house and fore deck are constructed of solid fiberglass with an end grain balsa core. The structural integrity of the hull is good. The bulkheads and interior tabbing are in good condition and secure. The hull

was checked for excess moisture and found to be within standard limits. All bulkheads are marine grade plywood. All stringers and frames are secure. The hull is rigid. The two part Epoxy finish looks new and is in excellent condition. The entire vessel has been refinished. (Top to Bottom) . The hull-deck attachment is secure and trimmed with a stainless steel and Oak rub rail. I was unable to locate any structural delamination or separating of glass, including the engine bearers and stringers. The bottom (sections below the water line) was not inspected. Receipts show the recent application of a multi coat Epoxy barrier coat.

The interior surface of the hull, as can be observed at the bilge area, is epoxy coated and in excellent condition. All through hulls below the boot are bronze and in operating condition. All through hull fittings are properly bonded.

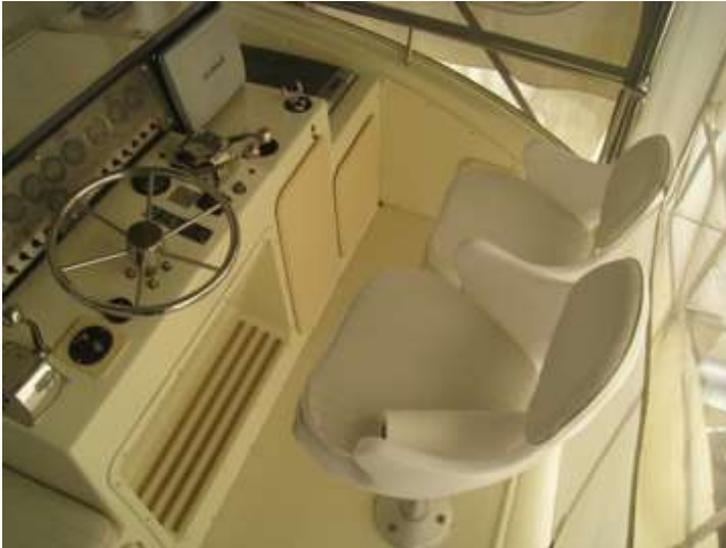
The bridge station is in overall like new condition and clean. The controls are easy to operate. All of the bridge upholstery has recently been replaced with new white vinyl and along with the recent full enclosure and all new electronics gives the appearance of a new vessel. The Epoxy paint, complete enclosure and upholstery was installed by professionals to the highest standards.

The bridge compass is accurate on the present bearing. All surfaces were checked for delamination and soft spots and no problems were found. The deck, and all painted surfaces show no use.

The semi ridged top along with its various antennas and radar dome is supported by the full enclosure structure. An aluminium welded web. (Very secure structure) The outriggers were off for the winter. The enclosure supports are in good condition. The bridge deck was checked for excess moisture and delamination and was found to be secure and sturdy. All wiring to the bridge and electronics enclosure (photo top of next page) is well harnessed and secure.

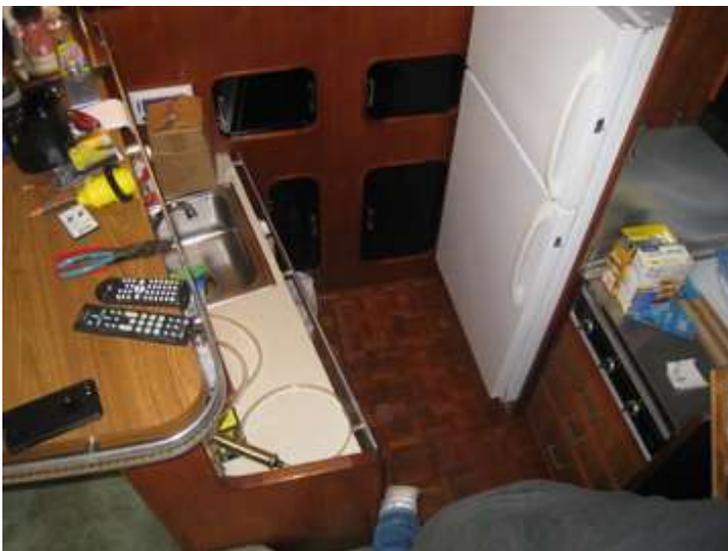
The main cabin houses the salon at the first level. This area is large, nicely finished in Vinyl, Nylon, mahogany veneer, and carpeted, and in good condition. No fresh water leaks were noted. No rot was detected at any location inside the vessel. The entire inside area was checked for excess moisture content in all partitions, the overhead, and all glass surfaces. All furniture has just been replaced with New color keyed furniture.

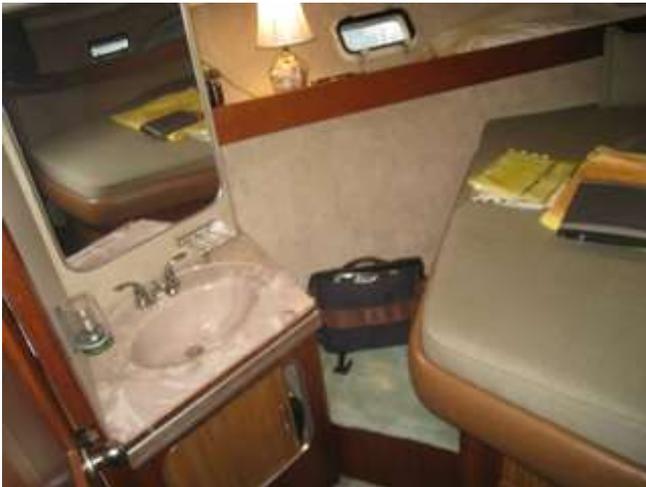
The owners stateroom is located at the v-berth, pictured at left. A queen size berth, dressing station and head are located in this forward section. Hand wash basin with mirror are in lightly used condition.

This area is clean, nicely finished and upholstered. There is adequate lighting and ventilation in this area. The deck in this area is properly supported, nicely finished in color keyed carpet and in overall excellent condition. I was unable to locate evidence any excess moisture on any surface or joint in this forward area. I double checked all assessable hull to deck joints and while the actual joint is not visible, there did not seem to be any leaks or previous damage.

The forward crews quarters (a double bunk type arrangement) berth area is also clean and in good condition. This area houses and adequate locker storage space, pictured at left.

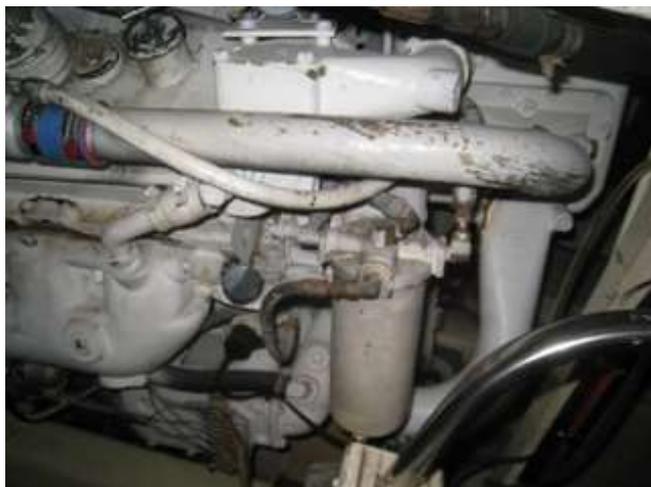
Propulsion is by a pair of counter rotating six cylinder fresh water cooled 475 HP Detroit Diesel engines with Twin Disk reduction gears, coupled to monel shafts and on to four blade bronze propellers. The water cooled shaft logs are in good condition. The fiberglass covered engine beds were sounded and were solid. The engine mount supports are in good shape. The engines and gears were not operated or checked by me as the vessel was winterized. New exhaust elbows were noted and no burn or hot spots were obvious. The engines all appear clean and well maintained. Ventilation to the engine spaces is adequate.

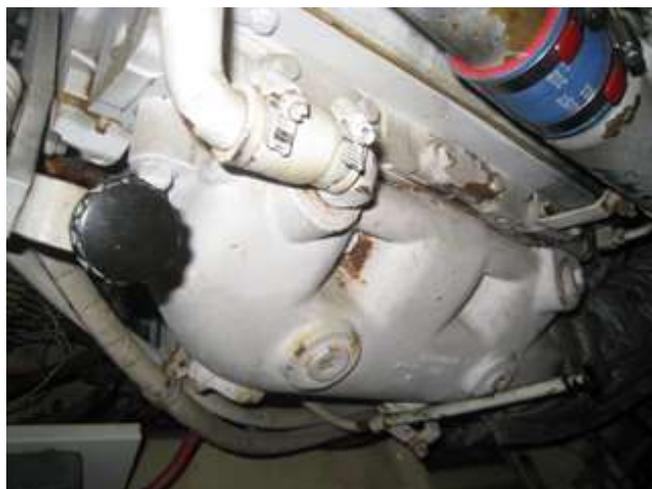
The exhaust system is cast and rubber, with fiberglass silencers, heavy duty, and appear to be recent upgrades. All exhaust hoses and related connections are secure. The system clamps are all doubled and in good shape.

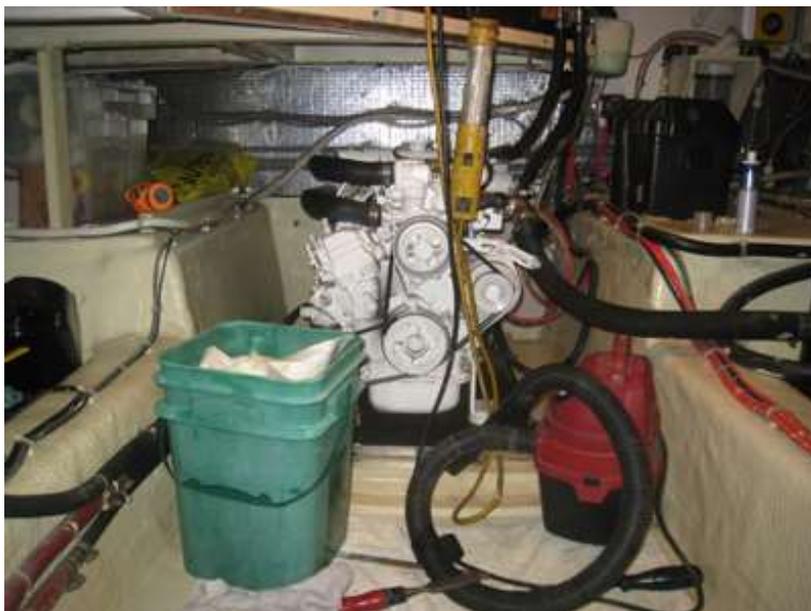
All below water through hull fittings including the valves are bronze and in working order. All valves were operational. The engine controls and cables are smooth operating, both from the upper and lower stations. The engine compartment is epoxy painted, sound, sturdy, but is not free from gear (winter storage) that should be stored properly.

The bilge in this area is in good shape. There are adequate bilge pumps installed and working in this area. There is no oil in the bilge. The raw water intakes are equipped with a proper sea water strainers, and are secure.

Ensure that a complete Coast Guard Safety and Signalling package is aboard. Remove all extraneous gear from around engines and batteries. Install backup ground tackle.

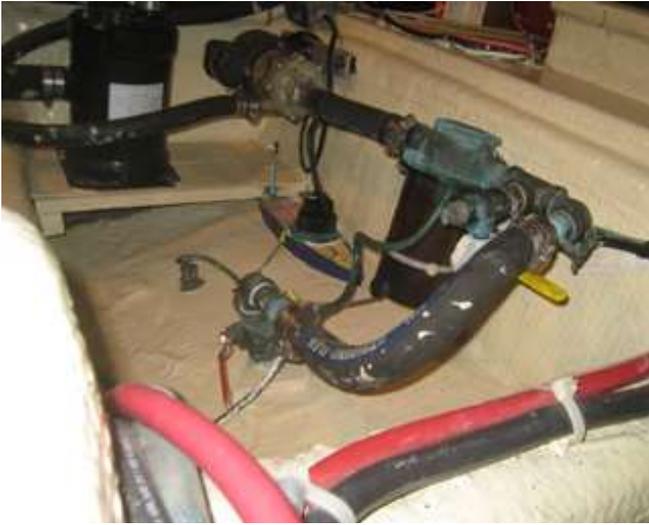
There are water cooled Cruise Air conditioners properly installed that provide heat and air-conditioning to all living compartments.
