JAMES CROSS, Certified Marine Surveyor
19 Nooseneck Hill Rd., West Greenwich, RI 02817
Phone (401) 397-5040
Member Association of Certified Marine Surveyors / ACMS.USA.COM
Check us out on the web at www.jimcross.net

March 19, 2019

Re: 1969 Concorde 47' MY Fly Bridge

This letter reports the results of a survey of the above vessel which was inspected while afloat on the 18th of March, 2019, at Brewers Coweset Marina in Warwick, Rhode Island. You requested the inspection to establish its condition and value.

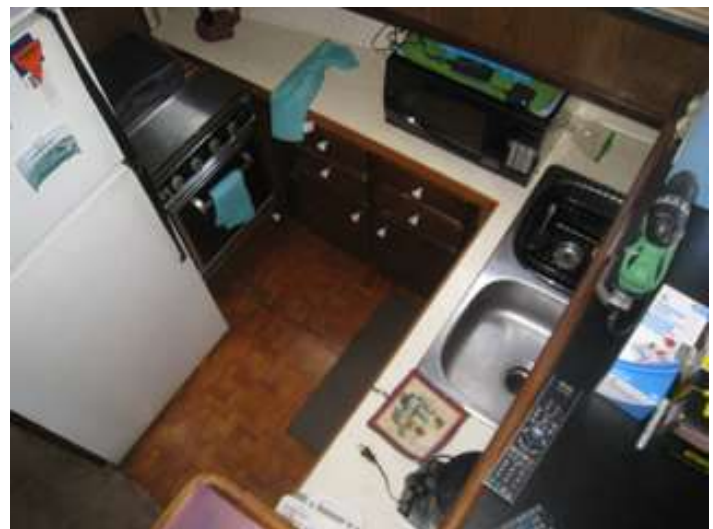
Above photo note the neat access to the main salon spaces. The deck, bulkheads and trim are in good serviceable condition in this salon area.

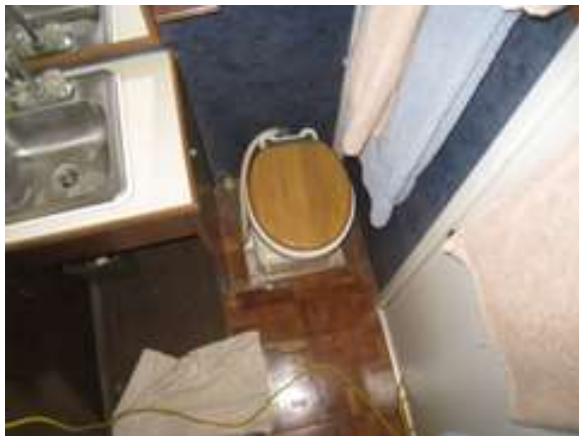
Both areas are equipped with standard electric marine toilets with macerators and hand wash basins. The toilets, hand basin, and their related fittings, including overboard discharges and through hulls, are in serviceable condition. There is a septic odor in the forward bilge indicating a leak from the head plumbing. You should check the overboard fitting for proper operation as the shutoff valves are very stiff and the hoses and related connections may be original equipment. These areas are clean and well kept. Both heads are functional.

No soft spots or wood rot were noted in any wood surface. The plywood decks are Parquet trimmed and well supported. The entire plumbing system was checked for leaks and odors. You should check all head plumbing and replace any original flexible hoses that appear original.

Inspect and tag the engine room auto CO2 system. Secure portable fire extinguishers. Ensure that a complete Coast Guard safety and Signalling package is aboard. Service all raw water intake valves and hoses. Remove unused wiring from engine room. Harness wiring as needed. Install GFI and AC/DC isolation device. Have yard check all fuel lines and filters and all exhaust systems. Secure and protect batteries. Air/Hear system needs service. Determine port engine oil leak and repair. Remove all extraneous material from engine room. Clean bilges prior to getting underway. Service bonding system terminals. Determine septic odor source and repair.

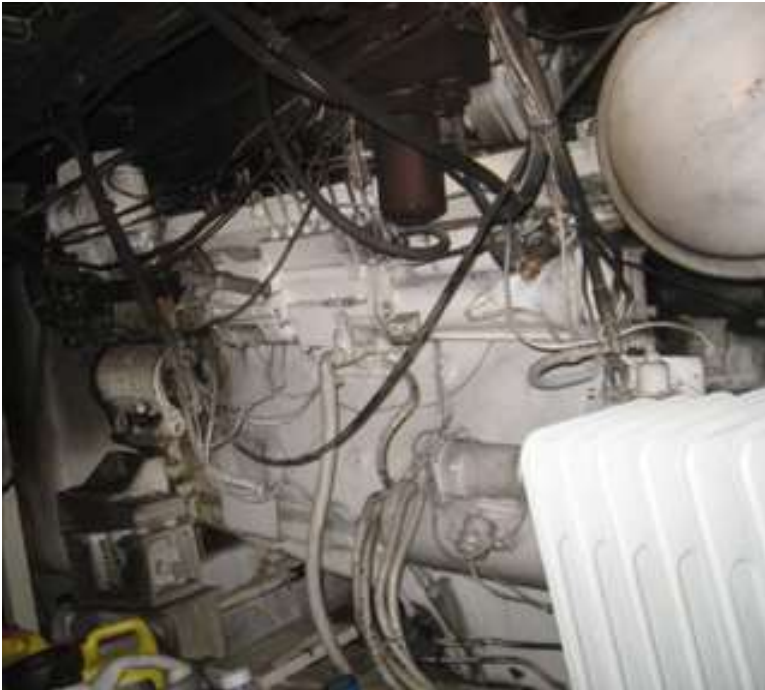
Engine and engine spaces

Propulsion is by a pair of 1995 Caterpillar 330 HP diesel fresh water cooled six cylinder engines with reduction gears. The previous owner provided documentation that the two main engines were replaced in 1995. The engines and gears were not operated as they were winterized. Ventilation to the engine spaces (natural and via a bilge blower) is adequate. The exhaust system is cast and monel and approved rubber and in need of service and a check by the yard. The engine compartment is sound and sturdy. The bilge in this area is in need of cleaning. There are appropriate bilge pumps installed. There is oil in the bilge and the engine room is in need of cleaning and maintenance. The large D-Cell batteries are not properly boxed and protected. The fuel shut-offs are in good order. The fuel fillers are properly installed. The twin air/heat units also need service.

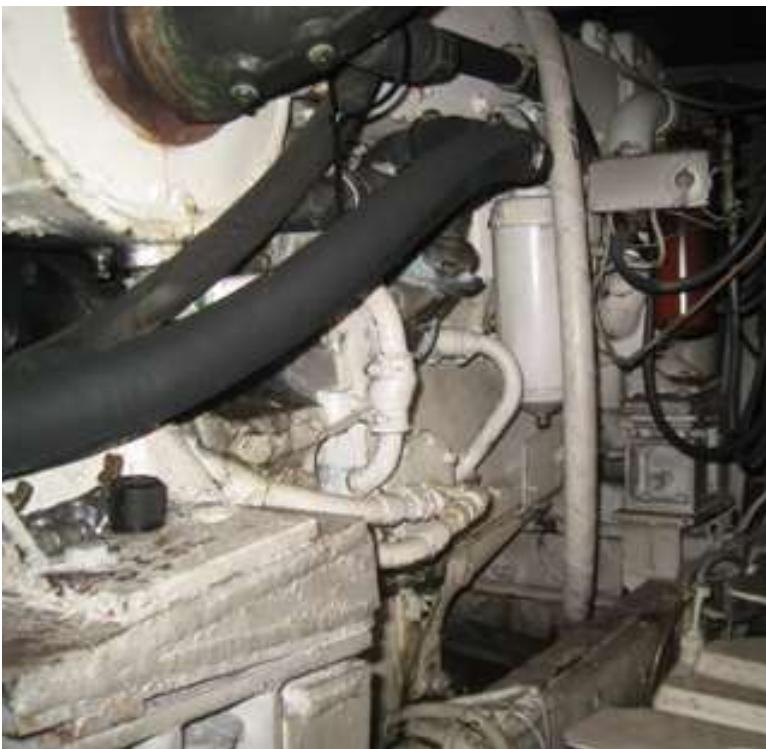
The fresh water cooled Onan 15 KW AC generator exhausts through approved rubber hose to a steel silencer to overboard at the side amidships. The generator is also in need of service and a check by the yard. The steel silencer hose fitting is also leaking. The raw water intake (proper sea water strainer and gate valve) which supplies the Onan is in need of service. Some of the clamps on this system are rusted and should be replaced. There are two bilge pumps mounted aft of the engine compartment. The fuel tanks are properly secured port and starboard of the engines. The fuel tanks are of

moulded fiberglass and could not be completely inspected. Their related fills, vents, and feed lines should be serviced. There are proper fuel shut-offs on all feed lines. The CO2 system is mounted just forward of the port engine should be dated and tagged. The engine spaces including the bilges are in structural good condition. The water tanks as can be observed are in good shape.

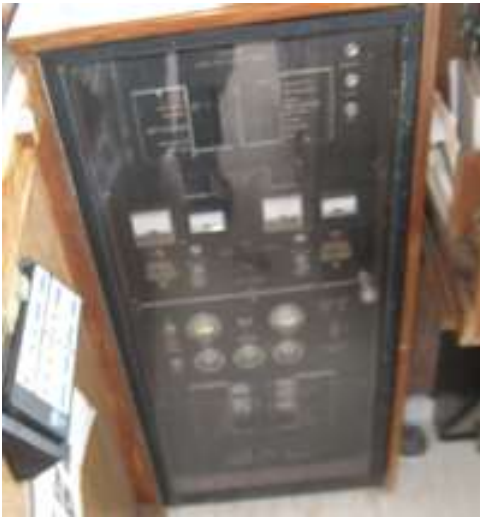
The electrical panels (main and breaker) are in good shape. There are two 2 position battery disconnect switches beneath the aft deck near the properly installed fuel shut-off valves.

The marine type batteries on board are not properly secured. They are covered, but the covers are not secure. All of the battery terminals are in need of cleaning.

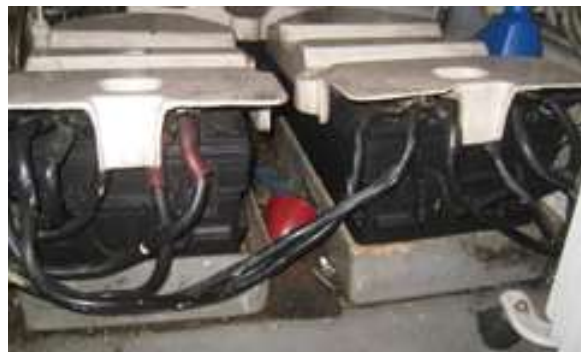
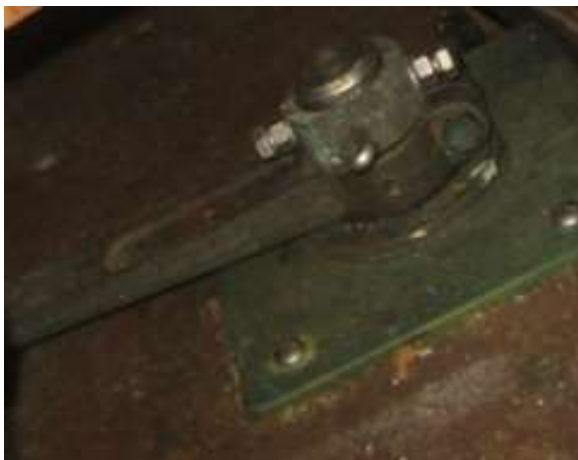
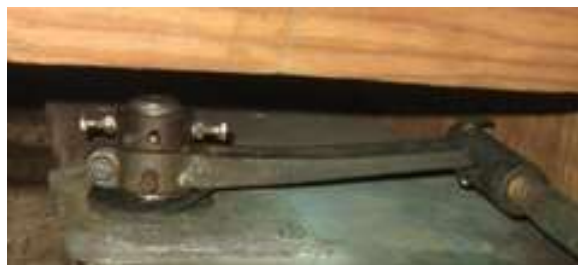
The rudder components and shaft logs were checked from the inside, only, and are secure. (photo above)
