**JAMES CROSS, CMS**

Re: 2001 Fountain Classic 42 Sport Boat

This letter reports the results of a survey of the above vessel which was inspected on the 28 th of February, 2016, while hauled at The Storage Facility in Westerly. Rhode Island. You requested the inspection to establish it's condition and value.

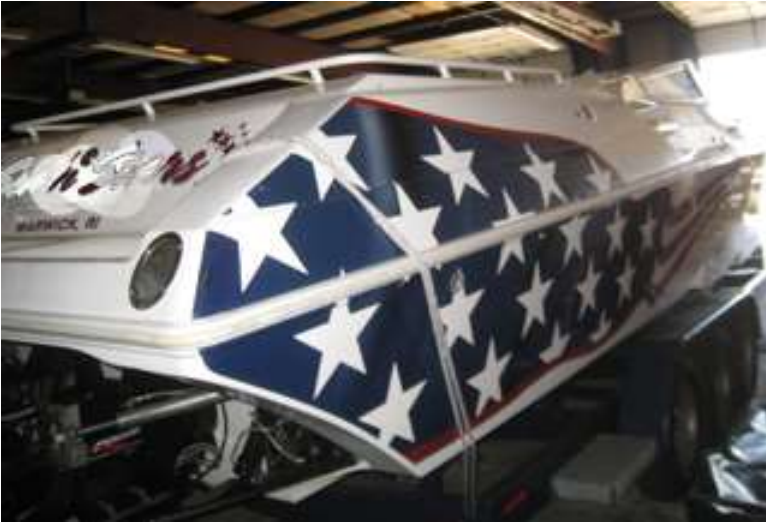
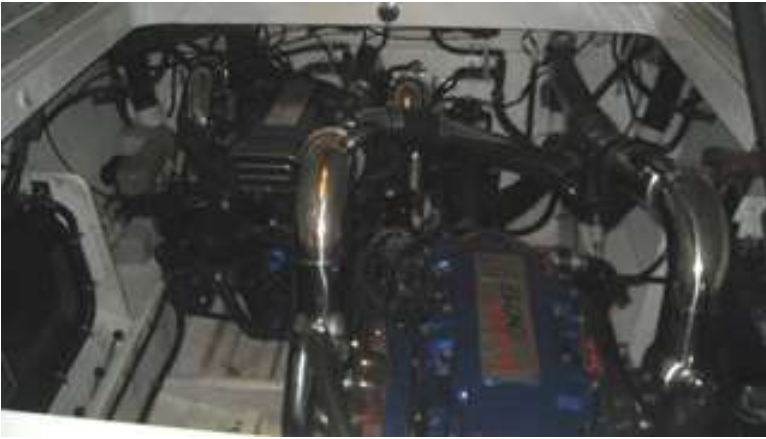
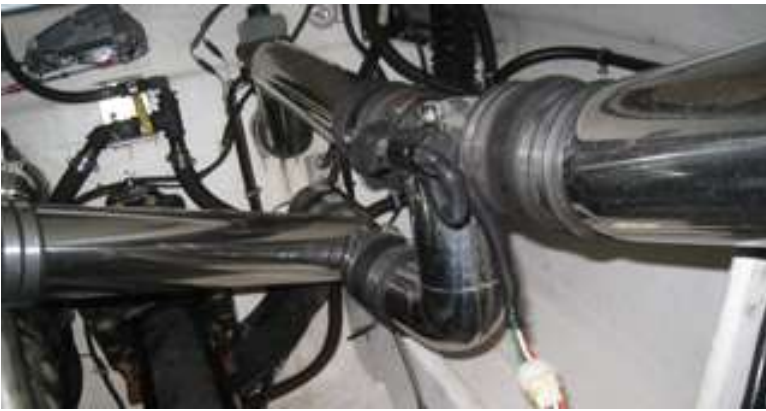
The hull is a typical polyester laminate reinforced with fiberglass matt and woven roving in a deep Vee configuration. The finish is a custom application, and in like new condition, overall, with no superficial mars or scratches. I was unable to locate any delamination or separating of glass, including the engine bearers. The bulkhead and stringer tabbing through out is matt and is properly installed and secure. The inside surface of the laminate has been painted with an epoxy finish. No hull stress situations were observed. The bottom (never been painted) is in good condition with no abrasions noted. The topside (deck is reinforced with balsa core) it is also white and is in very good condition. There are no through hulls below the water line. There is a large moulded in swim platform. The swim platform is integral to the structure and it is in good condition and secure. All of the deck hardware is properly backed and secure.

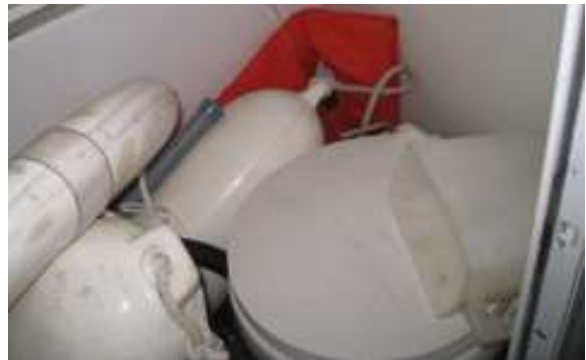
Head with toilet and macerator with holding tank has never been used.

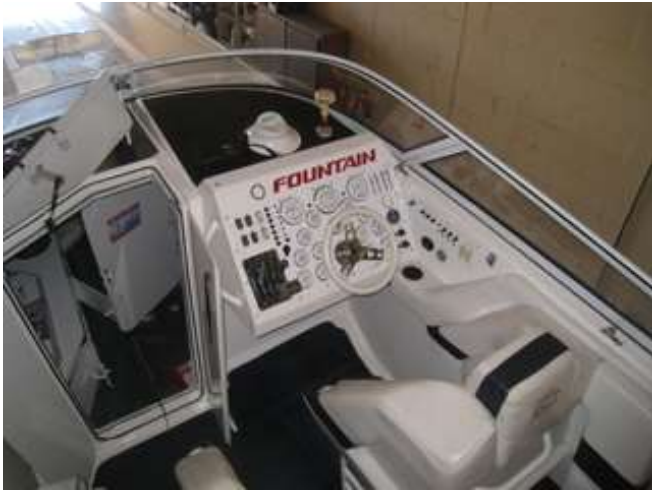
The cockpit area, including the upholstery and carpeting is in Bristol (appears lightly used) condition. The operating station is well designed and the controls easy to operate. The throttles operate smoothly. The shifts and heavy duty hydraulic power steering (components in good condition) are also smooth operating.

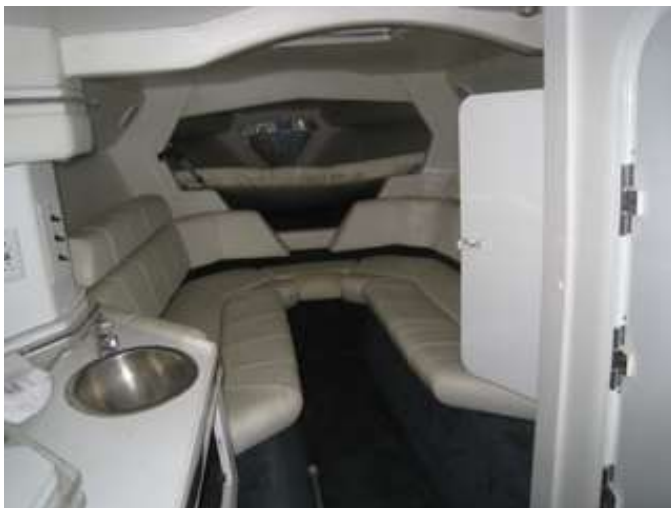
The V-Berth and Main Cabin is located beneath the forward deck. This area will sleep two. The V-berth area is clean, upholstered and carpeted. There is adequate lighting and ventilation in this area. Also, housed in the V-berth area are several lockers and rode storage. This area is spacious, nicely finished and in excellent condition. See photo at left. Includes refrigerator and small sink in galley.

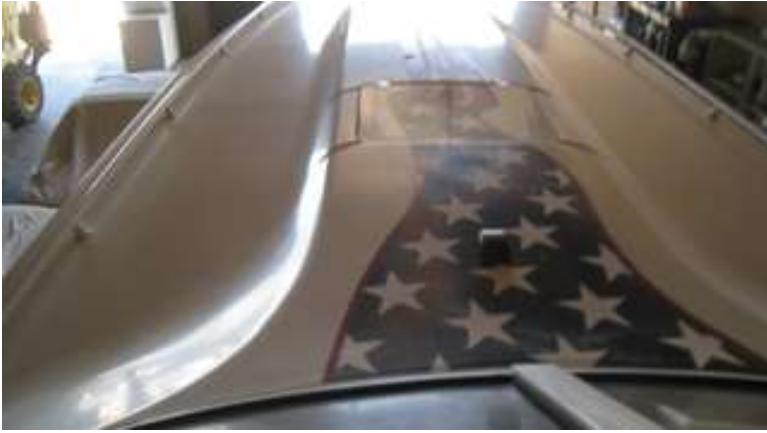
A flare kit, Bell, Whistle and throw ring were not noted.

Fire extinguishers on board include:  
One Kidde BC size 10 dry chemical.  
One properly sized and installed auto Halon system in the engine space. (Outdated)

Add the following devices:  
Backup ground tackle. Protect batteries positive terminals from shorting.  
Insure that a complete Coast Guard Safety and Signalling package is aboard.  
Inspect and Tag or Replace the Auto Halon System
