**JAMES CROSS, Certified Marine Surveyor**  
19 Nooseneck Hill Rd., West Greenwich, RI 02817  
Phone (401) 397-5040  
Member Association of Certified Marine Surveyors / ACMS.US.A.COM  
Check us out on the web at [www.jimcross.net](http://www.jimcross.net)

Re: 1973 Grand Banks 48

This letter reports the results of a survey of the above vessel which was inspected on the 27th of September, 2019, at Fort Rachael Marina in Pawcatuck, Connecticut while hauled. The inspection was completed to establish its condition and value.

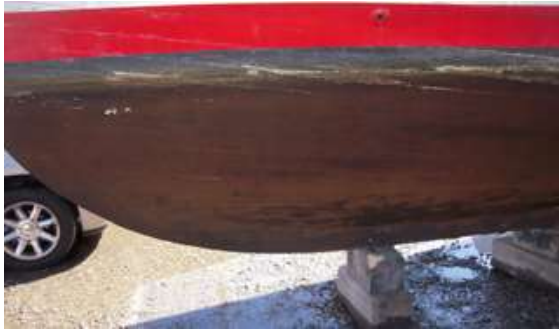
Note the photo at left for a sample of the condition of the frame work. The entire inside surface of the hull has been cleaned and checked for defects. All planks were checked and fasteners were removed from strategic locations. (under each, engine, below each head and, several along the garboard plank), The fasteners were found to be in good condition (photos on next page) and refastening is not recommended or planned at this time.

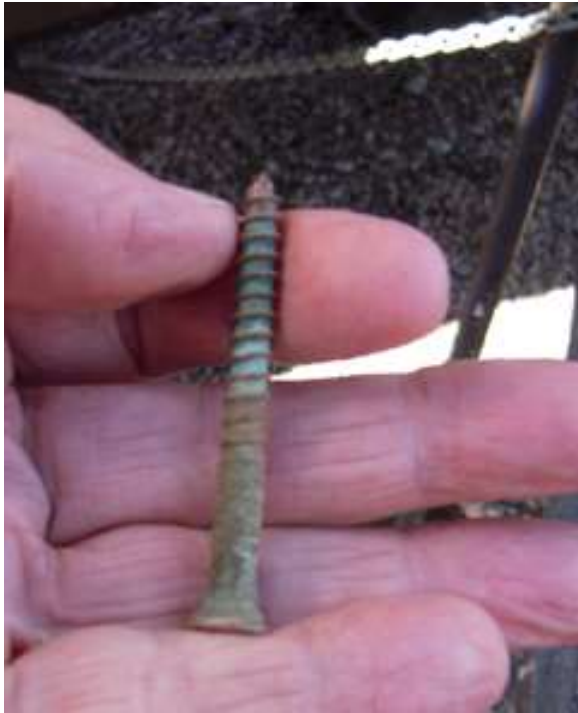
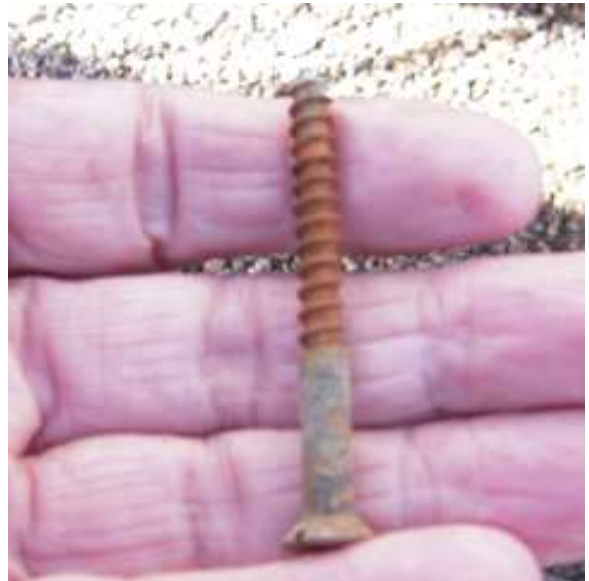
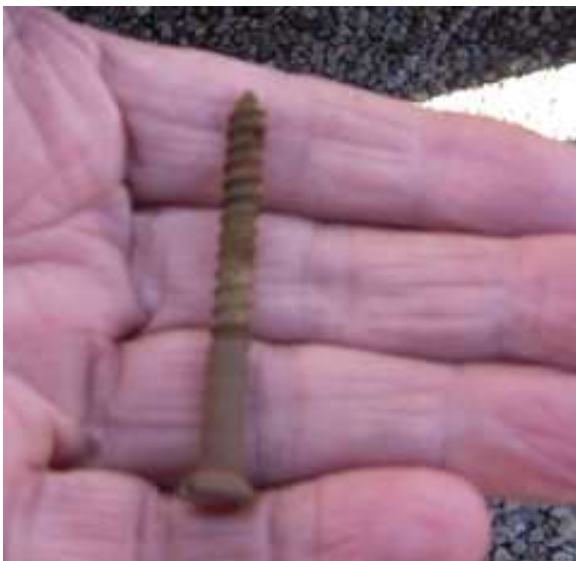
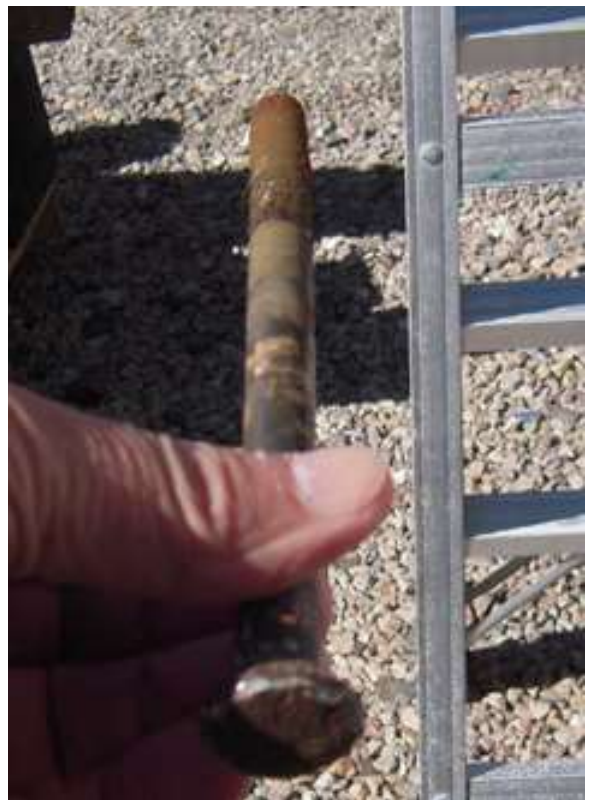
*Views of a sampling of the several fasteners that were removed for inspection*

*Fasteners were removed from the hull, below the engines, below the toilets, and a few from both garboard planks. There was no noticeable material missing from any of the fasteners. No oxidation or corrosion was noted on any fastener.*

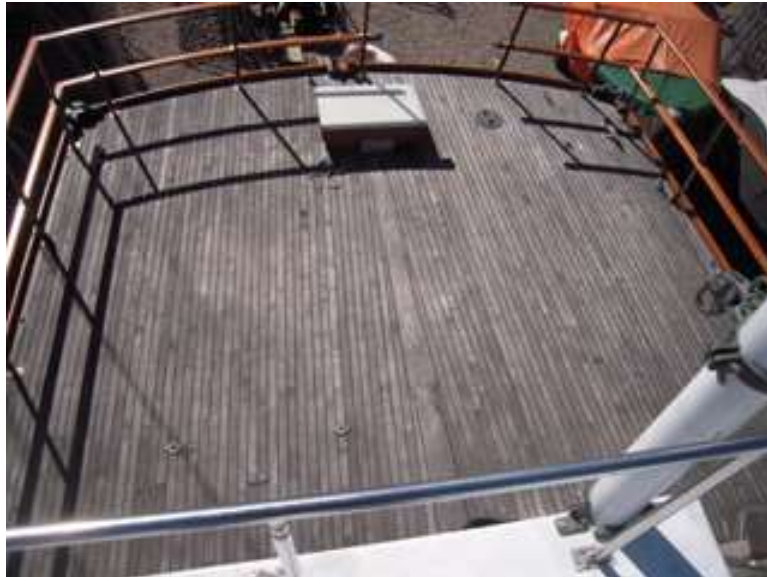
The aft deck (pictured at left) one inch thick Teak strips have all been re-secured

(copper ring nailed as original, counter sunk and bunged) and sealed to the plywood underlayment. The finish will remain natural and this deck is very secure and sturdy.

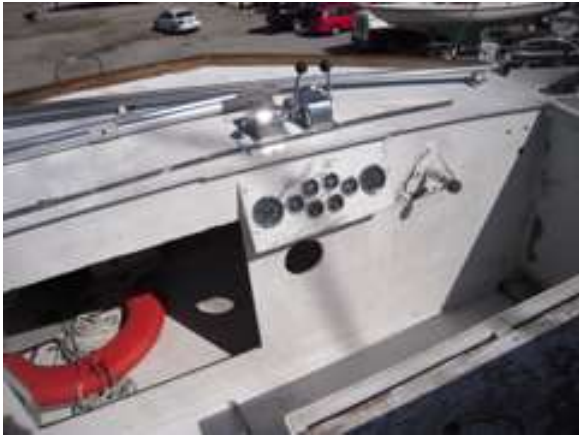
The operating station at the bridge, pictured at left (sans the wheel), has been upgraded and is operational at this time. All upholstery has yet to be refitted. The compass is accurate on its present heading. The shifts and steering are also smooth operating and in good condition. Steering is the original mechanical chain to stainless cable.

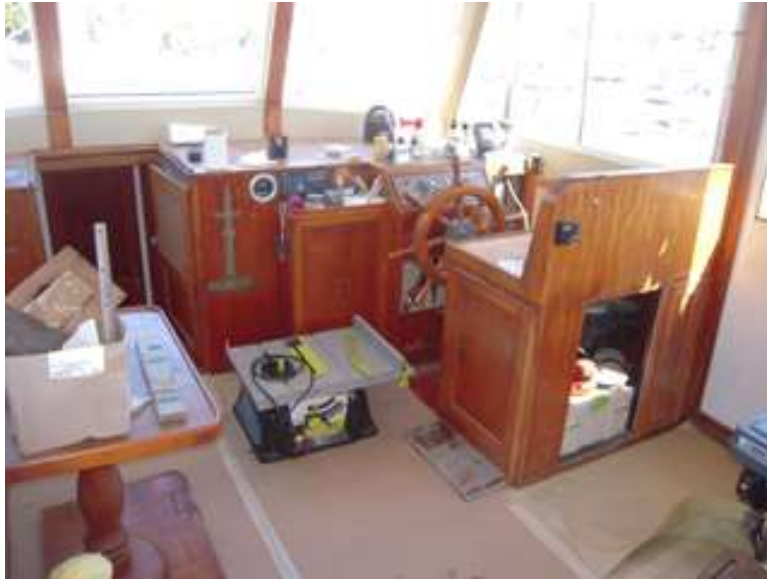
Pictured at left is the main salon that houses the galley, dinette, and lower operating station. This area is partially finished and in very good, dry condition. Ports and hatches are tight to the weather. While construction is ongoing the vessel remains in operational condition. During the last weeks it was delivered to Mystic from Westerly for haul out and winter storage under its own power.

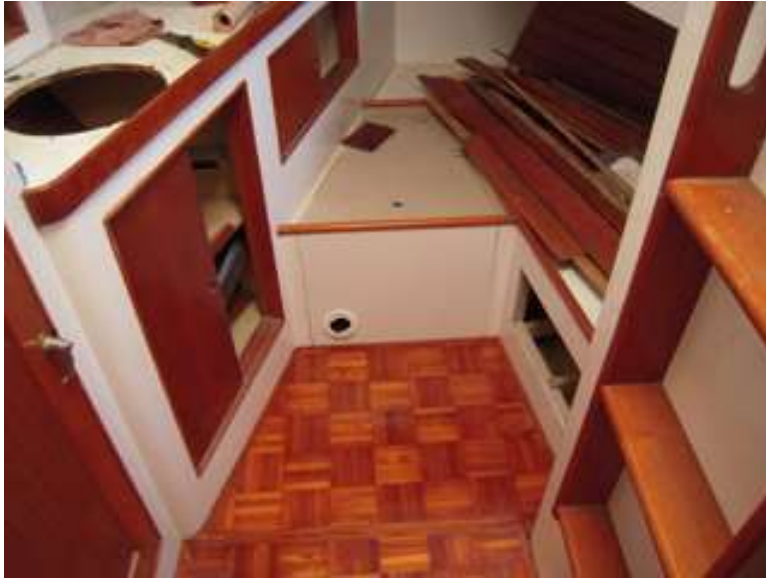
The forward berth area (V-Berth), pictured at left, is also clean and in excellent condition. (Very close to completion) No fresh water leaks were noted in any berth area. Also, housed in the V-berth area are several lockers and rode storage. Head liners in both areas were clean and in good condition and secure. All berth areas are equipped with adequate lighting, locker, and drawer space. Adjacent heads with showers are provided forward and aft.

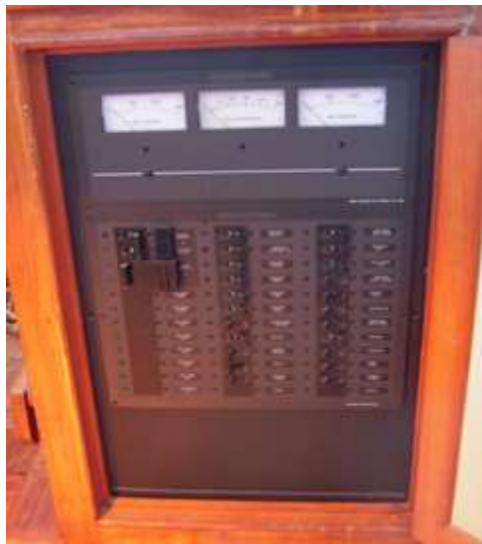
The electric motors which operate the fresh water system are in good working order. The bonding system, (partially installed) is in good condition. There are no traces of oil in the bilge, and the bilge is clean overall. The batteries on board (Four fairly new 8 D's) are properly boxed, secured, and connected. DC circuits are properly connected and harnessed (note photo at left).
