JAMES CROSS, Certified Marine Surveyor
19 Nooseneck Hill Rd., West Greenwich, RI 02817
Phone (401) 397-5040
Member Association of Certified Marine Surveyors / ACMS-USA.COM
Check us out on the web at www.jimcross.net

Re: 1986 Hunter "LEGEND" Sloop "NO NAME"

This letter reports the results of a survey of the above vessel which was inspected on the 14th of May, 2018, while hauled at Wharf Marina in Warwick, Rhode Island. You requested the inspection to establish it's condition and value.

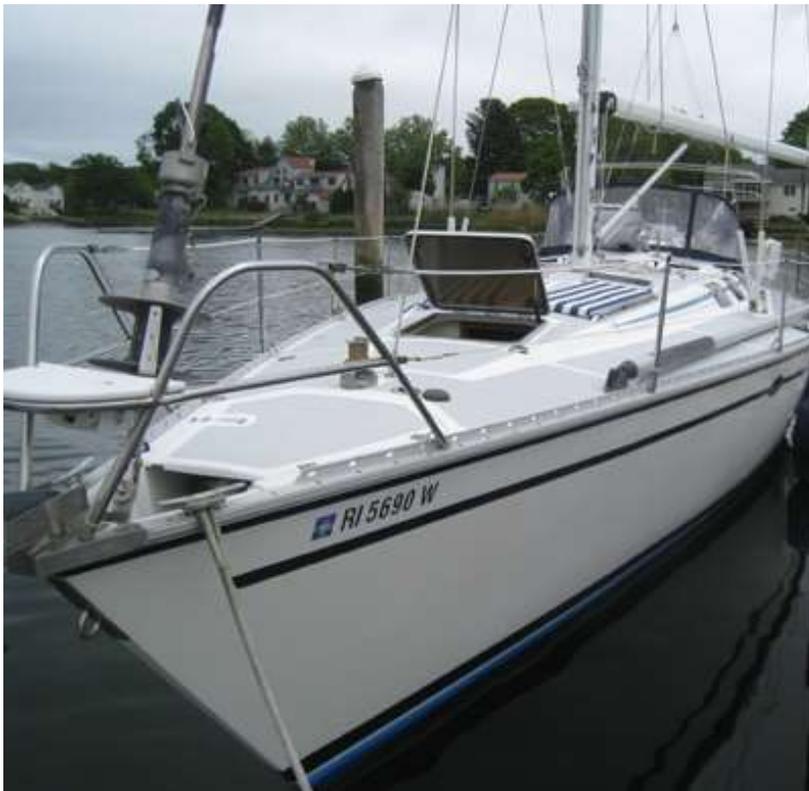
The vessel was built by Hunter Marine Corporation, of Alachua, Florida, in 1986. The vessel bears the hull numbers HUN45019D686. Pertinent dimensions of the vessel are: the LOA is 46' 8", the beam is 13' 10", and the draft is approximately 5'7". Displacement, according to the book is, 25,600 pounds.

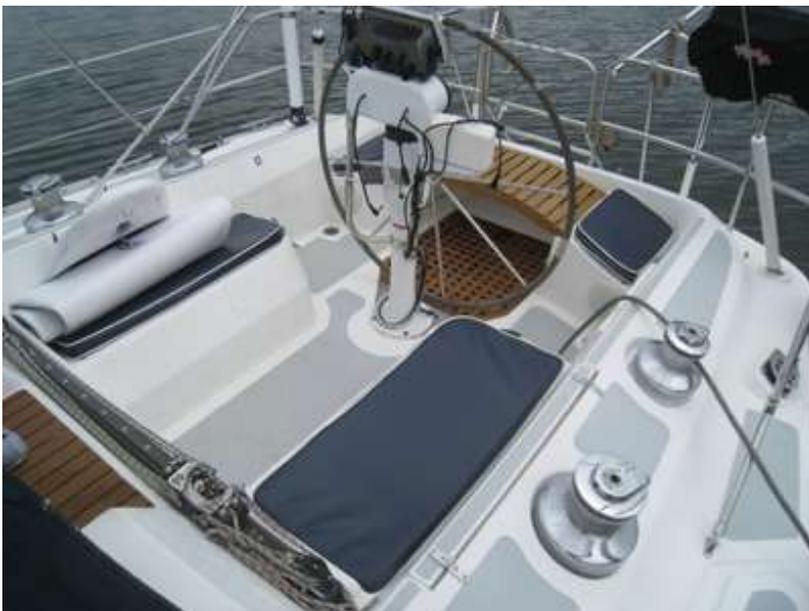
The hull is a typical polyester laminate, reinforced with fiberglass matt and woven roving. The hull is sturdy and is free from damage or noticeable repairs. The hull between the boot top and gunwale is the original white gelcoat and the finish is in excellent condition. There were no noticeable dings or scratches on the hull. This area of the hull was sounded with a light mallet and found to be free from voids or soft spots. The deck has the original white gel coat finish.

The hull, below the waterline, was sounded and is in good condition. The lead keel is properly bolted to the hull. New keel bolts have just been installed. The compression post is properly installed and supported. All through hull fittings are properly installed along with recent hoses and clamps. The shaft log

and Monel shaft are in good shape. The rudder, rudder post, and all bushings are in "ready to go" condition. The wheel steering and associated, quadrant and gear are in good shape.

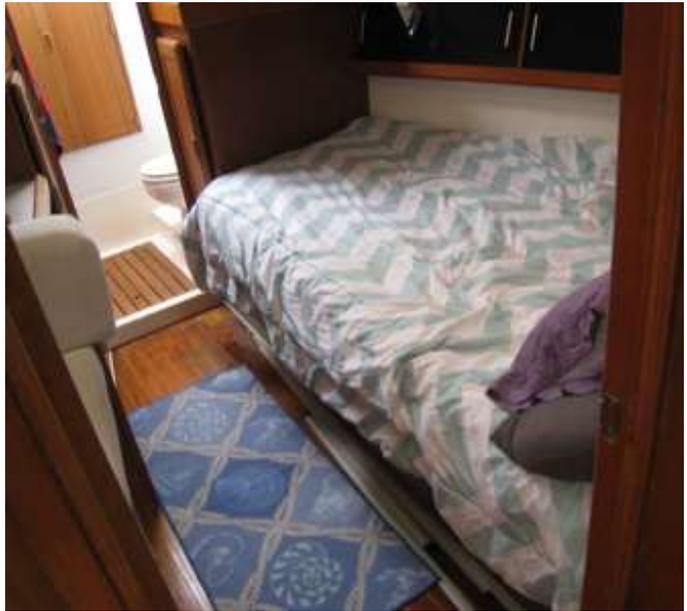
There are three berths areas. The forward Master Stateroom, pictured at left, is a large area, clean and in very good condition. It is located just adjacent to the large forward head. Lockers and storage areas abound. The aft berth, pictured below is also a large berth area. In both berth compartments the cosmetic refit has been completed and these areas are in like new condition. All bright work has been completed. The refit has been completed in a professional manner and all areas are also structurally sound.

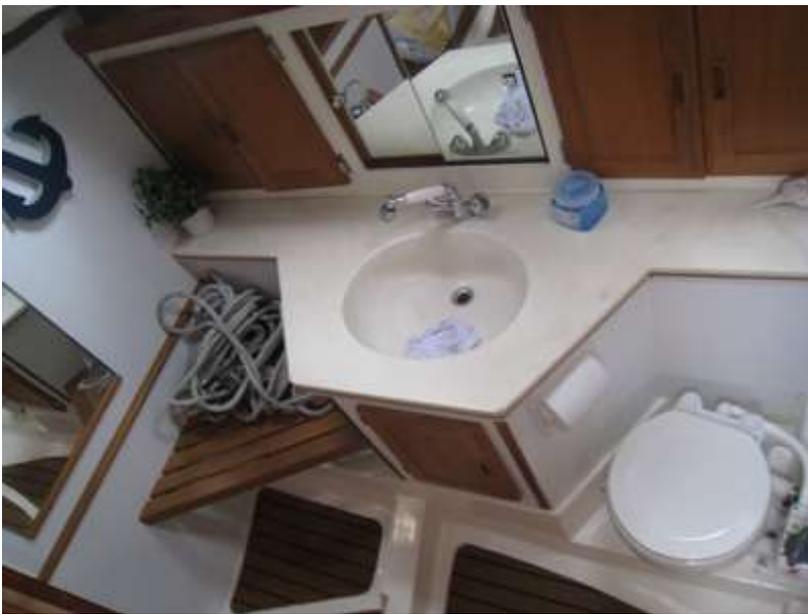
View of Forward head

The heads (two, fore and aft) are good sized and also in very good structural condition. Both heads are equipped with New manual marine toilets, showers, and hand wash basins. Both head areas are clean and odor free. All plumbing was found to be in very good condition and free from any leaks. The related plumbing and holding tanks are in good shape and no septic odor was noted below deck in any area.

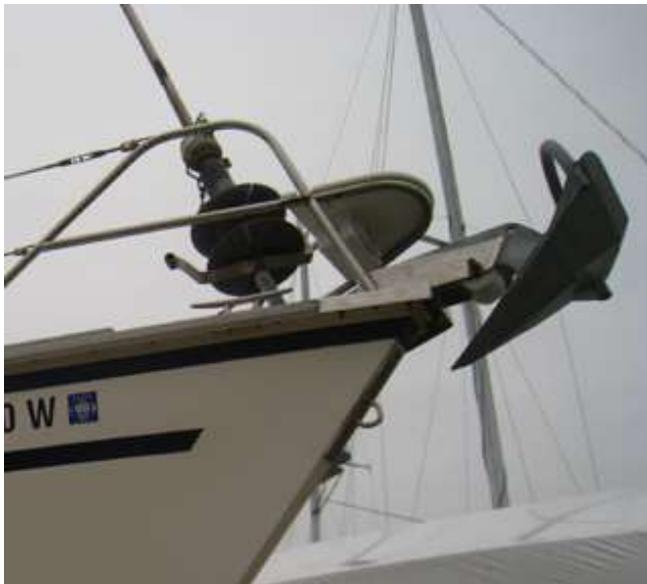
This vessel is equipped with a masthead sloop rig. The head stay is attached to a stainless steel weldment deck fitting which, in turn, is properly attached to the hull. The aluminum boom is equipped with jiffy reefing hardware. The mast is an aluminum oval extrusion in good condition. The mast, spreaders, and shrouds, are in good condition as can be inspected from the deck. The back stay is in good condition and secure. The mast steps on the deck onto a cast aluminum adjustable step. Bolts secure the mast step to the deck. Stainless tubular internal chainplates are installed and properly secured. The chainplates pass through the flange of the deck/hull connection and are secured to hull and other internal components. The upper shroud chainplates are bolted to bulkheads. The fore and aft are

properly secured to the hull. The bonding system is complete at the chainplates. The lower shroud chainplates are also well secured. There is no evidence of water leakage at any chain plate locations. Overall the chainplates are in good condition. An inspection was not made of the sails as they were not on board yet. They had been sent to the loft recently for cleaning and adjusting. All sheets are in like new condition. The halyards are in like new condition.

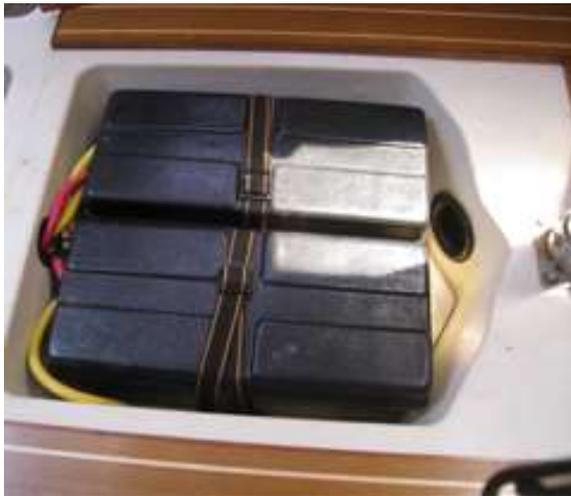
The house batteries (6D) in the port lazaret compartment are properly installed. The batteries feed the 12 volt system through a proper three way switch and breaker panel. The switch and all associated wiring is in good working order. The electrical wiring and terminals observed throughout the vessel are in very good condition. The engine instrumentation is adequate.

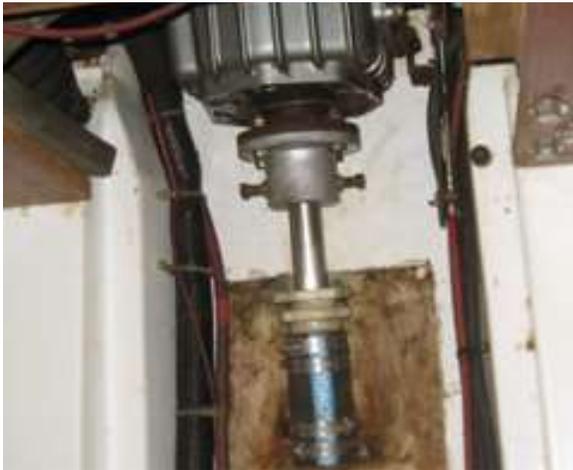
Propulsion is by a four cylinder Yanmar 55 HP Turbo fresh water cooled diesel engine and Hurth reduction gear, mounted under the companionway. The engine oil is clean, as is the coolant. Engine instrumentation, consisting of oil and heat lights are positioned just port of the pedestal. The engine was run at the dock during inspection. The engine shows signs of good care and proper maintenance. I was unable to locate an hour meter, but from outward appearances this vessel is sailed more often than motored.

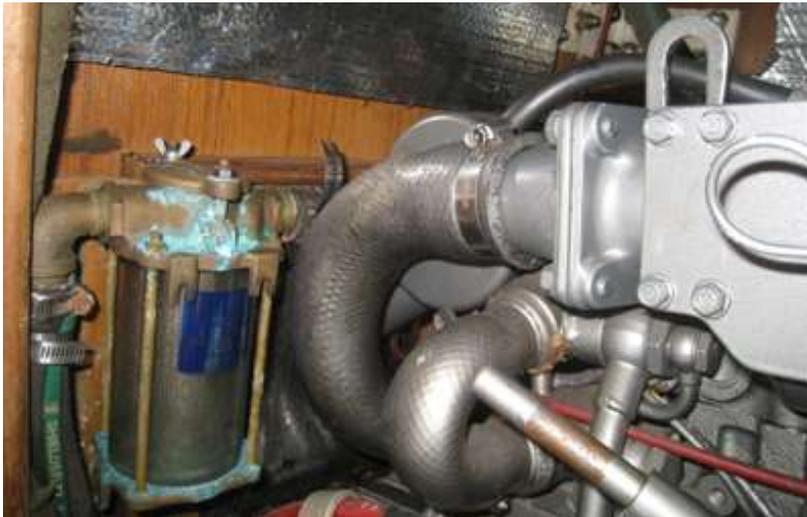
The engine intakes salt water through an intake pickup tube and on to the strainer. The intake and strainer are in good condition. The shaft log is a recent upgrade as is the stainless shaft and propeller. The engine compartment is clean and free of any unessential material. The fuel tank and associated lines and vents are in good condition. The fuel shut-off is easily accessible.

Recommendations: Insure that a complete Coast Guard Safety and Signalling package is aboard. Check engine raw water intake for rusted clamps.
