September 4, 2018

Re: 2007 Hydra-Sports Vector 2900 VX

This letter reports the results of a survey of the above vessel which was inspected while hauled and afloat on the 4th of September 2018, at Brewers Marina in Warwick, Rhode Island. You requested the inspection to establish its condition and value.

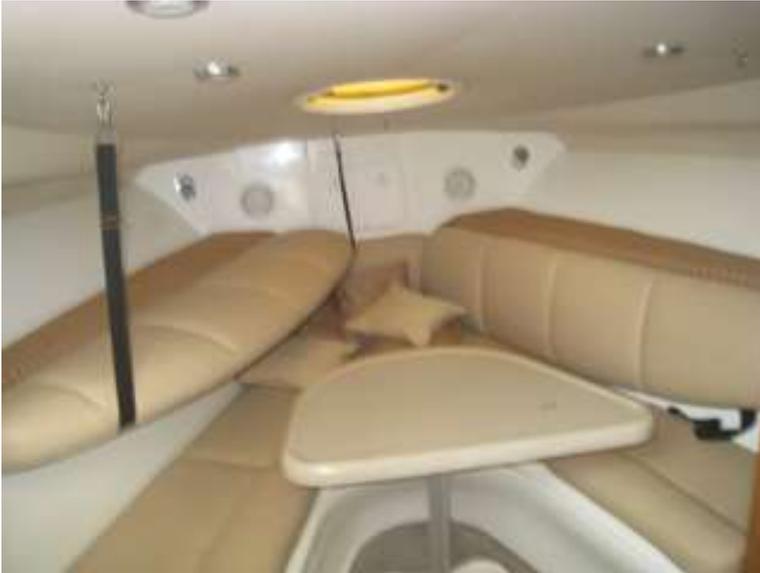
Main Cabin

The main cabin houses the V-berth, aft berth, mini galley, and head. This area is spacious, nicely finished and in Bristol condition. The AC/DC refrigerator is in working condition on the DC side. The moulded Corian counter top is in good shape. The interior trim has a well maintained finish. The upholstered sections and joiner work show good care and maintenance. The vinyl head liner is in very good shape.

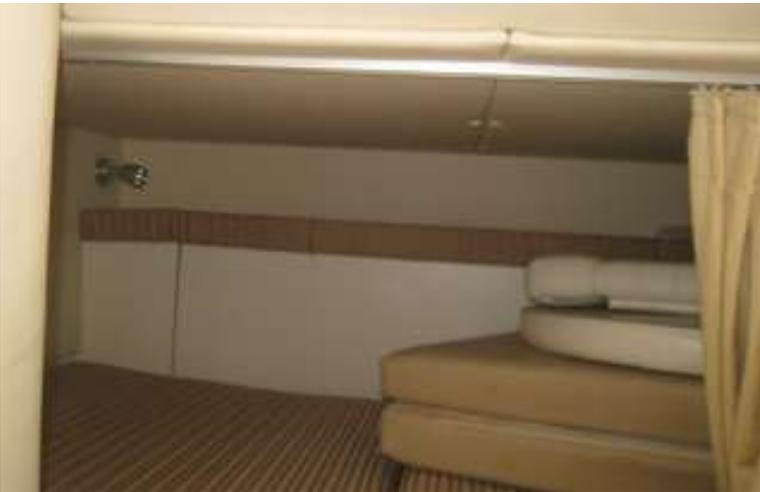
V-Berth and Aft Berth

The V-Berth is located beneath the forward deck. This area will sleep two. The V-berth area is clean and nicely upholstered. There is adequate lighting and ventilation in this area. Also, housed in the V-berth area are several lockers and storage. The aft berth area, located under the operators station, is also in good condition. The plastic potable water tank is located beneath the berth and is in good condition.

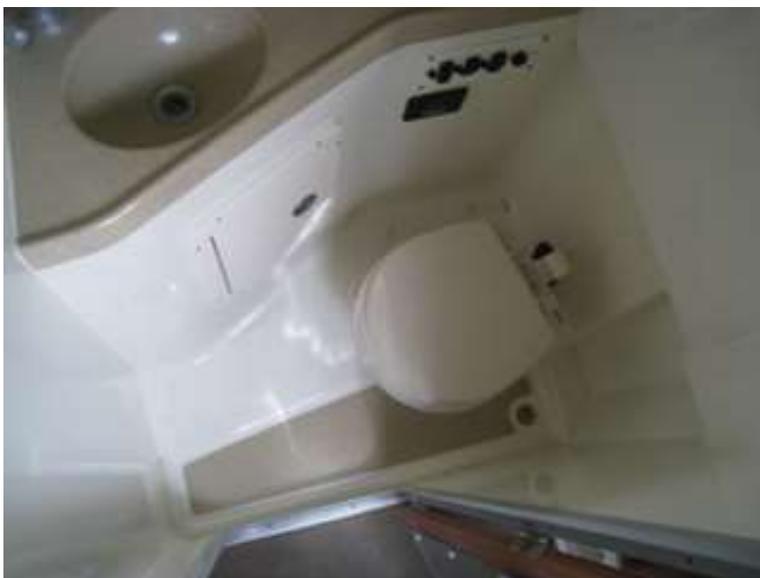
The Head

The head is a multi piece fiberglass enclosure which forms part of the inner liner. It is properly secured to the hull and forms an integral part of the hull unit. It houses a VaccuFlush - electric toilet, hand wash basin, and shower gear. The head

area is in excellent condition. The electric marine toilet is functional but the macerator was not tested.

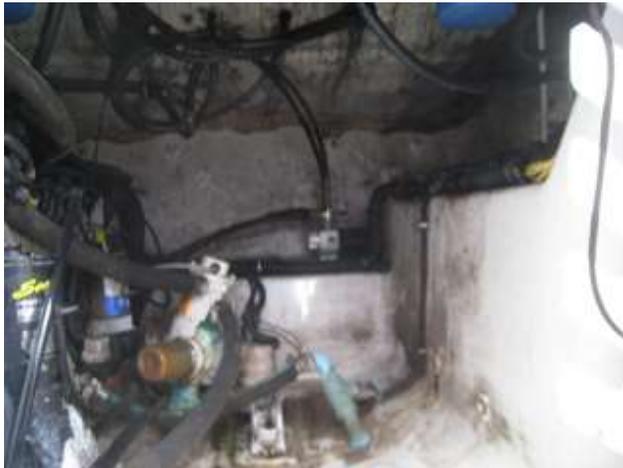
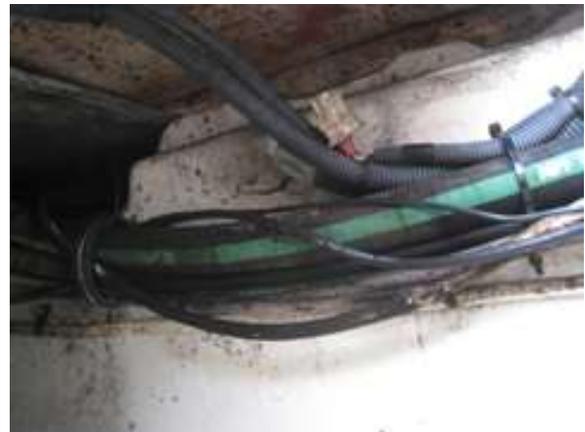
Aft mechanical space

The engine gear compartment, adjacent to the transom, houses, pumps, fuel filters, and other mechanical equipment. This compartment is in need of cleaning. All battery positive terminals should be protected from shorting.

The photo above show the aft mechanical space. This area has not been well maintained and needs service and a check by the yard of all components, hoses and devices, and then a good cleaning.

Recommendations: Insure that a complete Coast Guard Safety and Signalling package is aboard. Protect all batteries from shorting. Replace batteries as necessary. The 120 volt system is partially disassembled and did not check out. The Auto Pilot did not work. Add backup ground tackle. The air conditioner/heat system did not work, The water heater could not be checked out on the AC side. Have the yard check out the utility hoses as many are in need of service, note photos on page four. There was a serious septic odor in the head indicating a possible hose leak. The macerator could not be tested. The windscreen zipper needs service. Power steering is a bit stiff.

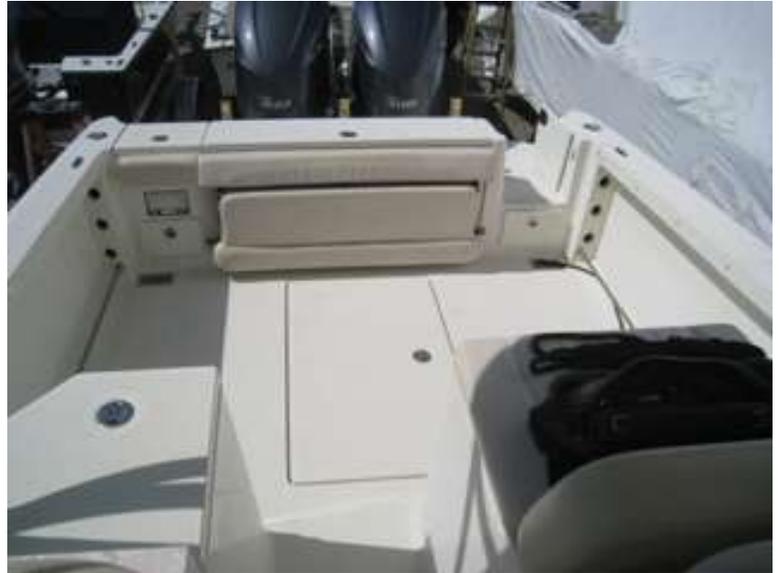
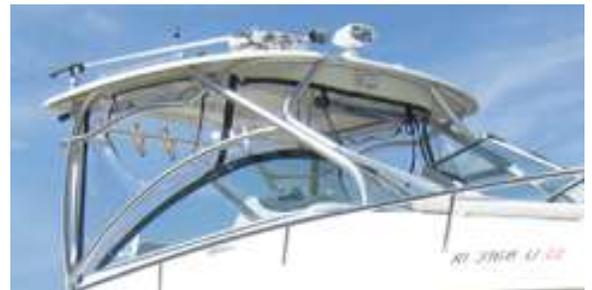
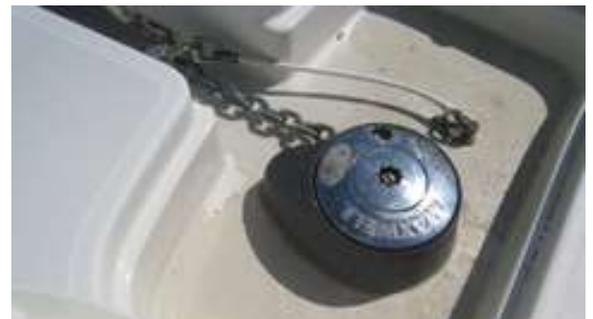
The photos at right indicate a very clean, undamaged cockpit area. The heavy duty, well secured hard top with complete enclosure and related hardware is in very good condition.
