JAMES CROSS, Certified Marine Surveyor
19 Nooseneck Hill Rd, West Greenwich, RI 02817
Phone (401) 397-5040
Member Association of Certified Marine Surveyors / ACMS-USA.COM
Check us out on the web at www.jimcross.net

March 31, 2019

Re: 1996 Mainship 47 Motor Yacht

This letter reports the results of a survey of the above vessel which was inspected on the 31st of March 2019 at the Riverside Marina in portland, Connecticut while hauled, winterized, and shrink wrapped. You requested the inspection to establish its condition and value. It should be noted that I have surveyed this vessel three times over the past twelve years.

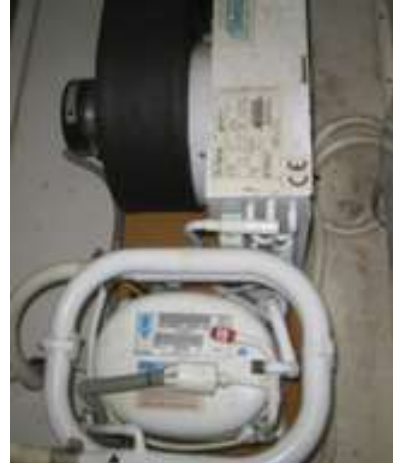
One of three CruiseAir, Heat Air units

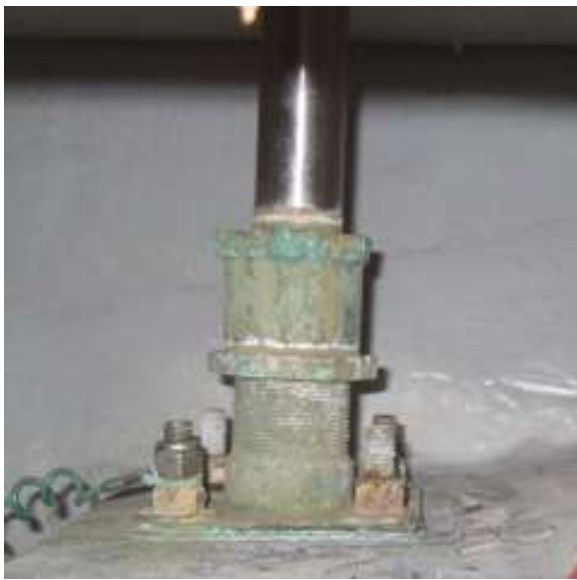
Starboard rudder shaft log is secure

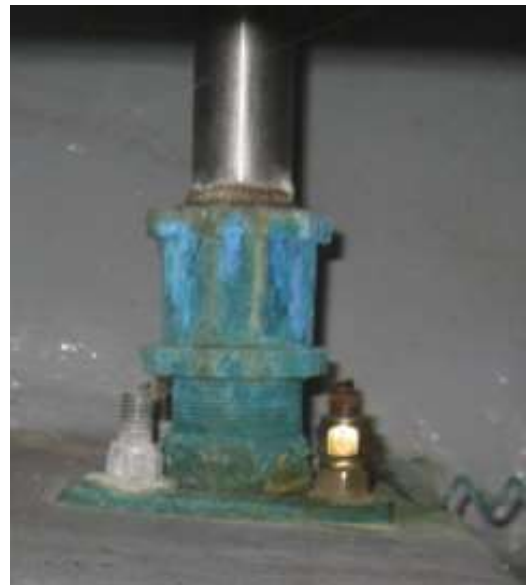
Port rudder shaft log is leaking, needs service

- 11A. Engine compartment ventilation.....Coast Guard Approved type 12 volt blower along with appropriate flexible ductwork.
12. Rudder shaft logs....One not leaking, one leaking a small amount (Note photo on Page 8)
13. Rudder tower.... Wood, reinforced, good shape
14. Steering gear and controls.... Hydraulic to manual, lines and hardware are original and are in good condition
15. Overboard fittings..... all bronze fittings below the water line, shut-off valves are operating. Overboard fittings are plastic above the waterline and are in serviceable condition.
16. Backup ground tackle.....Not Installed

1. Install backup ground tackle and CO device.
2. Ensure that a complete Coast Guard Safety and Signalling package is on board.
3. Repack or tighten port rudder shaft log.
4. Bow thruster may be leaking oil. (Check it out)

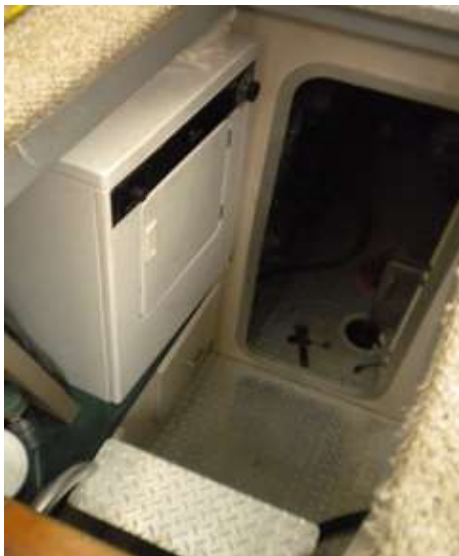
View of full size clothes dryer, a new washer is being installed

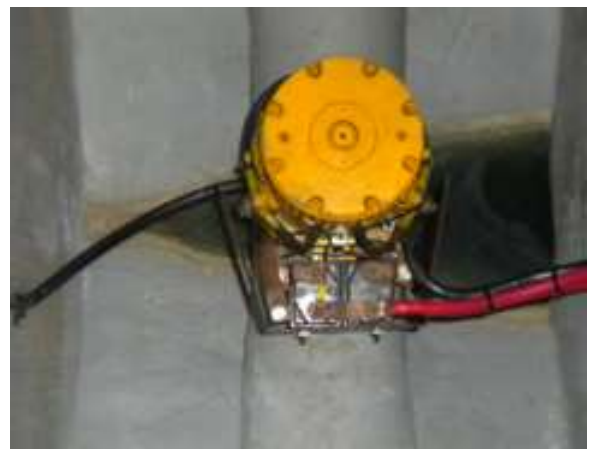
Determine source of oil near bow thruster

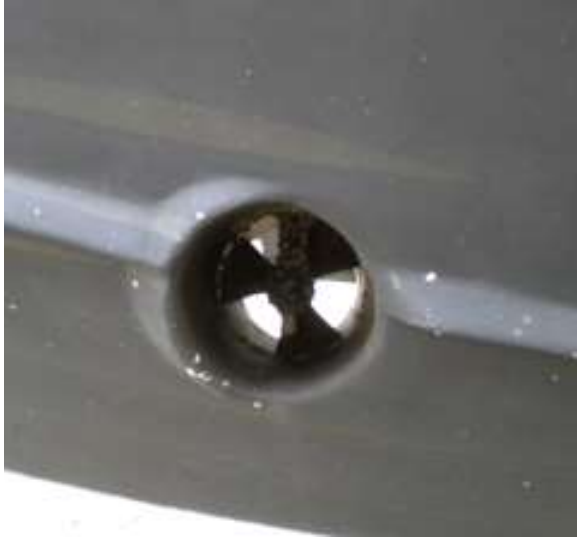
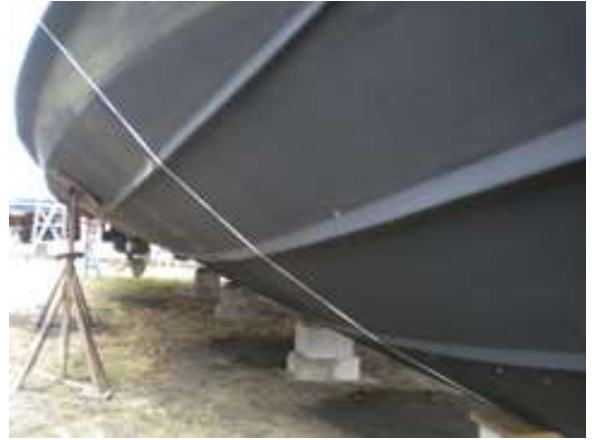
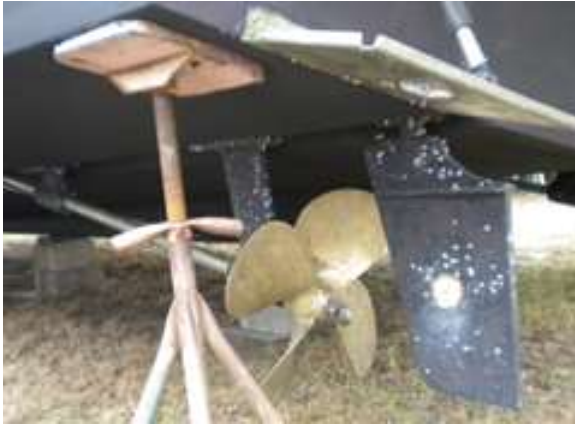
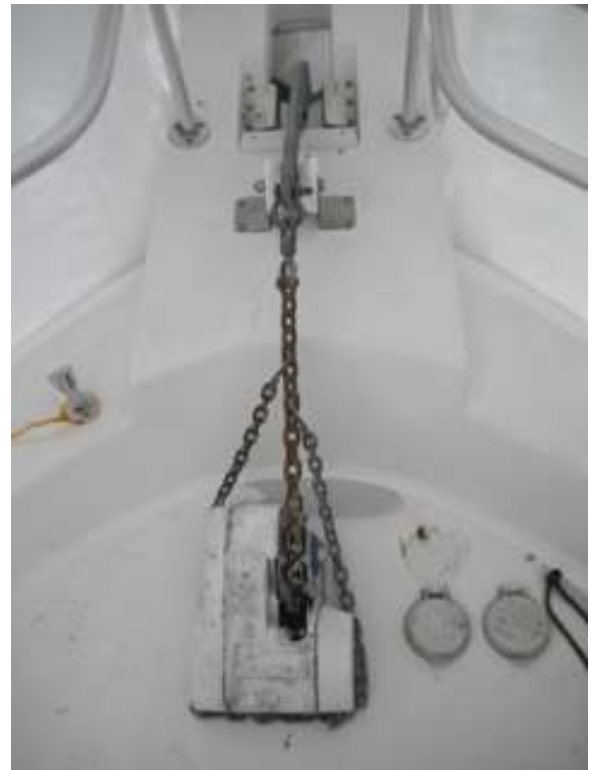
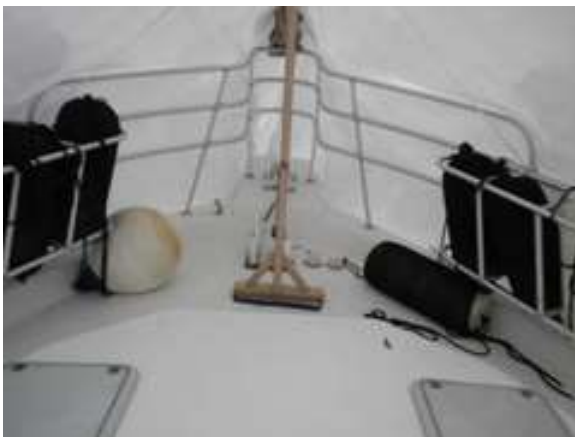
The above images show Bow Thruster, Very clean and smooth bottom finish Bronze four blade propeller, 3/8 chain rode, and fore deck and bow pulpit, all in good shape
