**JAMES CROSS, Certified Marine Surveyor**  
19 Nooseneck Hill Rd., West Greenwich, RI 02817  
Phone (401) 397-5040  
Member Association of Certified Marine Surveyors / ACMS-USA.COM  
Check us out on the web at [www.jimcross.net](http://www.jimcross.net)

March 31, 2020

Re: 1996 Mainship 47 Motor Yacht

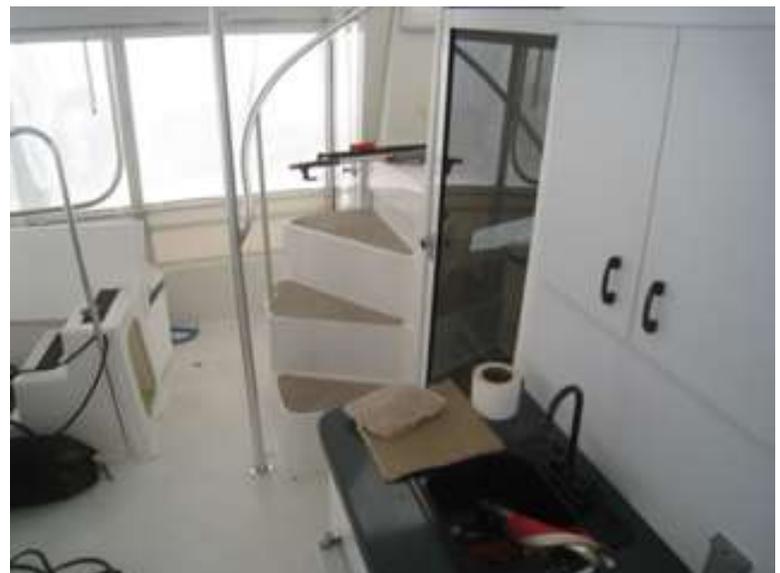
The moulded in ladder (pictured at right) to the bridge is secure and no blemishes were noted.

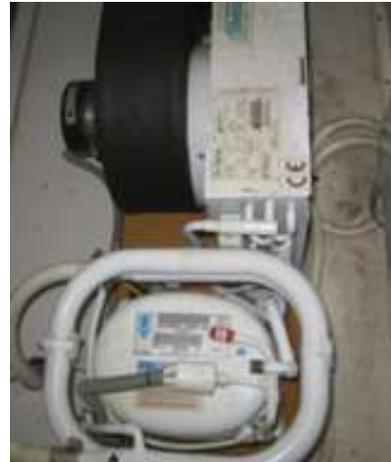
One of three CruiseAir, Heat Air units

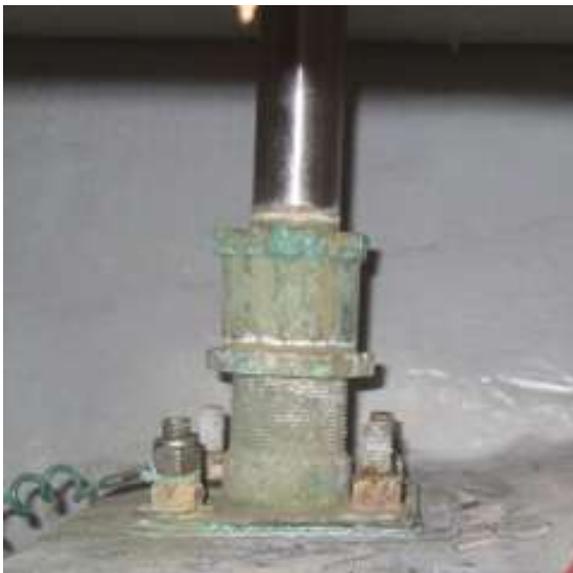
Starboard rudder shaft log is secure

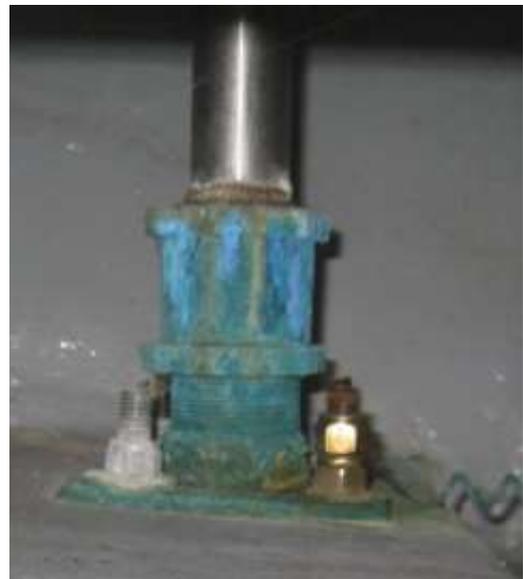
Port rudder shaft log is leaking, needs service

- 11A. Engine compartment ventilation.....Coast Guard Approved type 12 volt blower along with appropriate flexible ductwork.
12. Rudder shaft logs....One not leaking, one leaking a small amount (Note photo on Page 8)
13. Rudder tower.... Wood, reinforced, good shape
14. Steering gear and controls.... Hydraulic to manual, lines and hardware are original and are in good condition
15. Overboard fittings..... all bronze fittings below the water line, shut-off valves are operating. Overboard fittings are plastic above the waterline and are in serviceable condition.
16. Backup ground tackle.....Not Installed

1. Install backup ground tackle and CO device.
2. Ensure that a complete Coast Guard Safety and Signalling package is on board.
3. Repack or tighten port rudder shaft log.
4. Bow thruster may be leaking oil. (Check it out)

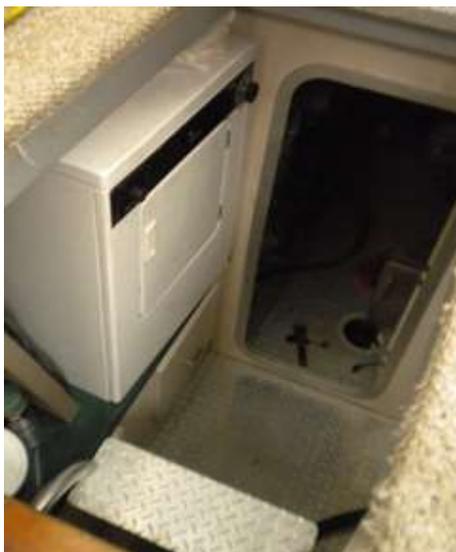
View of full size clothes dryer, a new washer is being installed

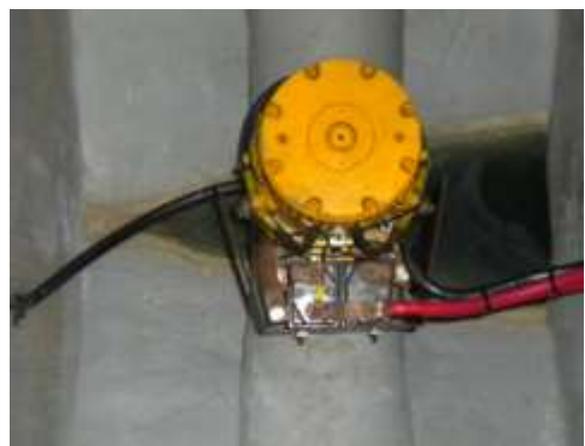
Determine source of oil near bow thruster

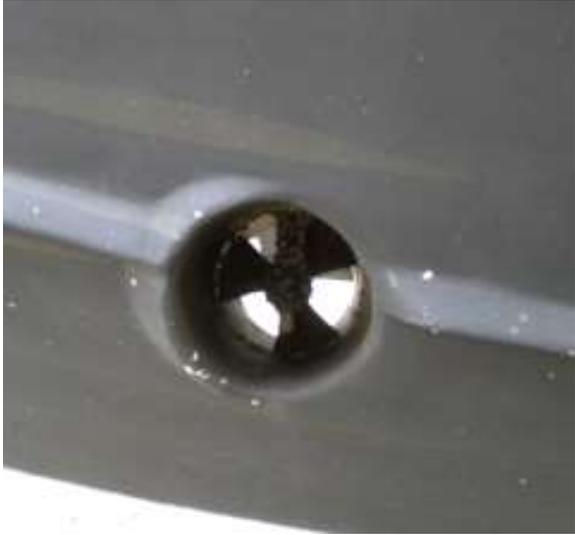
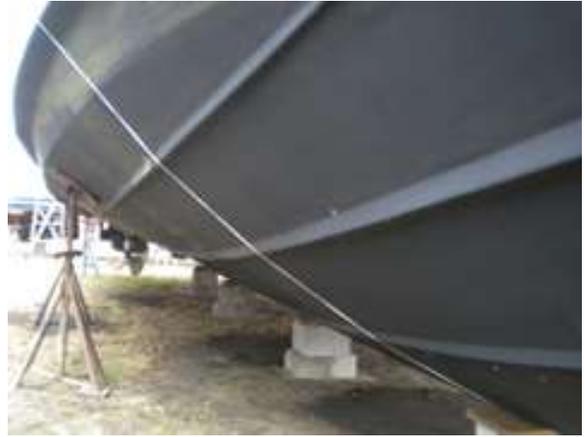
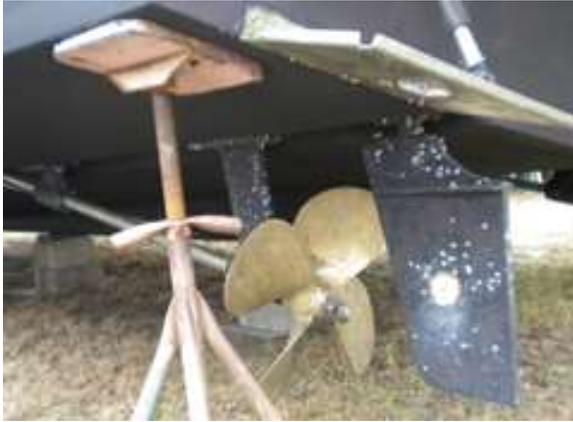
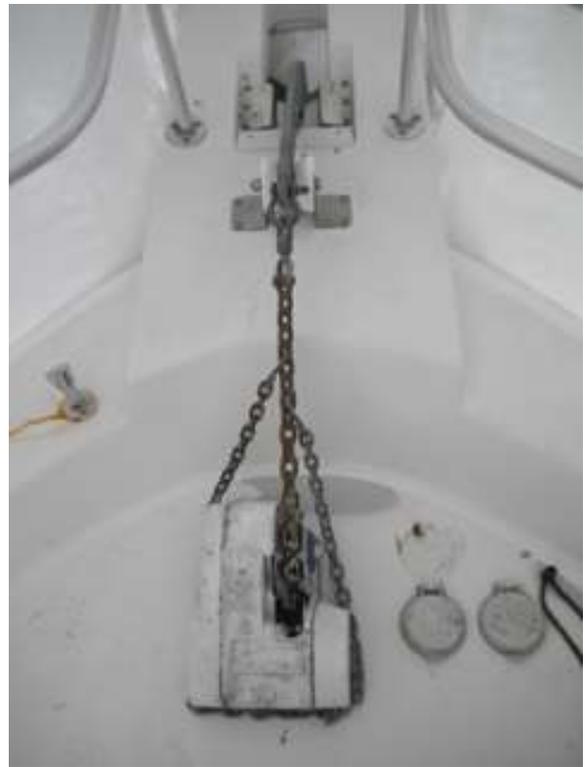
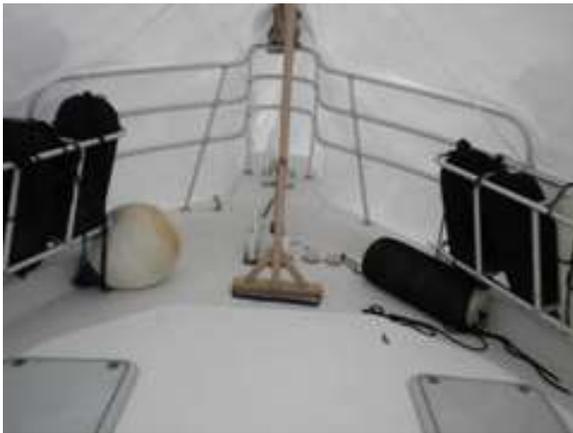
The above images show Bow Thruster, Very clean and smooth bottom finish Bronze four blade propeller, 3/8 chain rode, and fore deck and bow pulpit, all in good shape
