Re: 1989 Marine Trader 38 Fly Bridge Sedan Europa

This letter reports the results of a survey of the above vessel which was inspected while afloat at Greenwich Cove in East Greenwich, Rhode Island on the 11th of August, 2020. This survey is a resurvey, as I have surveyed this vessel in the past. This vessel has been in ocean use for several years and very little has changed since the previous inspection. You requested the inspection to establish its condition and value.

Addendum to Pages One through Ten on August 20th, 2020

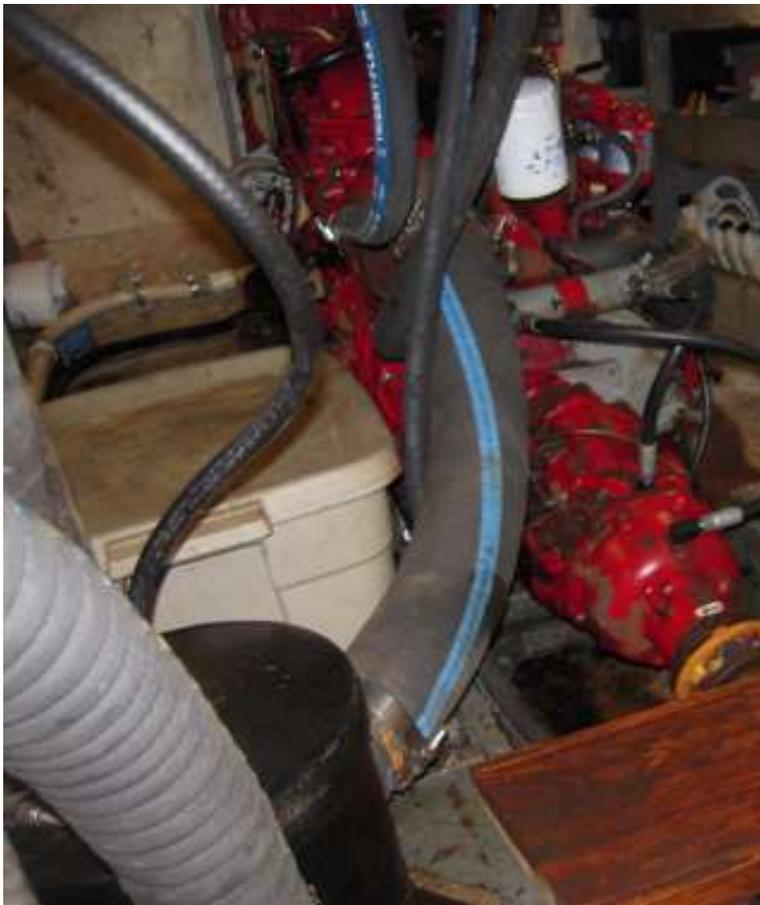
Engine and spaces

Propulsion is by a 135 HP fresh water cooled Ford Lehman six cylinder naturally aspirated diesel engine with reduction gear. The exhaust system is cast and rubber with a fairly new silencer, heavy duty, and in good condition except for a short length at the silencer which should be replaced. The system clamps should be checked and all double clamped. All through hull fittings including the valves are bronze and in working condition, but should be serviced. (THEY ARE A BIT STIFF TO OPERATE) The Morse controls and cables are smooth operating, both from the upper and lower stations. The custom steering gear is in good condition and operates smoothly from both stations. The engine compartment is sound and sturdy. The entire bilge hull surface is coated with a grey epoxy paint and in very good, clean condition.

There are adequate bilge pumps installed and working in this area. There is no oil in the bilge. There is a provision for an emergency tiller but the tiller was not on board.

1. Date and tag the engine room fire suppression system.
2. Install new CO device
3. Provide a proper connection fitting in the short length of exhaust hose.

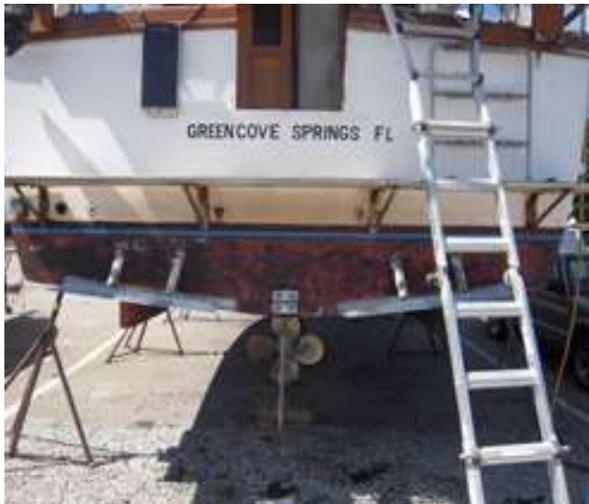
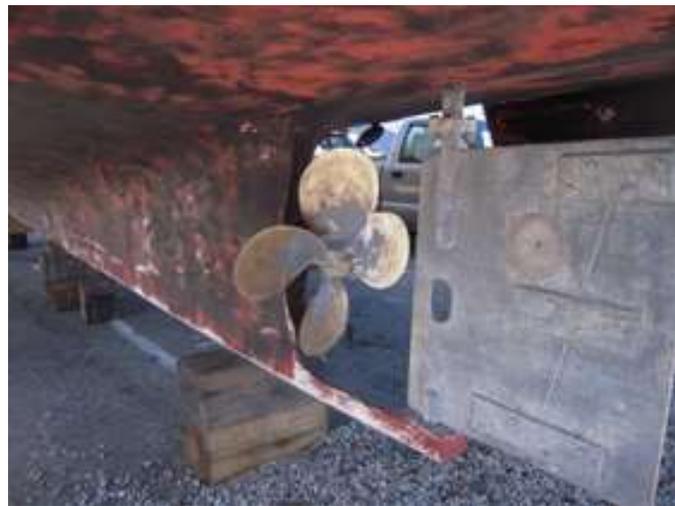
I sounded the bottom with a metal mallet and found it to be in good condition, free from any soft areas, or delamination. The keel is solid and in good shape.

The stainless propeller shaft and log are secure and in good condition. The Trim Planes are well secured. The rudder and rudder post are secure and feel

tight, indicating security at the shaft log.
