JAMES CROSS, Certified Marine Surveyor
19 Nooseneck Hill Rd., West Greenwich, RI 02817
Phone (401) 397-5040
Member Association of Certified Marine Surveyors / ACMS, U.S.A. / C.O.M.
Check us out on the web at www.jimcross.net

Re: 1992 Ocean 42 Super Sport

This letter reports the results of a survey of the above vessel which was inspected on the 16th of January 2019 while hauled, winterized, and shrink wrapped, at Brewers Ferry Marina in Old Saybrook, Connecticut. You requested the inspection to establish its condition and value.

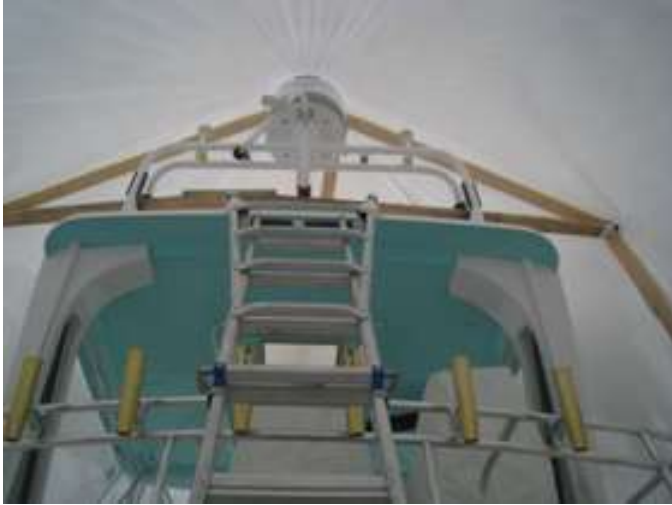
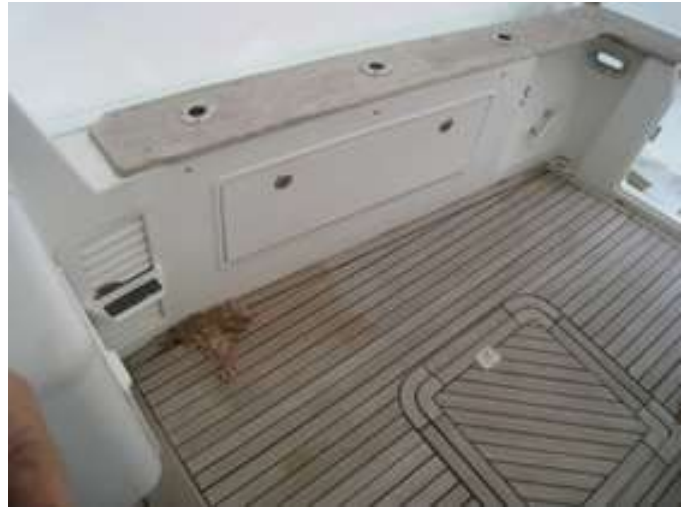
The image at left shows the new custom built aluminum tower and radome support structure and the continuation of the new paint scheme.

The image at right shows the cockpit in excellent with Teak decking and Teak coaming trim. All deck hatches fit and open properly and are secure.

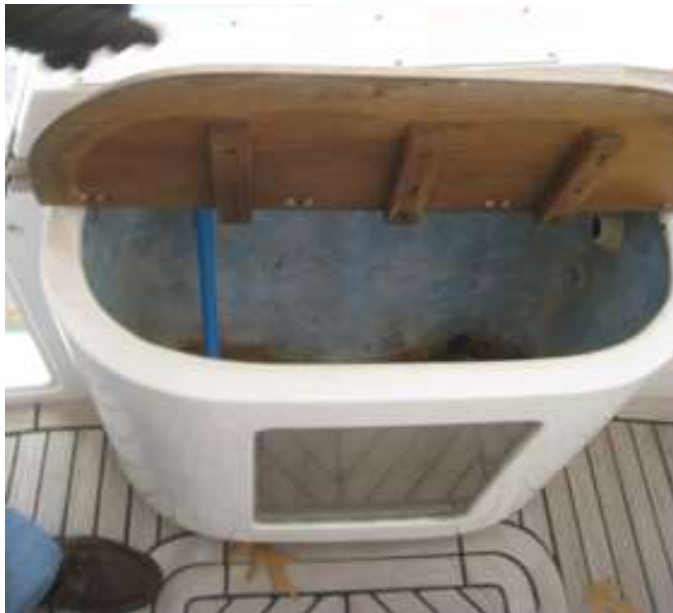
The image at left is of the live bait well with front viewing glass. This unit is equipped with a raw water circulating system.

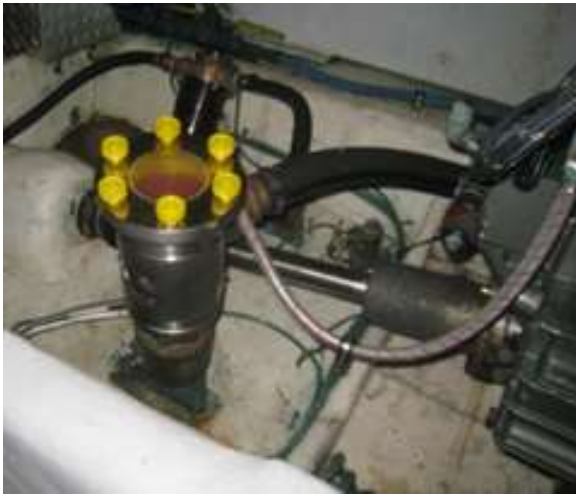
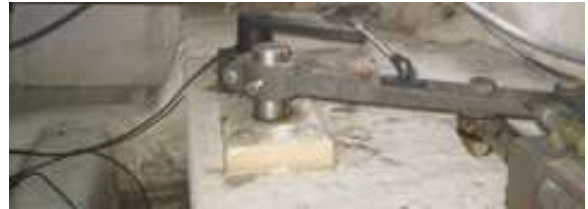
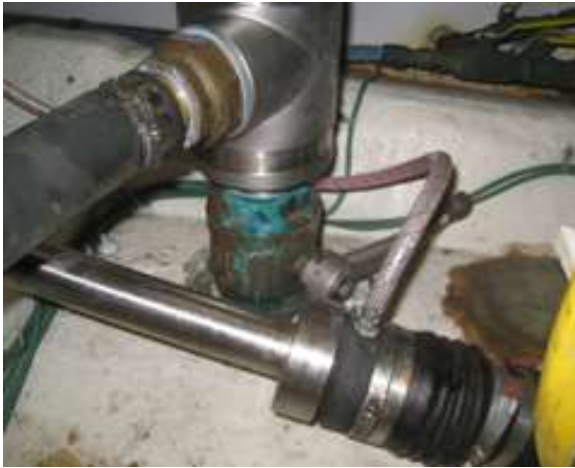
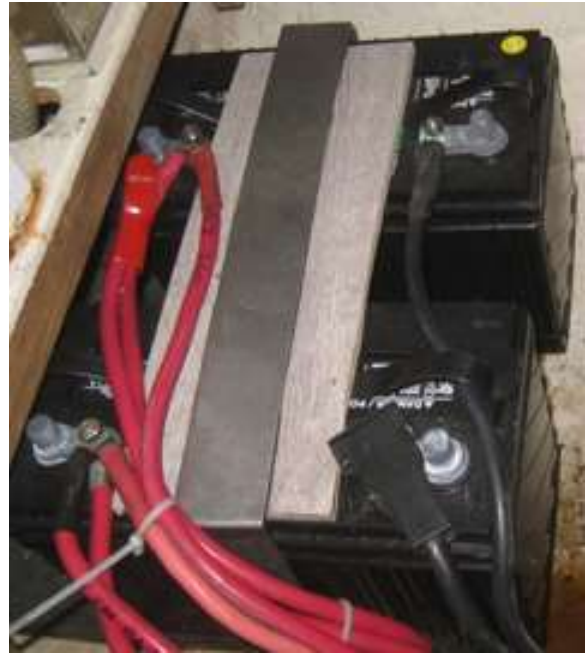
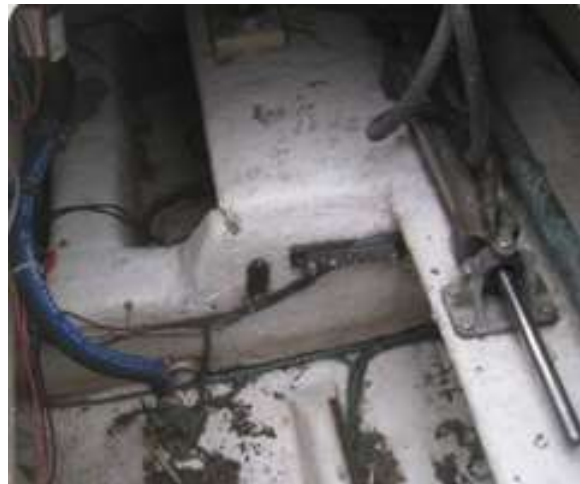
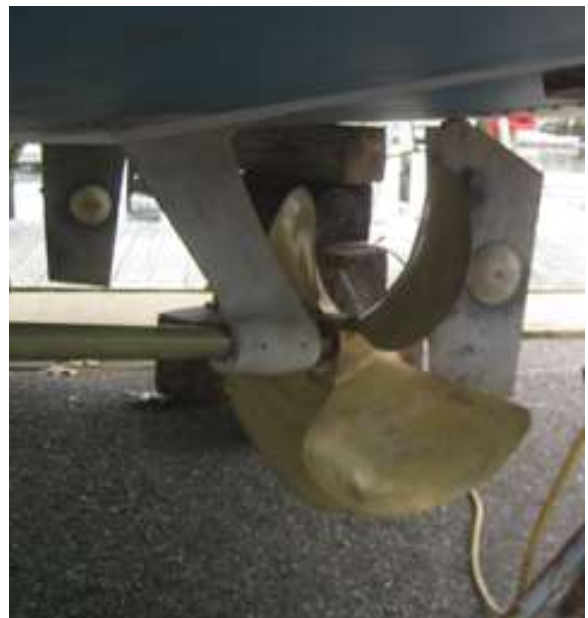
The above images show new water cooled shaft logs, new sea strainers and shutoff, reinforced rudder shafts, batteries that need positive terminal protection, and one hose clamp that should be replaced.

1. Install backup ground tackle and CO device.
2. Protect batteries from shorting.
3. Ensure that a complete Coast Guard Safety and Signalling package is aboard. Have auto fire suppression system inspected and tagged.
4. Replace one rusty through hull fitting clamp.
