JAMES CROSS, Certified Marine Surveyor

March 15, 2013

Re: 1997 SeaRay Express Bridge 44

This letter reports the results of a survey of the above vessel which was inspected on the 12th of March 2013, at Silver Spring Marina in Narragansett, Rhode Island while hauled and winterized. You requested the inspection to establish its condition and value.

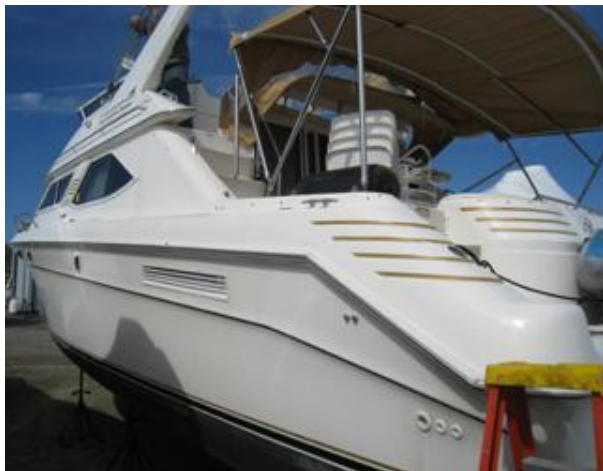
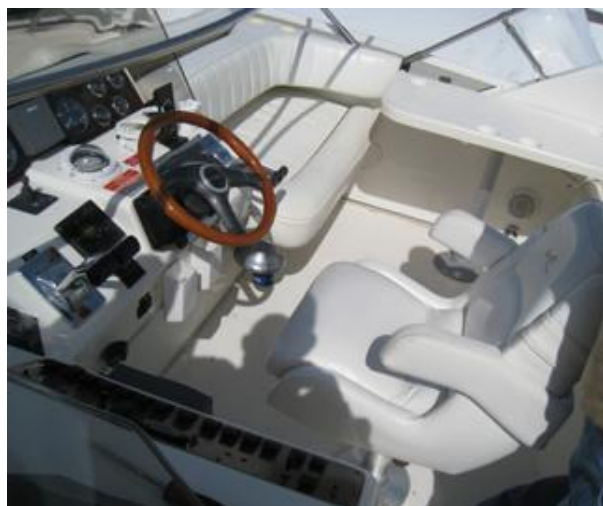
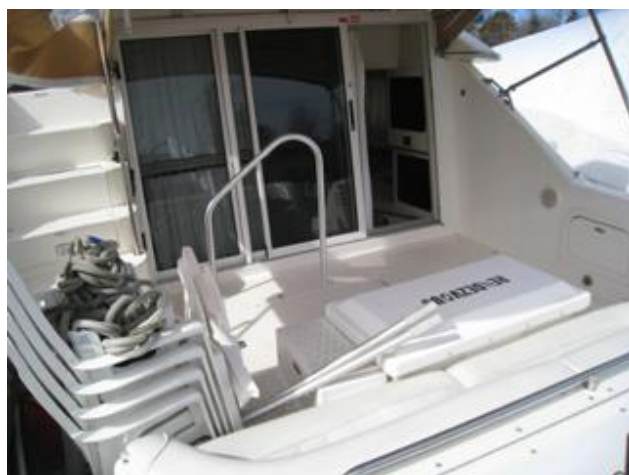
The hull is a typical polyester laminate reinforced with fiberglass matt and woven roving in a modified deep Vee configuration. The finish is the original white gel coat with stainless trim, and in excellent condition, overall, with only two very small superficial scratches. The bottom was percussion sounded and found to be in good, solid condition. No soft spots were noted. The overall appearance of the hull and super structure is that of a lightly used vessel. I was unable to locate any delamination or separating of glass, including the engine bearers. The bulkhead and stringer tabbing through out is matt and woven and properly installed. The inside surface of the laminate has been painted with an epoxy finish. No serious hull stress situations were observed. The topside (deck is reinforced with balsa core) is also white and in good condition. All through hulls are plastic or bronze and are in good condition. The cockpit door is in good condition and closes properly. The vessel is equipped with a large, integral fiberglass swim platform. No damage was noted to the platform. There are stainless bow and fiberglass anchor pulpits, and they are in good condition and secure. All of the deck hardware is properly backed and secure. A factory installed fiberglass radar arch is properly installed and secure. The canvas (recent upgrade) and supporting structures are in good shape and secure. The bridge unit is properly secured to the main cabin.

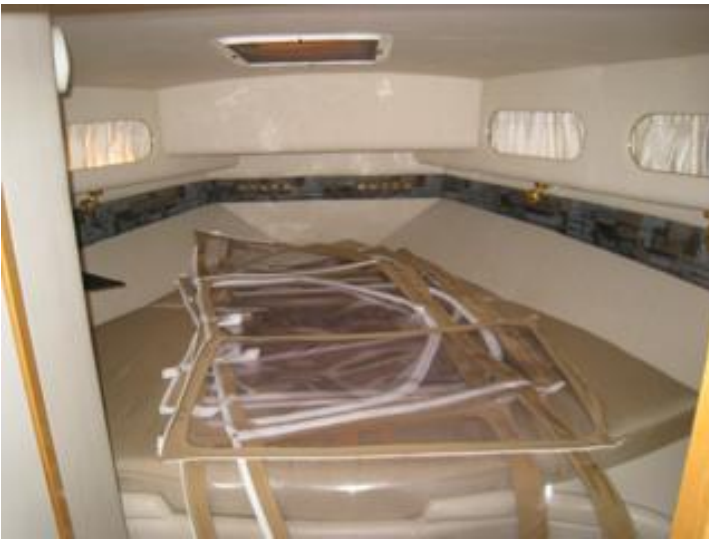
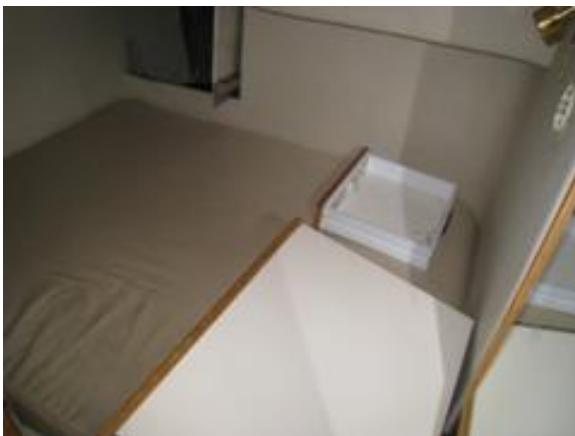
The forward berth is located beneath the forward deck. This area will sleep two in a custom shaped over size queen berth. The forward berth area is clean. The upholstery is also in good condition. There is adequate lighting and ventilation in this area. Also, housed in this forward berth area are several lockers and drawer storage. A TV/VCR is installed along with stereo speakers. Translucent hatches and ports provide ventilation and light. The hatches and ports are in good condition and tight to the weather.

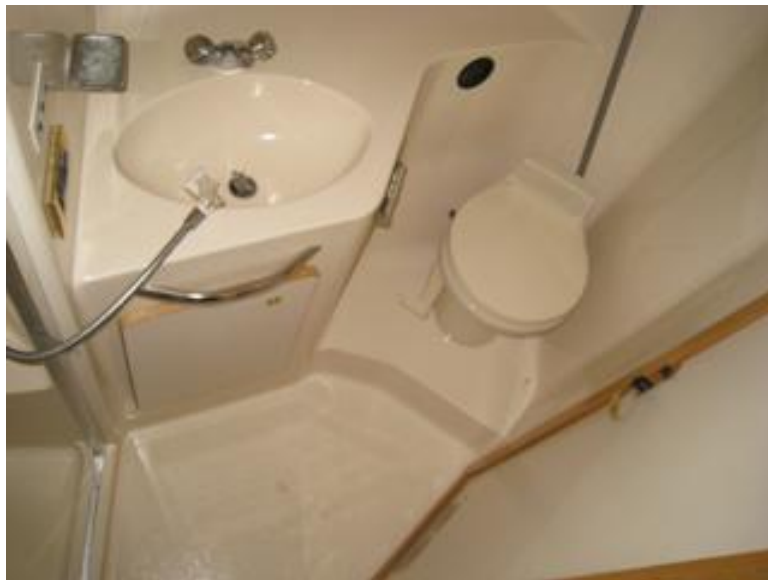
There are two complete heads, both also in very good condition. They are equipped with standard VacuFlush electric marine toilets, showers and hand basins. The shower units are an integral part of the inner liner. The showers drains into a sump pump arrangement and is then pumped overboard. From the appearance of the plumbing, carpet, and other fixtures, including the galley gear this vessel has been lightly used, and certainly not abused. Plastic holding tanks and related Y valves and plumbing are included. The hot and cold fresh water system is also in good shape.

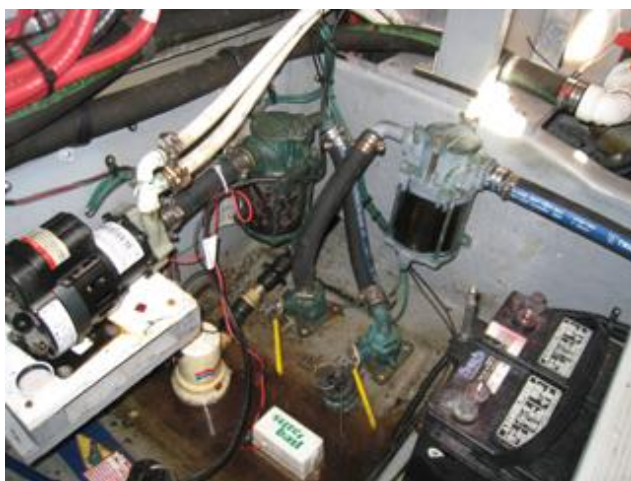
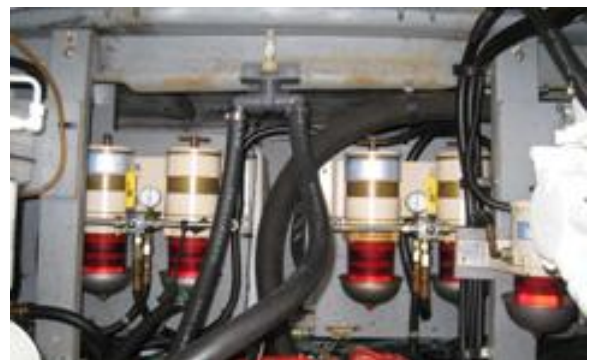
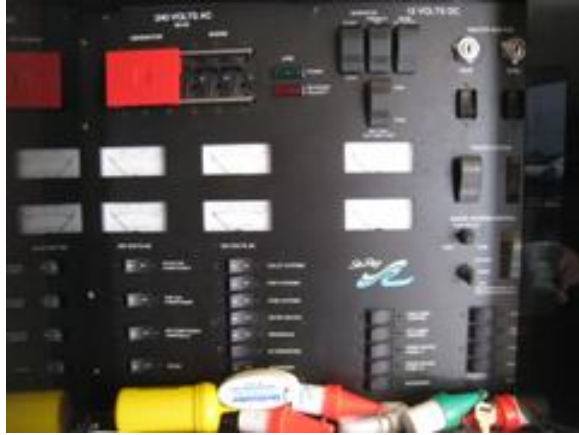
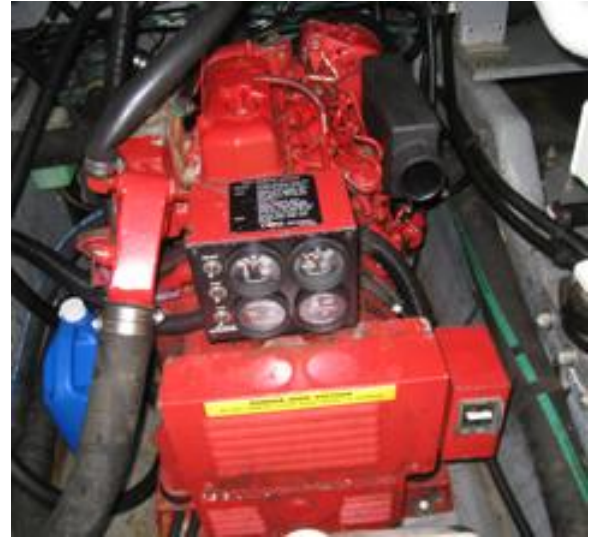
The fuel tank is aluminum and is in good condition, as can be inspected. There are proper fuel shut-off valves on both feed lines. Shut-offs are in good working order. All fuel lines and valves are in good condition. The water heater is in good shape. The entire potable water system is in good condition and appears lightly used. The water and holding tank PVC are in good condition as can be inspected, as are their related fills, vents, and feed lines.

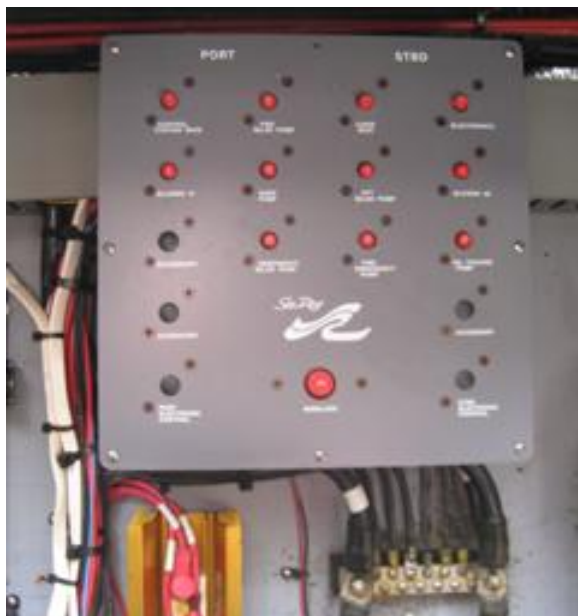
The electrical panel (combination AC and DC) is in good shape. There are two 2 position battery disconnect switches beneath the aft deck near the properly instal protected. All of the battery terminals are in good condition and free from corrosion. Two 120 volt 35 amp shore power cables are in use. One cables are in good condition. There is a complete bonding system installed, along with a factory installed electrical isolation system. The running lights conform to the CFR.

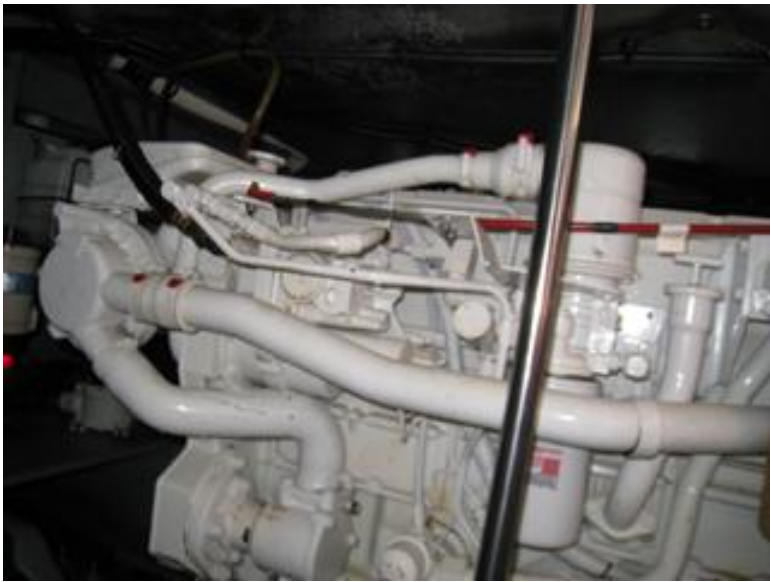
The fresh water cooled gen set is a good clean installation with no obvious faults. The raw water cooling input and exhaust systems are in good shape and secure. A complete entertainment system is installed, which includes television, and stereo with CD to all cabins including the bridge. A very nice setup

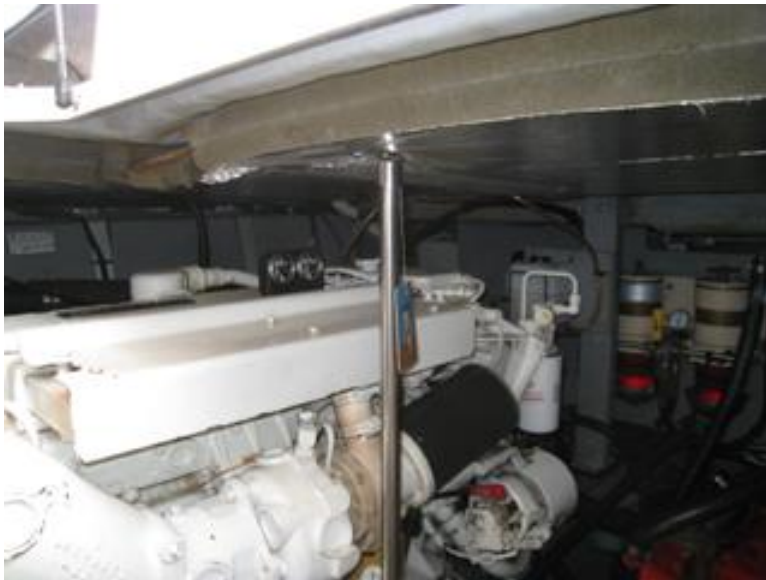
Propulsion is by a pair of fresh water cooled counter rotating Caterpillar 3116-350 Diesel engines with reduction gears. Visual inspection of the engines, oil, filters, coolant, and related connections show that a good maintenance regime is in effect.

The monel shafts, silicone bronze logs, and rubber cutlass bearings are in good shape. The rudder shafts and shaft logs are in good condition. Bronze and steel rudder towers are in good condition.

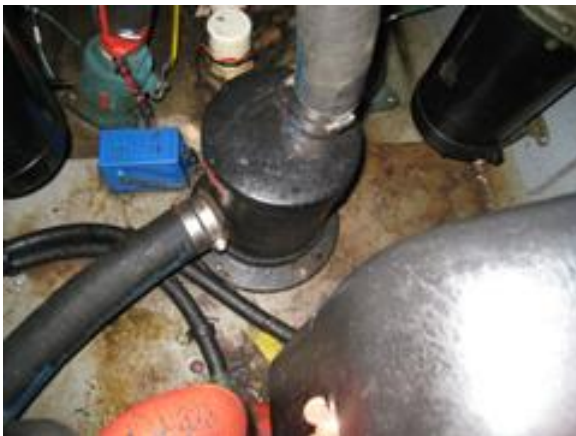
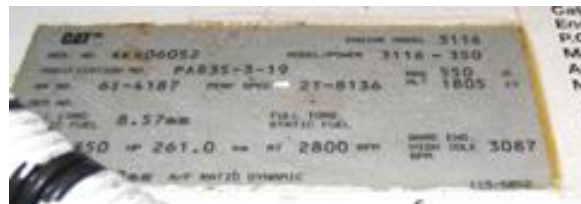
Approved bilge blowers and hoses are installed and working. There are two bilge pumps mounted in the bilge, and functioning. . Electric/hydraulic trim tabs are sized and installed. There is no trace of oil in the bilge, but the bilge is in need of cleaning.

The exhaust systems is also in good condition. All bronze valves and salt water devices in the engine compartment are in good condition and properly bonded. The intake and exhaust systems, including the silencers and sea water strainers are in good condition.

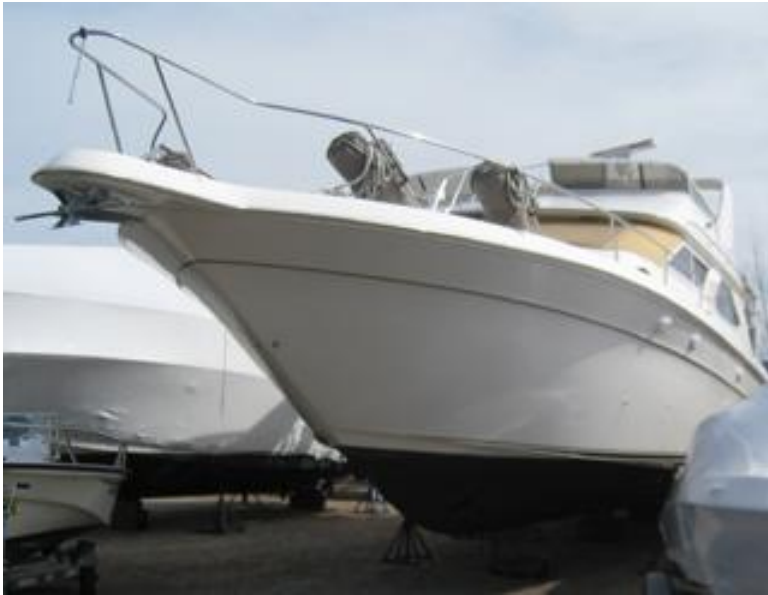
- 11A. Engine compartment ventilation.....two Coast Guard Approved type 12 volt blowers along with appropriate flexible ductwork to hull outlets.
12. Rudder shaft logs.... secure
13. Rudder tower.... steel, (original) good condition
14. Steering gear and controls.... Hydraulic to manual, lines and hardware are original and are in good condition
15. Overboard fittings..... all bronze fittings below the water line, shut-off valves are working and are well maintained, appear original. Related hoses US Coast Guard approved type and are double clamped.
Overboard fittings are plastic above the waterline and in serviceable condition
16. Backup ground tackle..... not observed

Recommendations: Ensure that a complete Coast Guard Safety and Signalling Package is aboard. The engine room fire quenching system should be inspected. Add backup ground tackle.
