April 12, 2020

Re: 1975 Nautor Swan 38 Sloop

This letter reports the results of a survey of the above vessel which was inspected on the 10th of April, 2020, while hauled and winterized at Stanley's Boatyard in Barrington, Rhode Island. You requested the inspection to establish its condition and value in order to acquire insurance. The vessel owner was present during the survey.

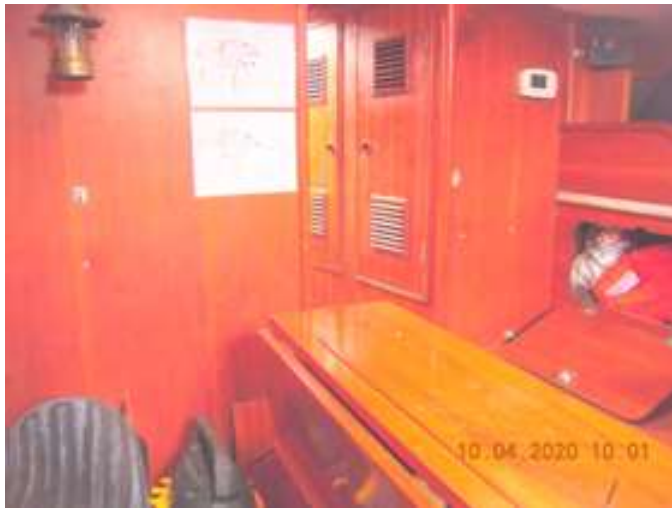
There is proper ventilation to the main cabin area through vents and ports. The main cabin houses the dinette, galley and head. There is a propane range with oven properly gimballed in the galley. A large reefer system with freezer is built in. The reefer system is equipped with a refrigeration compressor. The stove, and sink are in good condition. There is a pressure hot and cold water system installed. A salt water foot pump is installed to provide salt water to the galley sink. Closets, lockers and other storage areas are more than adequate through out the vessel. The interior areas are clean and in excellent condition. The jointer work is Cherry and Mahogany. The jointer work is nicely done and in very good condition with a bright finish. The headliner is a composite of insulated vinyl with trim. The head liner is in good condition.

The upholstered sections are also in excellent condition and show only light use. The sole is teak and holly over heavy marine plywood and also in excellent condition.

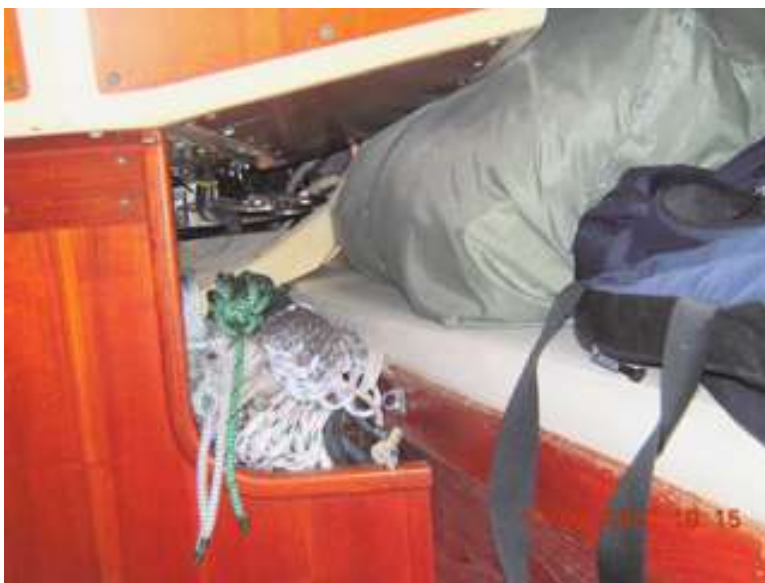
The Aft-Berth compartments located beneath the after deck. This areas will sleep three. This compartment is clean, dry, and odor free. There is adequate lighting and locker space in these area. The escape hatch to these areas is an internal door. Access to the quadrant and steering gear is gained from this area.

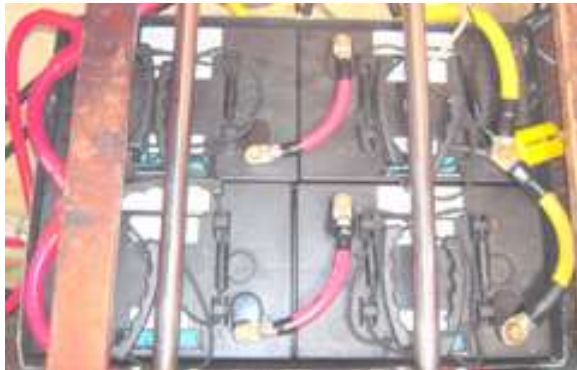
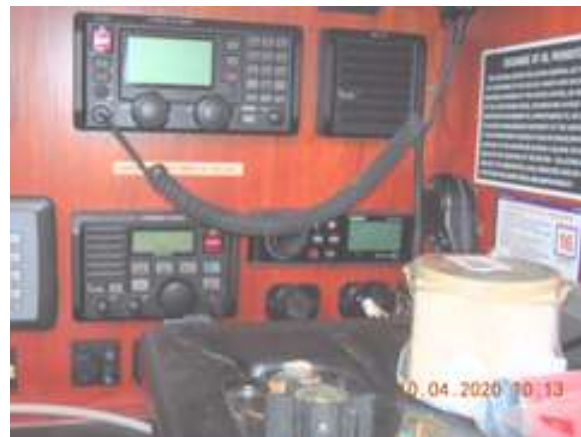
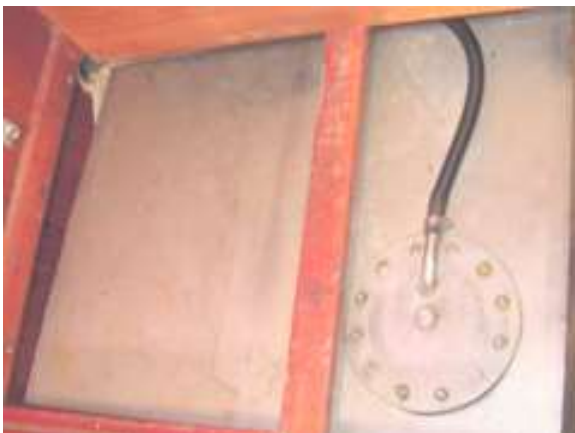
The batteries appear fairly new and are in good condition and properly connected to the approved three-way switches and then on to the custom breaker panel. The batteries are properly secured and covered below the salon berths. The wiring and terminals that could be observed are in good condition. All of the electrical wiring has been properly harnessed and is secure. The shore power system overall is in good condition as are the cables. The automatic battery charger was not checked out. The navigation equipment and electronics, was not checked out while operating. All of the electronics and navigating equipment is contemporary and appears lightly used. The anchor windlass is in excellent condition and secure. The Auto pilot hardware is properly installed and appears in good condition. The radar display is mounted on the steering pedestal.

Recommendations: Protect batteries from shorting, as needed.
Replace sacrificial anodes on shaft and propeller
Secure bilge pump and switch
Free up FW system tank shutoff valves
Grease all through-hull valves (5)
Re-bed covers deck cover plates for shroud tangs (4)
Protect all battery Positive terminals from shorting
