R048

June 11, 2020

Re: 1990 Viking 45 Convertible | Flybridge

This letter reports the results of a survey of the above vessel which was inspected on the 11th of June 2020 at the Pleasure Marina in Warwick, Rhode Island while afloat. You requested the inspection to establish its condition and value.

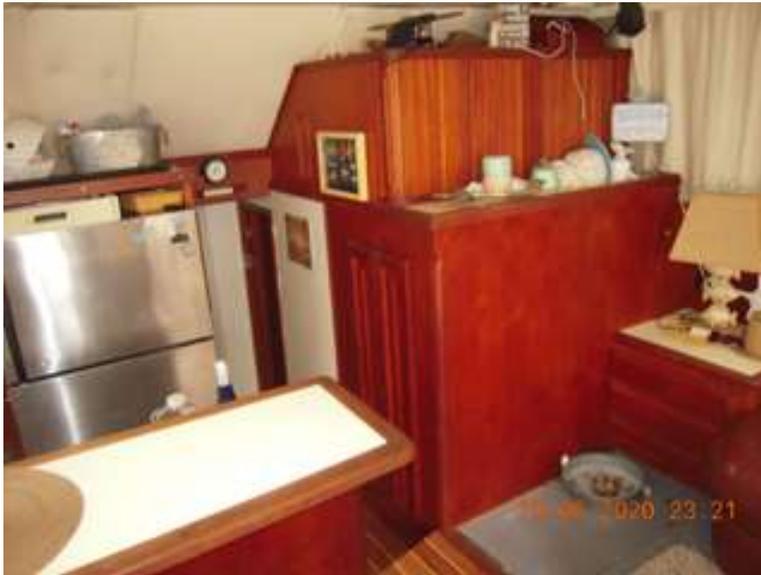
There is a complete inventory of full size galley appliances, two burner surface mounted stove, microwave oven, and full size refrigerator, which appear in lightly used condition. The counter top in the galley is comprised of Formica which is in good shape. There is a large sink located between the stove and refrigerator in the galley area. The sink and its related faucets and over board drain are in good condition and clean. The sole in the galley is Teak and Holy striping and is in excellent condition and secure. No rot was found in any deck timbers or supports. The galley is located a few steps forward and below the main salon and dinette. The galley, overall, is in excellent condition.

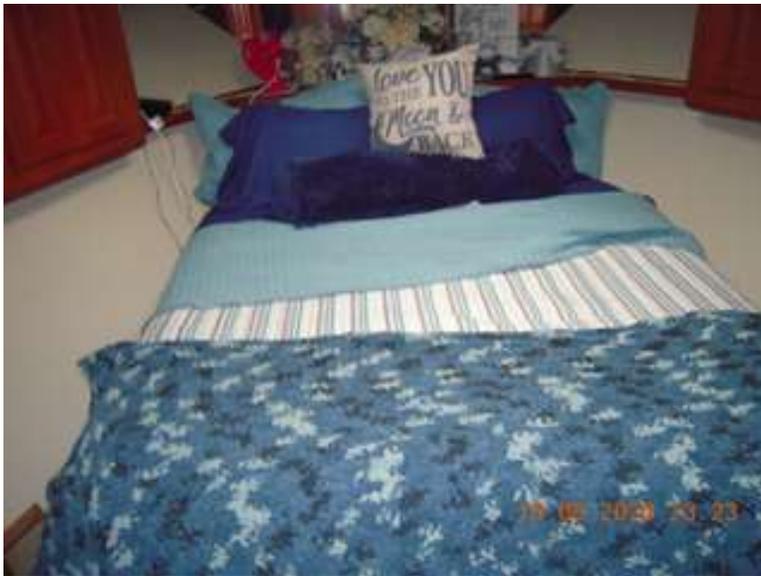
A large custom sized bed is located beneath the forward deck. This area is clean, nicely finished and upholstered. There is adequate lighting and ventilation in this area. The deck (fitted with new Nylon moisture resistant Nylon carpet) in this area is properly supported, and in overall good condition. Some of the this area is sheathed with vinyl and some in nylon, the jointer work is solid Mahogany with a bright finish. I was unable to locate any excess moisture on any surface in this area.

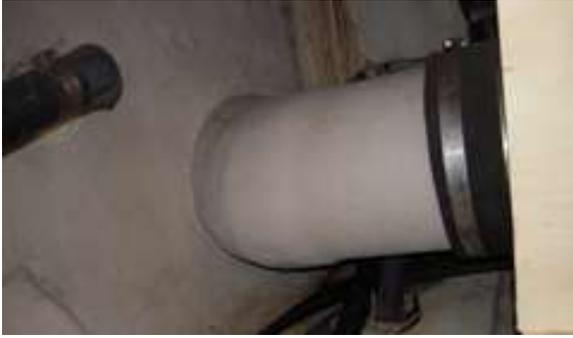
*Exhaust system hardware and rudder shafts at transom, in good shape.*

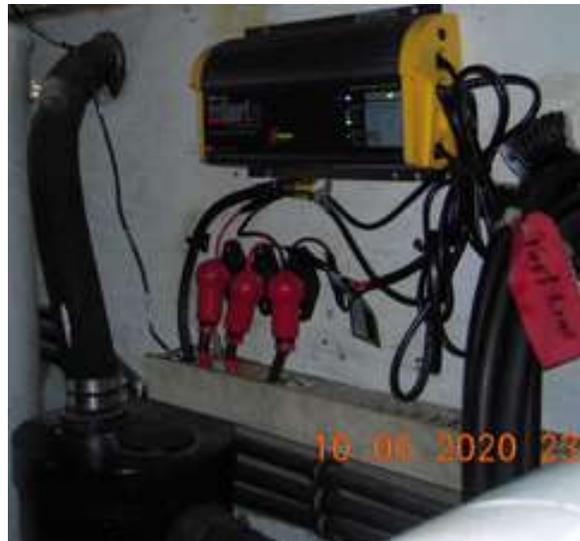
*Battery charger*

The shore power system is in good condition, as are the cables. The automatic battery charger was not checked out, but appears fairly new. The navigation equipment and electronics has been operated.

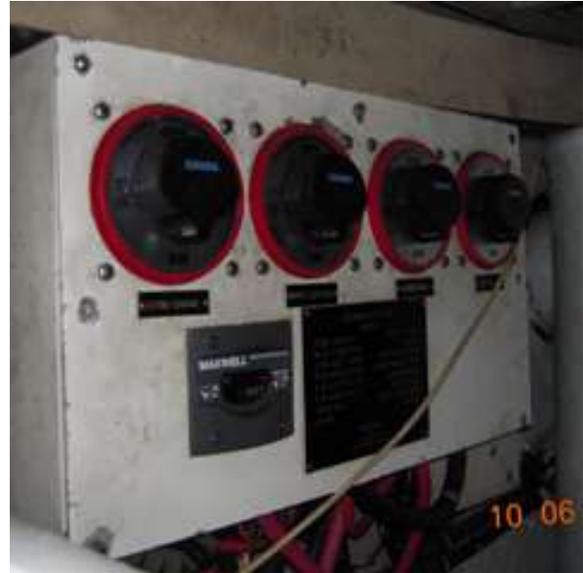
Battery switch control panel

The electrical panels are in good shape. There are three 3 position battery disconnect switches mounted on a bulkhead below deck. They are in good condition and properly wired. All DC circuits were rung out and found to be in good condition. The 120 Volt power panel, breakers, and circuits were found to be in operating condition. All wiring is properly harnessed and secure, as can it be observed through out the vessel. Two shore
