JAMES CROSS, Certified Marine Surveyor
 19 Nooseneck Hill Rd., West Greenwich, RI 02817
 Phone (401) 397-5040
 Member Association of Certified Marine Surveyors / ACMS.USA.COM
 Check us out on the web at www.jimcross.net

June 10, 2019

Re: 1988 Wellcraft Portafino 430

This letter reports the results of a survey of the above vessel which was inspected on the 10th of June, 2019, at your property in Warwick, Rhode Island while hauled, partially covered, and winterized. You requested the inspection to establish its condition and value.

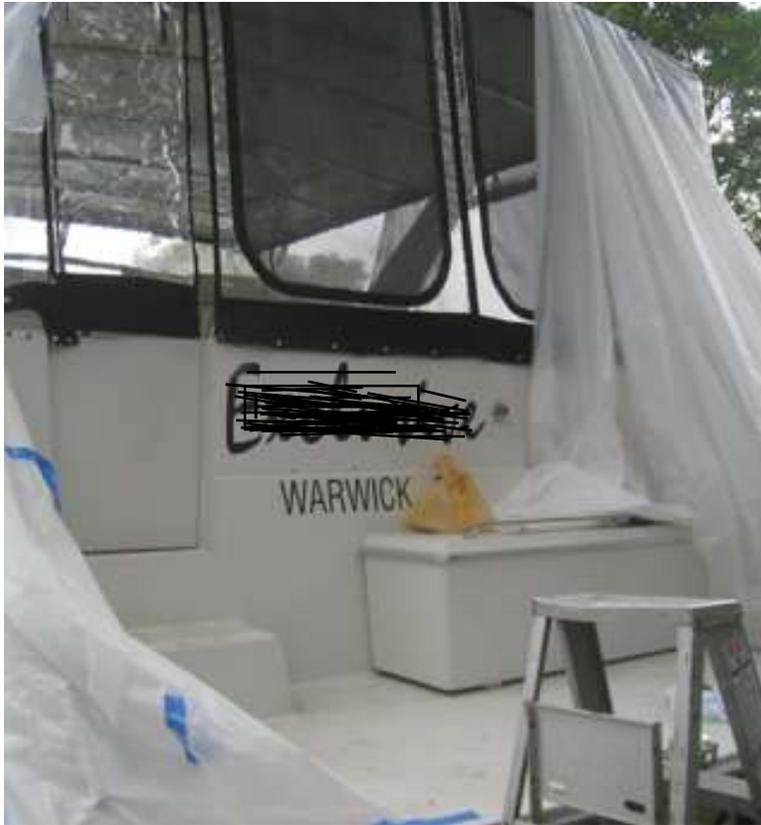
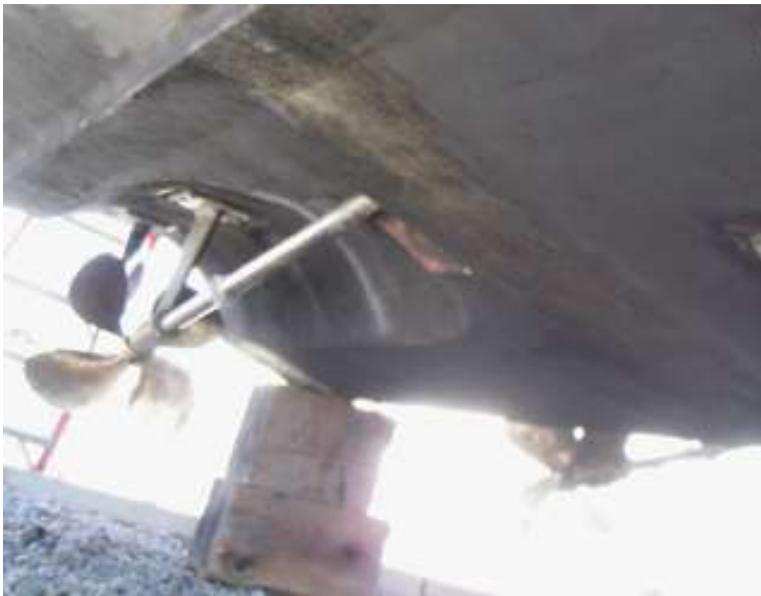
Hull and Structures

The hull is a typical polyester laminate reinforced with fiberglass matt and woven roving in a modified deep Vee configuration. The freeboard finish is white gelcoat with stainless trim, and is in very good condition, overall, with just a few superficial mars and scratches.

The hull - deck attachment is secure and reinforced. I was unable to locate any delamination or separating of glass, including the engine bearers and stringers.

The bottom was sounded with a mallet and was found to be in good condition and has a proper coat of anti fouling paint applied. The propeller shafts are in good condition as are the shaft logs, cutlass bearings and struts. The bronze propellers are in good condition. The rudder posts and rudder shaft logs are secure and in good shape.

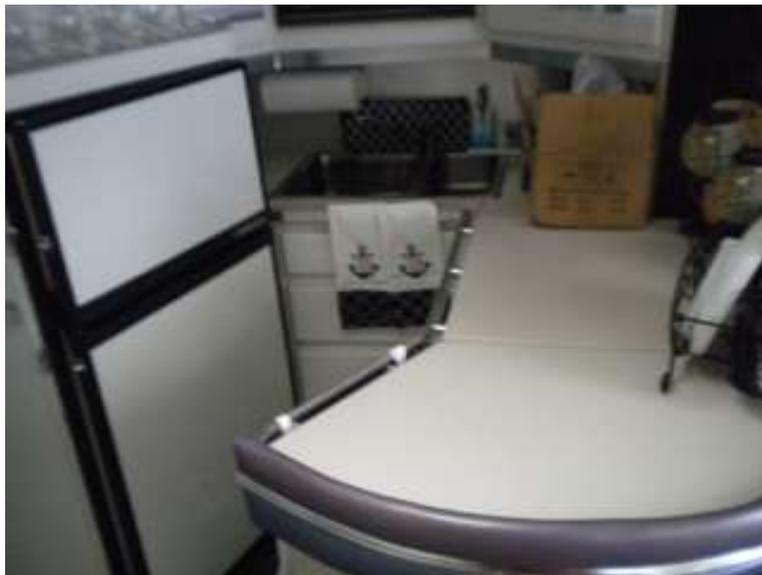
Galley

There is a 120/12 volt refrigerator / freezer and a Formica counter top electric stove, which were not tested, but appear in serviceable condition. The counter top in the galley is comprised of white Formica with vinyl trim which is in good shape. There is a large stainless steel sink located between the stove and refrigerator in the galley area. The sink and its related faucets and over board drain are in good condition and clean. The sole in the galley and forward is also

plywood and is in good condition and secure. No rot was found in any deck timbers or supports. The galley is located a few steps forward of the main salon and dinette. The galley, overall, is in excellent condition.

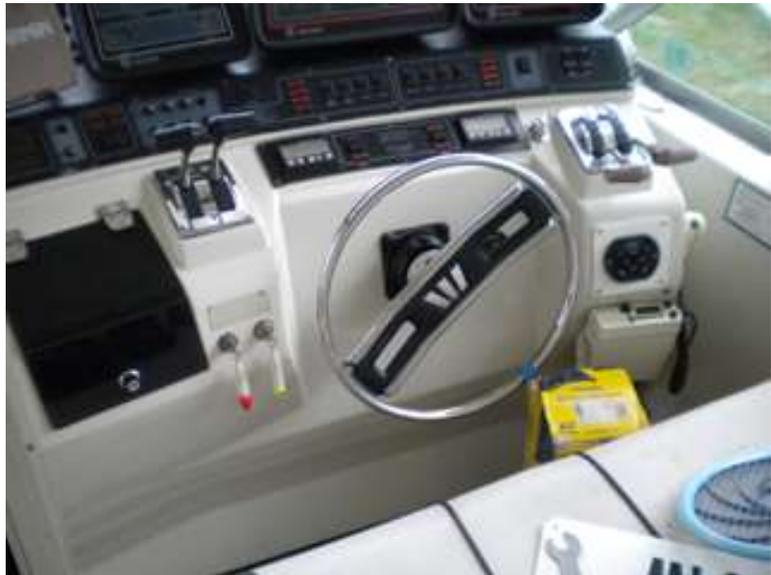
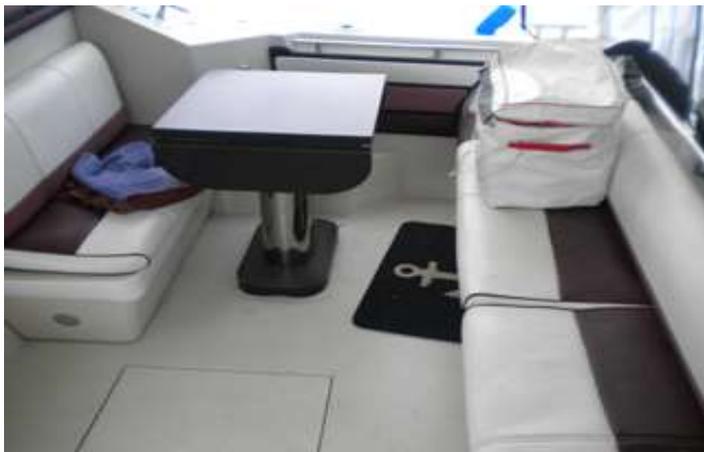
Aft deck, and Operating Stations

The operating station is well designed and the controls are easy to operate. The upholstery is in good condition overall. The compass is accurate on its present heading. The shifts and steering are also smooth operating and in good condition. Steering is hydraulic and the related lines are in good condition. There is a full cockpit custom made fiberglass hardtop installed. It is secure and well supported. The aluminum supports are backed and secure.

There is a new color keyed canvas complete weather enclosure installed. The station is equipped with stainless life rails which are secure and properly backed. Overall, this area, including the operating station and upholstery is in excellent condition. The navigation equipment and electronics was not checked out. Access to steering gear and fuel tanks is gained via large deck hatch. (In good condition.)

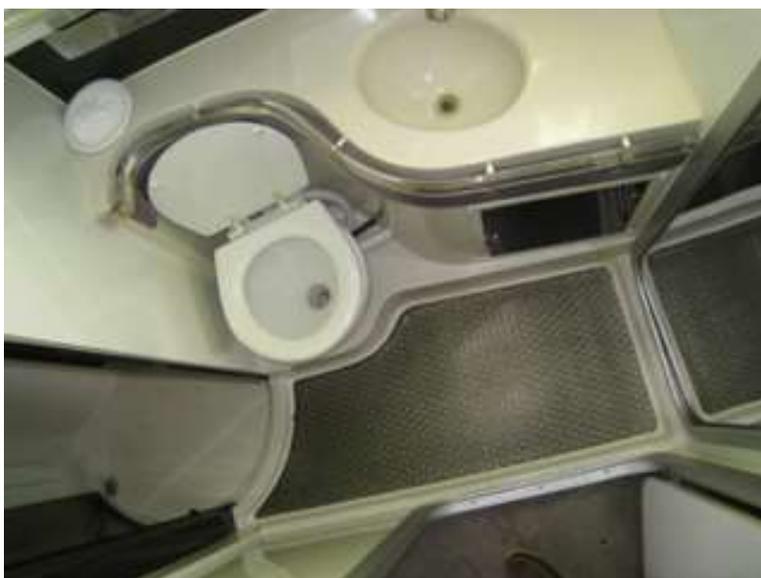
Head

The head is in very good condition. The head is equipped with shower, hand basin and an electric marine standard toilet. The shower unit is an integral part of the inner liner. The shower stall is good sized fiberglass enclosure. The shower is equipped with a sump pump and overboard drain. There is a macerator unit, Y-gate, and holding tank installed. The head plumbing is in good condition and conforms to A.B.Y.C. standards.

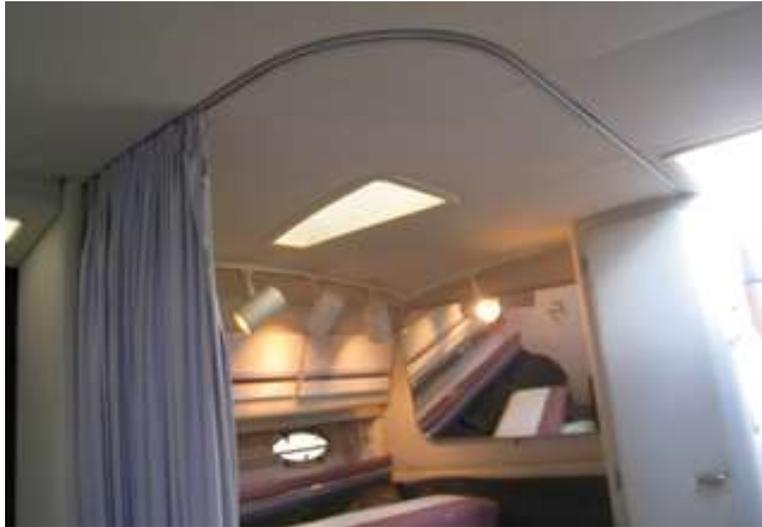
A large berth (Owners State-room) is located forward from the main Salon. This area is structurally sound and also cosmetically in excellent condition. There is adequate lighting and ventilation in this area. The deck in this area is properly supported, and the new carpet has been installed. The old carpet has been replaced in this area. Otherwise this area is in excellent condition. I was unable to locate any excess moisture on any surface in this forward cabin.

This area also appears lightly used. Also, housed in this berth area are several lockers and rode storage. The head liner in this area is clean, in good condition, and secure. There is adequate lighting, locker, and drawer space. Adjacent head with shower is provided forward.
