JAMES CROSS, Certified Marine Surveyor

June 4, 2013

Re: 1988 Irwin 44 Center Cockpit Sloop

This letter reports the results of a survey of the above vessel which was inspected on the 4th of June 2013, at Tiger Marina in Warwick, Rhode Island while afloat. You requested the inspection to establish it's condition and value.

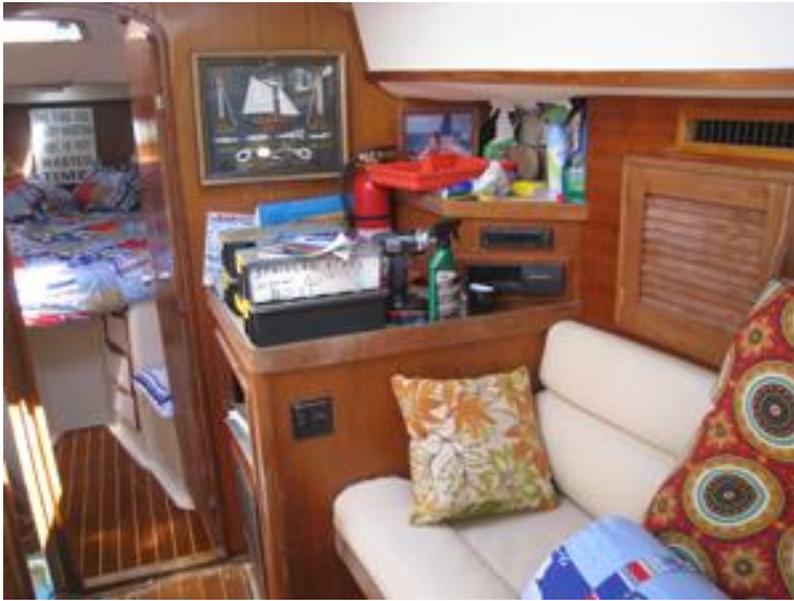
The interior joiner work and trim, as evidenced by the photo at left, has been the subject of a refinishing project

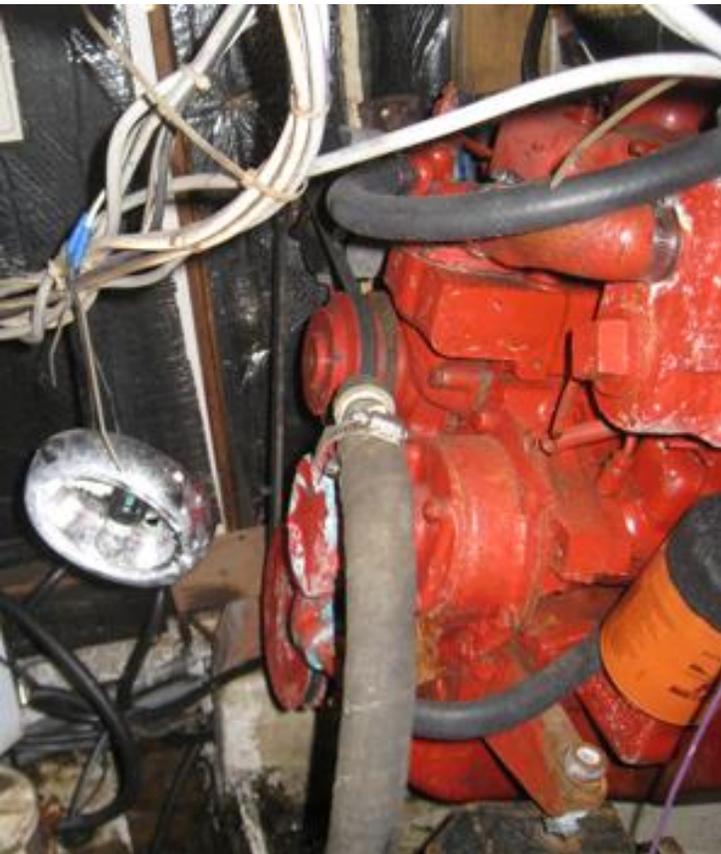
Propulsion is by a Westerbeke 40 hp fresh water cooled Diesel engine with reduction gear. Engine instrumentation, consisting of a tachometer, gauges, and warning lights, are positioned at the helm for easy viewing while under way. The engine was not tested during inspection. The throttle and shifting levers are in good condition. The engine intakes salt water via the through hull, strainer, and on to the heat exchanger. The intake and filter are secure, and double clamped.

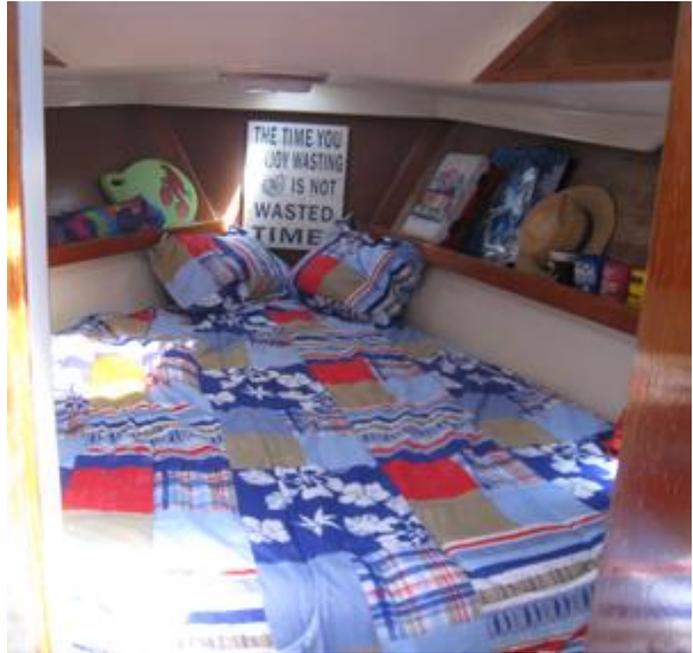
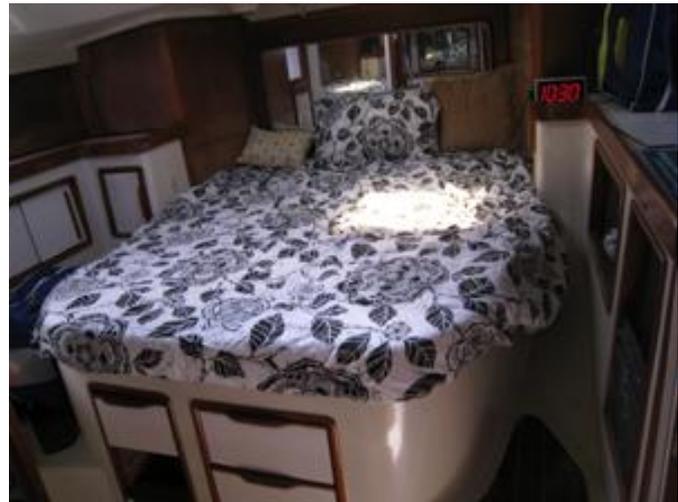
Pictured at right are the two large berth compartments. These areas are nicely finished and in good shape, structurally. There is adequate lighting and ventilation in these areas. The sole in these areas is properly supported, nicely finished and in overall good condition.
