JAMES CROSS, Certified Marine Surveyor

Re: 1987 43 Morgan Sloop

This letter reports the results of a survey of the above vessel which was inspected while hauled on the 15th of May 2013 and then again on August 15, 2013 while afloat, at Nortons Shipyard, in Warwick, Rhode Island. You requested the inspection to establish its condition and value.

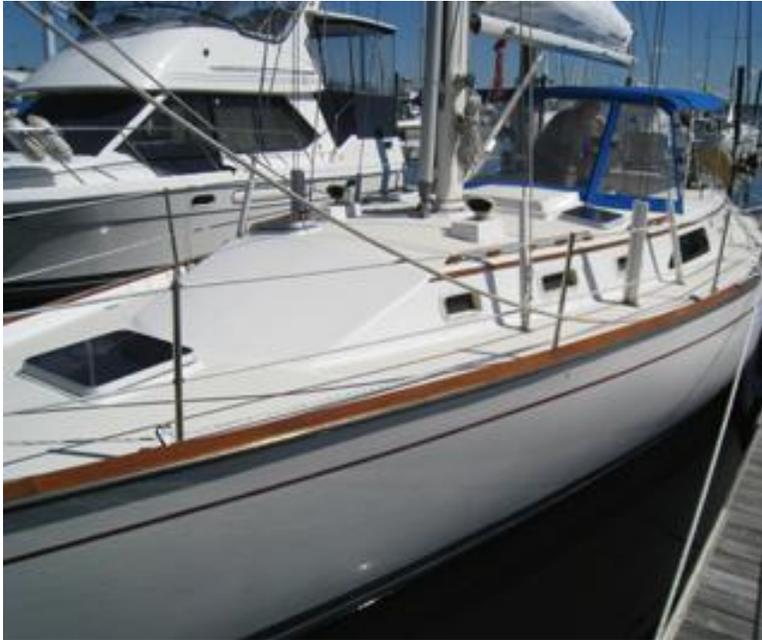
This vessel was designed and heavily built to withstand years of off shore yacht service. She is an center cockpit cruising sloop rigged for high performance and comfortable cruising.

The hull is a polyester laminate reinforced with fiberglass mat and woven roving. The hull is hand laid up solid fiberglass. The deck is similar, but with some end grain balsa coring. The surface above the water line is the original white gelcoat, presently waxed and clean, and has been well maintained. The hull area from the boot top to the gunwale is in excellent condition and blemish free. I sounded the hull with a mallet and no voids or soft spots were detected. The hull

from the boot top down was inspected and found to be in excellent condition. The lead ballast is properly fitted and secure inside the lower part of the keel. The bottom finish is smooth and free from excess buildup.

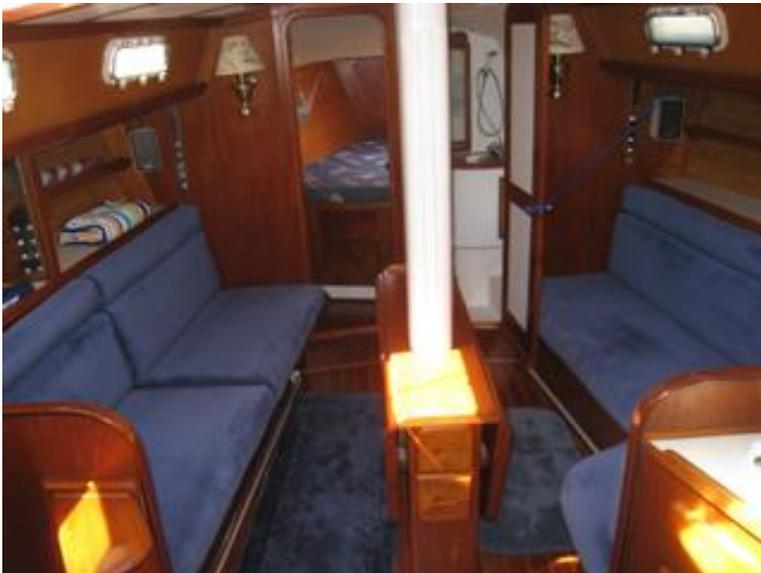
The main cabin houses the salon-dinette, and galley. This area is spacious, nicely finished and in excellent condition. The Teak and Holly sole is in brightly finished condition, partially attired with plush color keyed scatter carpets. The jointer work is Teak and Mahogany. The jointer work is nicely done and in very good condition with a bright finish. The vinyl headliner is clean, in good condition, and secure. Teak overhead hand rails are well secured to the structure. The upholstered sections, bulkheads, and joiner work show very light use, good care and maintenance.

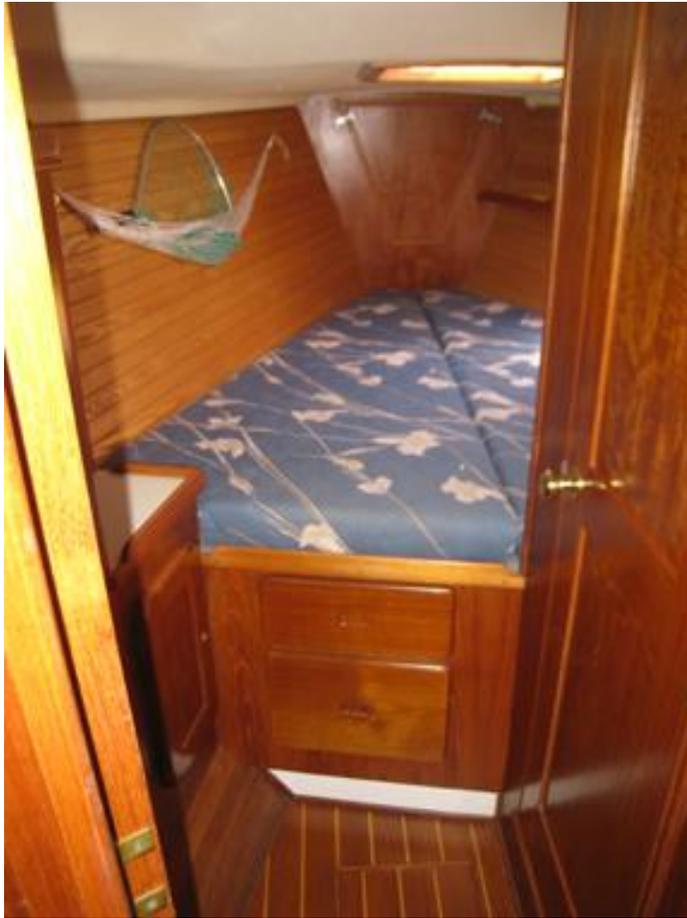
The V-Berth (Photos at left) is located beneath the forward deck. This area will sleep two. This area is clean and nicely upholstered. There is adequate lighting and locker space in this area. Also housed in the V-berth area are several PFD's and rode storage at the forepeak. The deck escape hatch to this area is tight to the weather and in good condition.

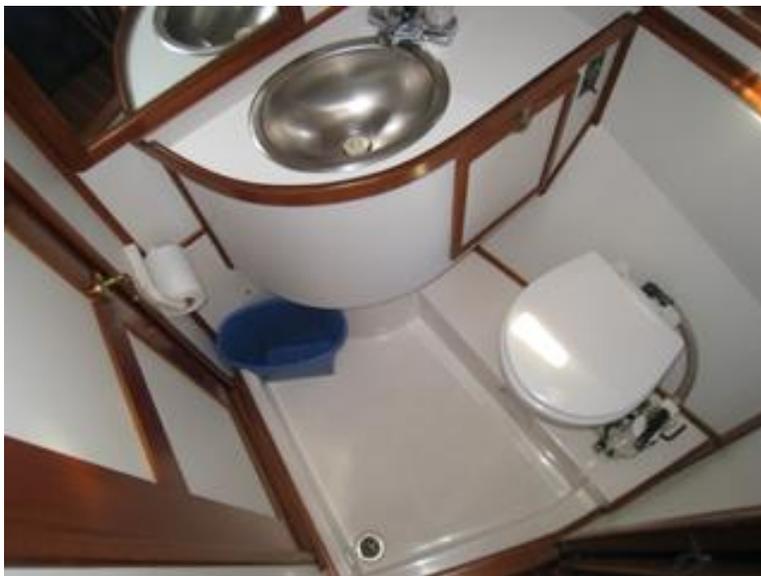
Both forward and aft heads are good sized and equipped with showers and manual marine toilets that discharges into bladder type holding tanks, or can be pumped overboard via a proper Y-gate. There are hand wash basins in both heads and a fiberglass tub installed aft. No wood rot was noted in these areas. The heads are finished in Teak and Mahogany and are exceptionally clean. (Aft head Photos on Page 6).

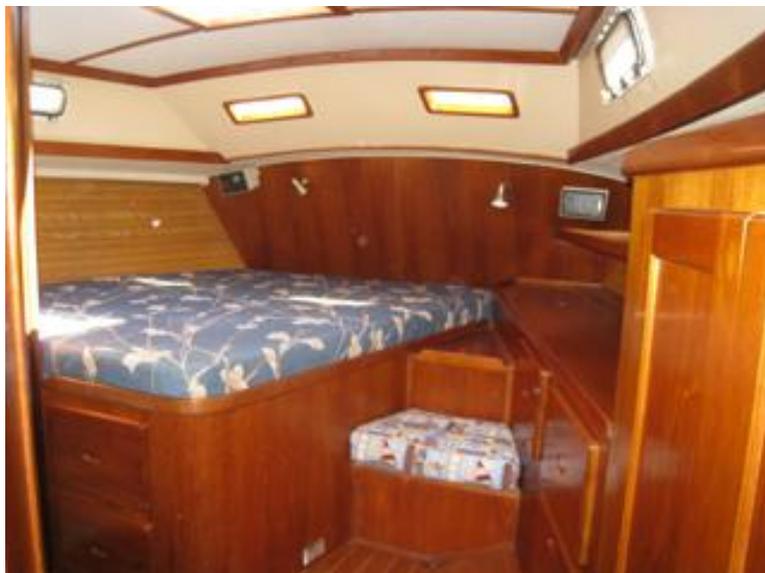
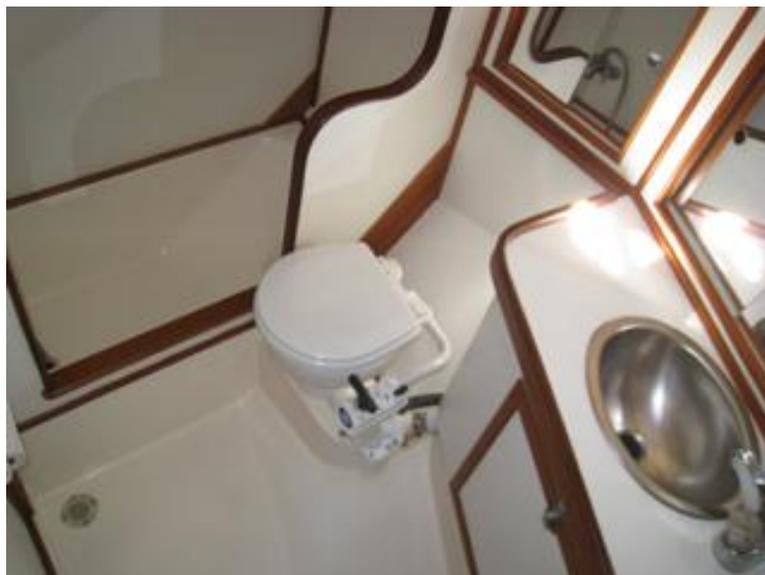
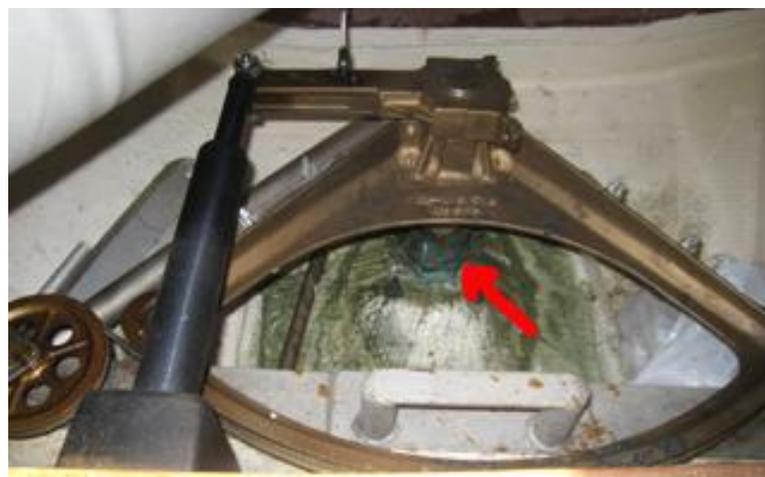
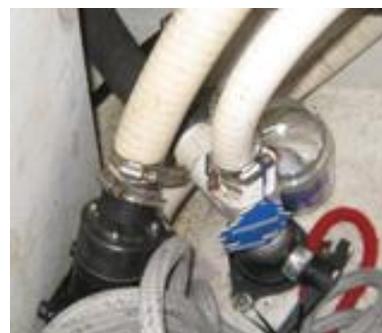
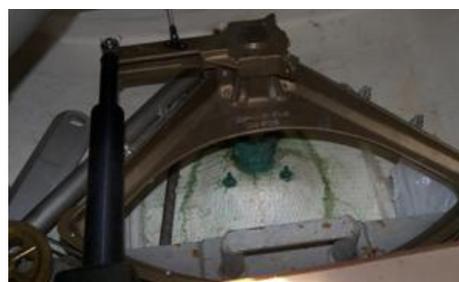
The Aft-Berth compartment is located beneath the after deck. This area will sleep two. This area is clean and nicely upholstered. There is adequate lighting and locker space in this area. Also housed in the aft berth area are several PFD's . The deck escape hatch to this area is tight to the weather and in good condition. Located beneath the aft berth is the auto pilot steering gear and rudder quadrant. The steering gear is in excellent mechanical condition. Note the photo below of the quadrant which is secured to the rudder post. The through hull fitting is a shaft log which may be leaking as evidenced by the green stains in the area. This log should be re-packed and tightened. Note the photo (Below right) of the quadrant from the previous survey, five years ago indication no stain or leak. Y-gate and overboard fittings are also located adjacent to the steering gear.

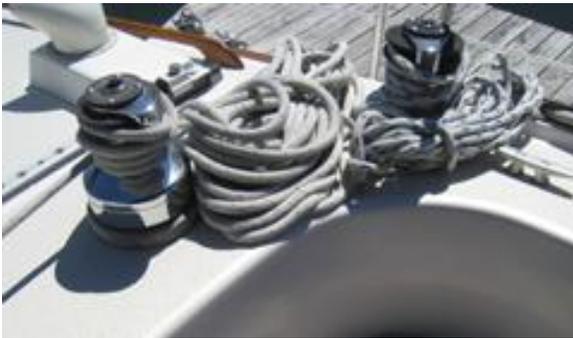
The aluminum mast and boom and related winches and hardware are in excellent condition as can be observed from on deck. The main mast steps through the deck and on to a step which is secured to the keel makeup. The mast step, (properly fitted), is an aluminum casting and shows signs of corrosion. All deck hardware, including winches, are properly backed and secured. The mast and standing rigging are properly bonded to the ground plate. The standing rigging hardware is properly sized for this vessel. The shrouds, spreaders, and turnbuckles also check out. The winches are properly sized. All deck hardware is properly secured and backed.

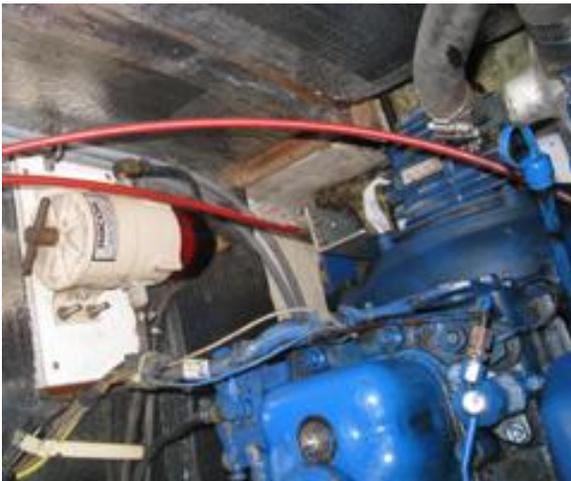
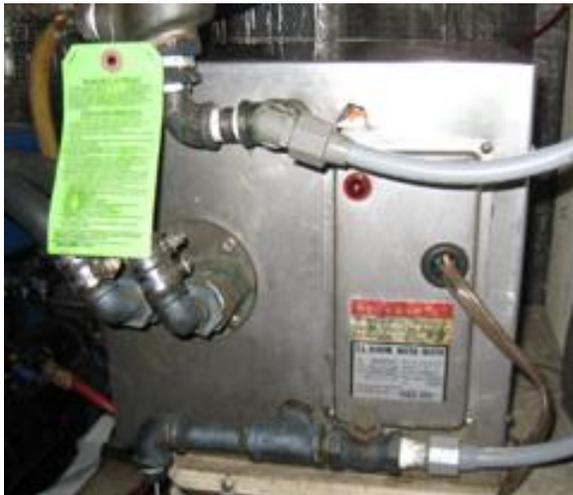
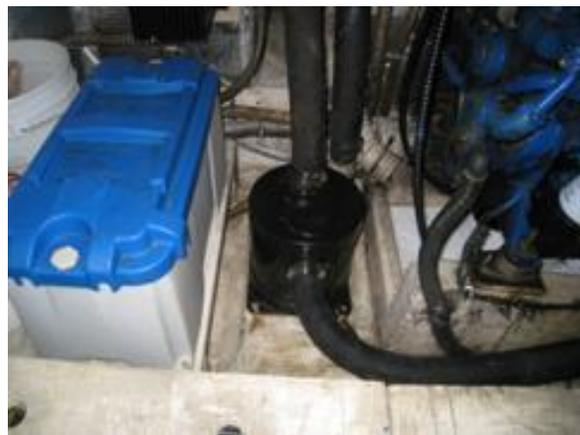
Propulsion is by a 50 HP fresh water cooled Perkins diesel engine with Hurth reduction gear, coupled to a monel shaft and then to a three blade feathering propeller. The shaft and shaft log, are in good condition. The engine and gear appear in good condition, very clean and well maintained. Ventilation to the engine spaces is adequate. The exhaust (most can be inspected) system is cast and rubber, heavy duty, and in good condition. The system clamps are all double and all are in good shape. All through hull fittings including the valves are in working condition and properly bonded. The engine controls and cables are smooth operating. The engine compartment bilge is epoxy painted, sound and sturdy. The bilge in this area is clean and free from unessential material. There are adequate bilge pumps installed and working in this area. There is no oil in the bilge. All fuel and water tanks are in good condition as can be inspected. The fuel lines, including a Racor filter are approved type and in good condition. The flex fuel line appears to be a recent upgrade. The fuel fills, vents and shut-off are in good order.

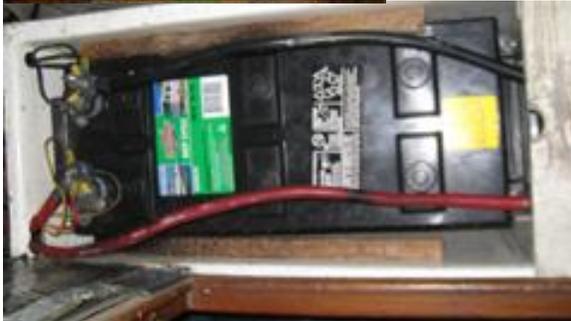
The batteries three (D cells) appear new and are in good condition and properly connected to the approved three way switches and then on to the custom breaker panel. The batteries are properly boxed and covered. The wiring and terminals that could be observed are in good condition. The electrical wiring is properly harnessed. The shore power system overall is in good condition as are the cables. The automatic battery charger was not checked out. The navigation equipment and electronics, was not checked out. The electric anchor windlass is in excellent condition and secure. The Auto pilot hardware is properly installed and appears in good condition. All of the electronics devices were not checked out as a sea trial was not conducted. The navigation lights conform to the CFR and are working.
