JAMES CROSS, Certified Marine Surveyor
19 Nooseneck Hill Rd., West Greenwich, RI 02817
Phone (401) 397-5040
Member Association of Certified Marine Surveyors / ACMS.USA.COM
Check us out on the web at www.jimcross.net

Re: 1977 44' Atlantic Trawler

This letter reports the results of a survey of the above vessel which was inspected on the 20th of August, 2020, at the Prime Marina in Warwick, Rhode Island while hauled. You requested the inspection to establish its condition and value.

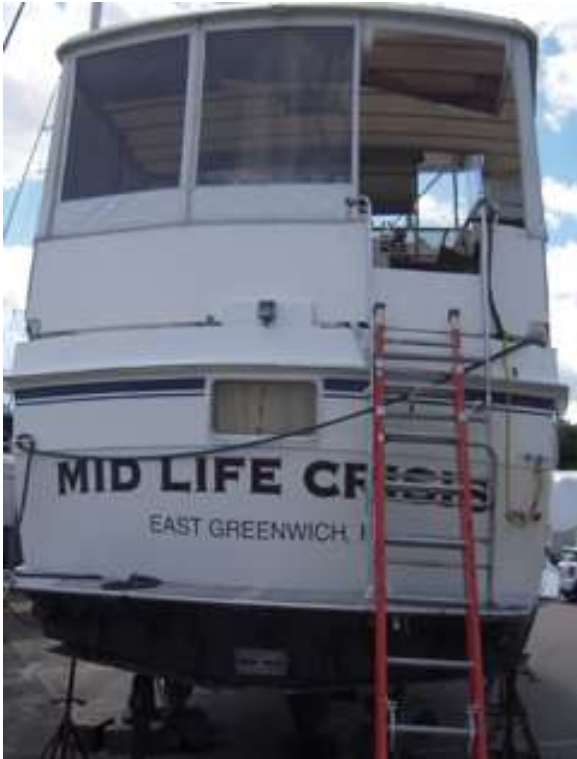
Preface

This vessel has been the subject of an ongoing extensive professional maintenance regime since the owner purchased the vessel I have surveyed this vessel a number of times and have noted that all work was carried out in a professional manner using the highest grade materials.

I would like to note that the overall appearance of the vessel is that of one that is receiving professional service. The vessel is, without question, as compared to my previous surveys in 2008 and in 2014 in Bristol condition.

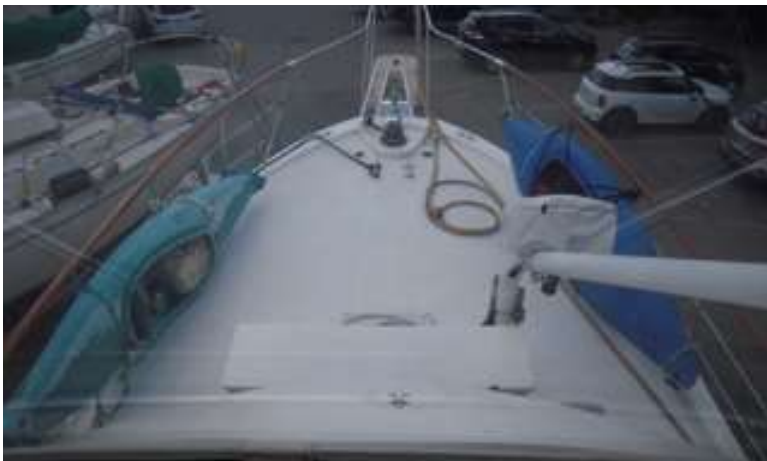
The hull is a typical polyester laminate reinforced with fiberglass matt and woven roving in a modified deep Vee configuration. The finish is fairly new white AwlGrip with teak and stainless trim, and the finish is in excellent condition, overall, with no mars or scratches. There are minor gelcoat abrasions on the fore deck, but they are not structural. The hull - deck attachment is secure and reinforced. I was unable to locate any delamination or separating of glass, including the engine bearers and stringers. The bottom (section below the water line) was inspected. The bottom was sounded with a metal mallet and found to be solid with no soft areas or delamination. The bottom was barrier coated after the previous survey. The two inch monel shafts are in good condition as are the shaft logs. The rudder posts are secure and properly packed. All through

hulls are in good condition and their related valves are working properly. The vessel is equipped with a teak swim platform with attached stainless steel swim ladder. The platform is supported by brackets and attached to the transom. The platform is well secured.

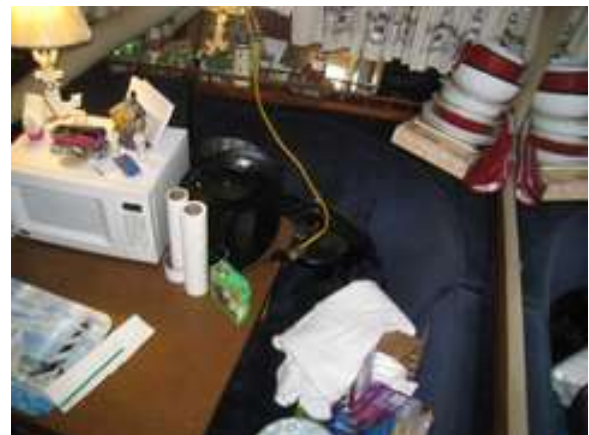
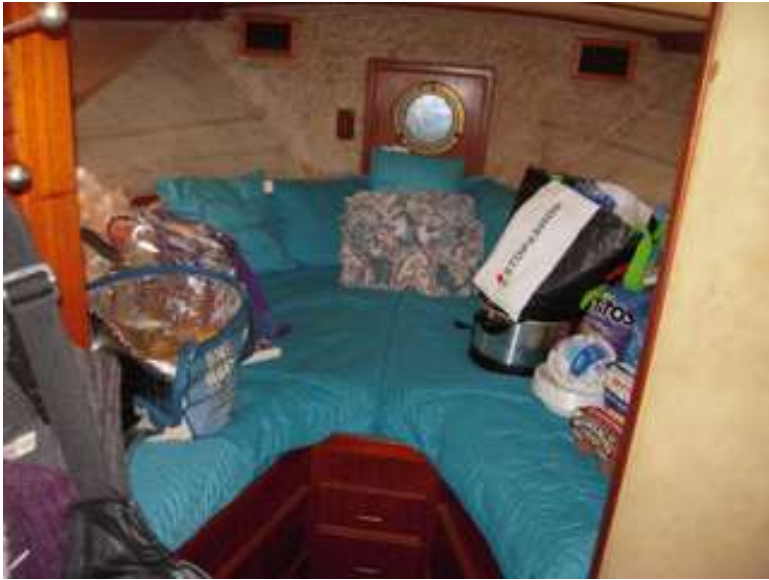
lightly used condition. The counter top in the galley is comprised of Formica which is in good shape. There is a large sink located between the stove and refrigerator in the galley area. The sink and its related faucets and over board drain are in good condition and clean. The sole in the galley and forward is also Vinyl (New upgrade) and is in excellent condition and secure. No rot was found in any deck timbers or supports. The galley is located a few steps forward and below the main salon and dinette. The galley and dinette (space for four), overall, is in excellent condition.

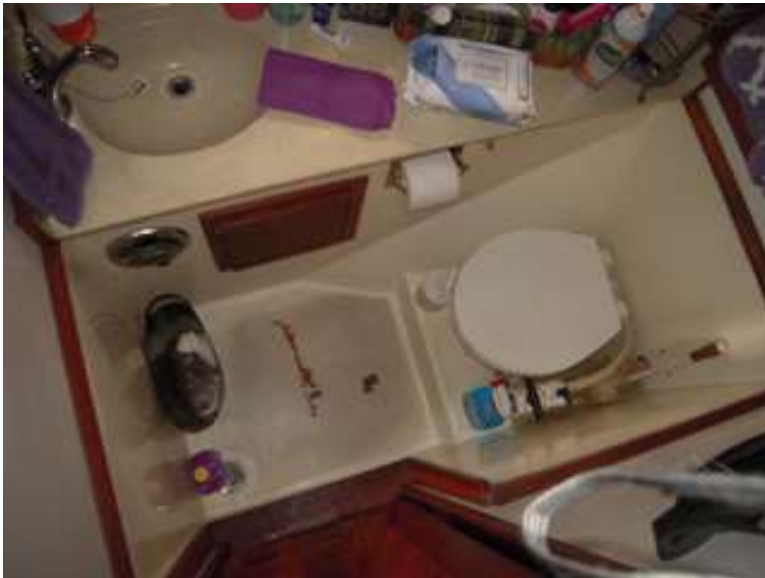
The heads (one forward and one in the master stateroom) are in good condition. The heads are equipped with showers, hand basins and an electric/manual Wilcox-Crittenden standard toilets. The shower units are an integral part of the inner liner. The shower stalls are good sized fiberglass enclosures. Each shower is equipped with a sump pump and overboard drain. There are macerator units, Y-gates, and holding tanks installed.

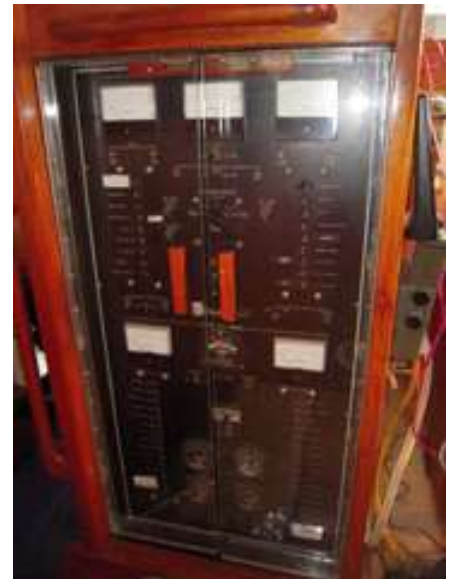
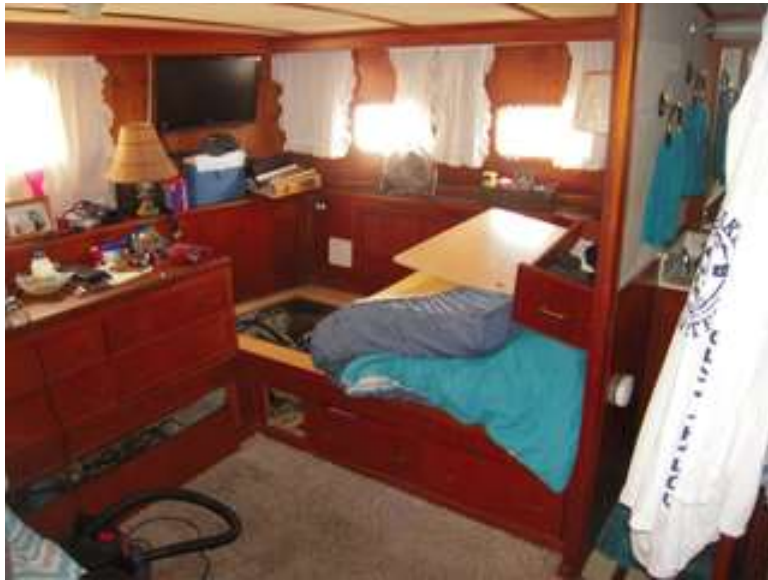
The electrical panels are in good shape. There are two 3 position battery disconnect switch mounted on separate frames in the engine compartment, and in good working condition and properly wired. All DC circuits were rung out and found to be in good condition. The 120 volt power panel, breakers, and circuits were found to be in operating and safe condition. Two fifty amp (250 Volt) service receptacles are mounted aft. One fifty amp (120 Volt) is mounted amidships on the starboard side. All wiring is properly harnessed and secure, as can it be observed through out the vessel. Telephone circuits and receptacles are installed. Two 50 amp 50 feet long shore power cables are on board and in good condition. The running lights conform to the CFR and ring out okay. There are two VHF transceivers, Signet depth finder, knot log and wind speed indicators installed at both stations and are operating. The electric motors which operate the toilet pumps and fresh water system are in good working order.

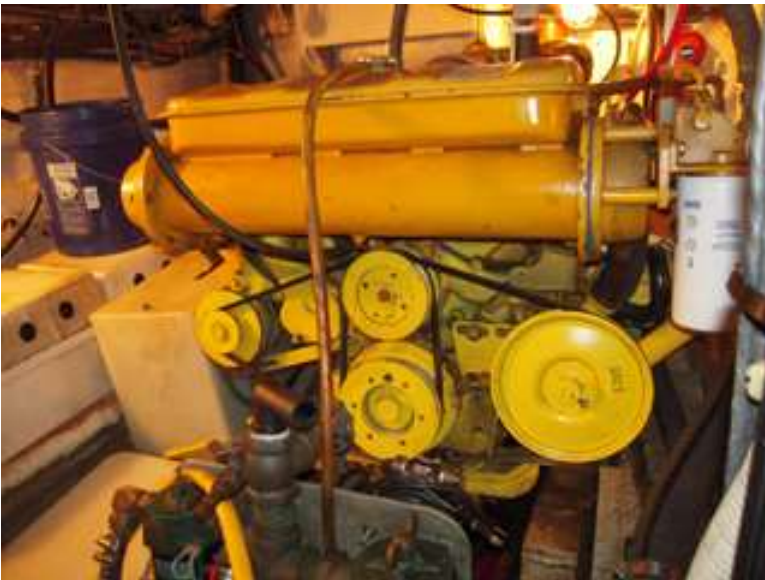
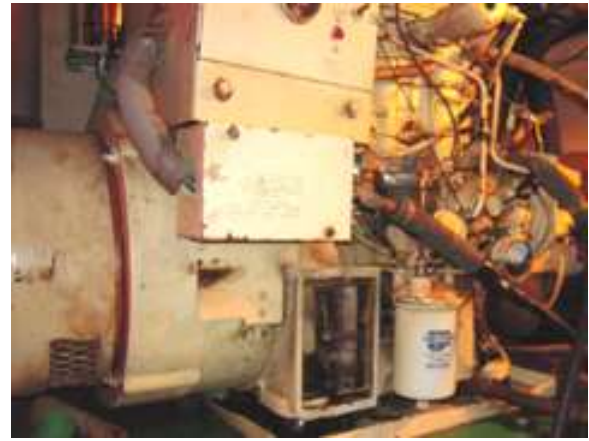
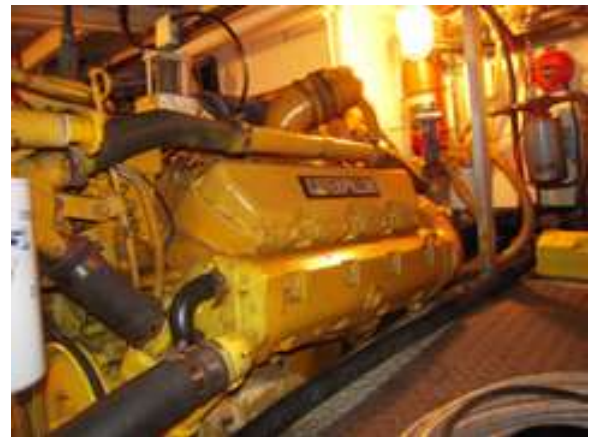
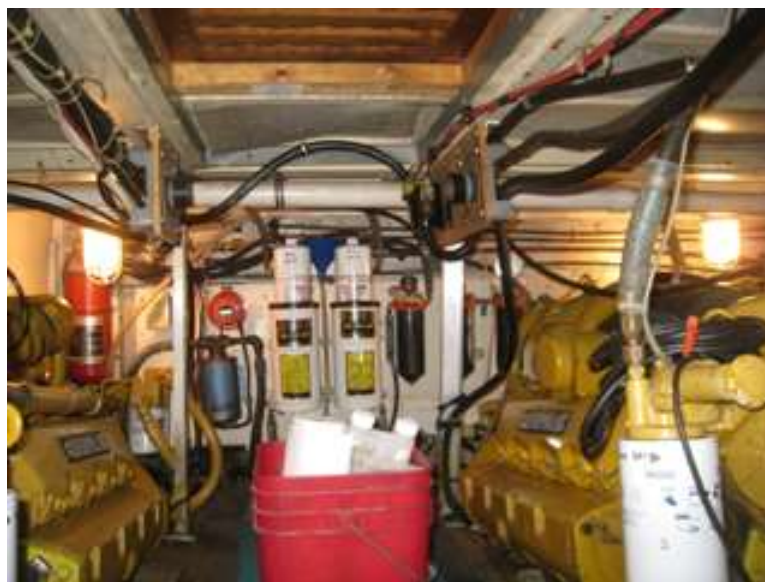
Engine and engine spaces

Propulsion is by a pair of counter rotating fresh water cooled Turbo charged Caterpillar 3208T diesel engines with reduction gear. The engines are rated at three hundred horsepower each. Visual inspection of the engines, oil, filters, and related connections show a good maintenance regime is in place. The stringers that support the engine mounts are 1 1/4" by 10" and fiberglass covered and tabbed to the hull. The stringers also provide rigidity to the hull. The stringers are in good condition. The raw water intakes are equipped with a proper sea water strainer, and secure. The engines exhaust through an approved rubber composite hose through the transom. The entire exhaust system is in good condition. The Onan diesel generator engine exhausts through approved rubber hose and steel silencer to overboard at the stern. The raw water intake which supplies the generator is in good condition. There is a bilge pump mounted aft of the engine compartment. The fuel tanks (can not be inspected) are 310 gallons each. There are three water cooled Cruise Air air conditioners mounted in the engine compartment that provide heat and air-conditioning to all living compartments. The units are in good working condition.

The bonding system is in good condition. There is no trace of oil in the bilge, and the bilge is clean overall. The batteries on board (four heavy duty "D cells" and one RV-Marine type) are properly boxed and secured. The generator set output was not checked. The fuel lines and filters to the generator set are in good condition.

All rubber fuel lines should be checked for possible service. Tag auto fire suppression system in engine room. Install CO device.
