JAMES CROSS, Certified Marine Surveyor
19 Nooseneck Hill Rd, West Greenwich, RI 02817
Phone (401) 397-5040
Member Association of Certified Marine Surveyors / ACMS-USA.COM
Check us out on the web at www.jimcross.net

Re: 2002 Carver 444 Motor Yacht "SARDO"

This letter reports the results of a survey of the above vessel which was inspected on the 1st of July, 2018 for an "in water test" and then again while hauled at Brewers Marina in Warwick, Rhode Island. The inspection was completed to establish its condition and value.

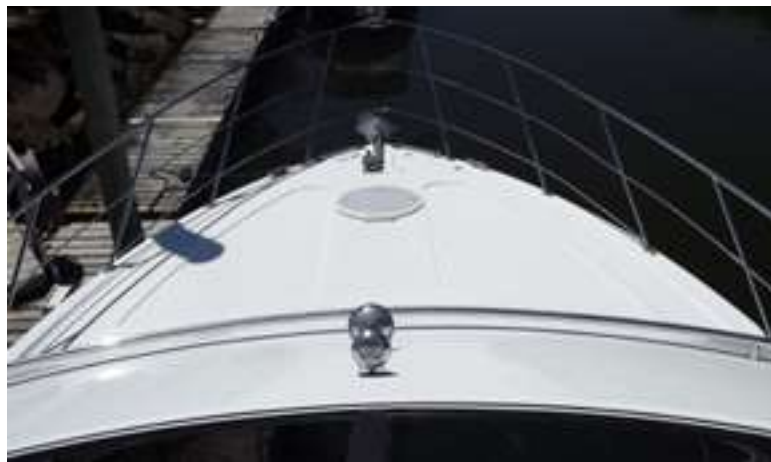
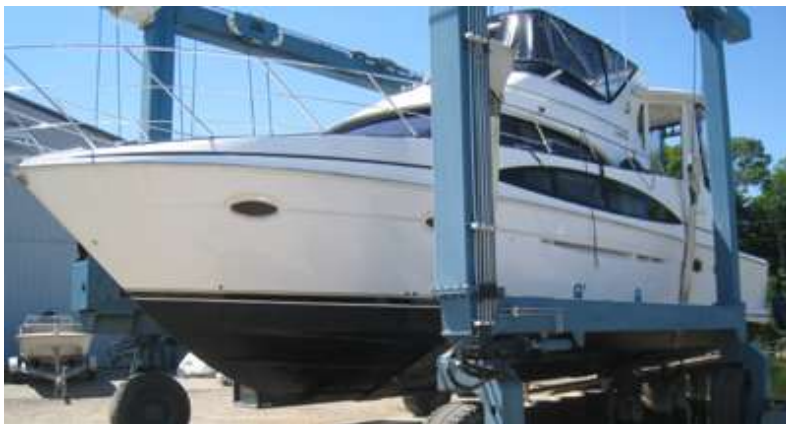
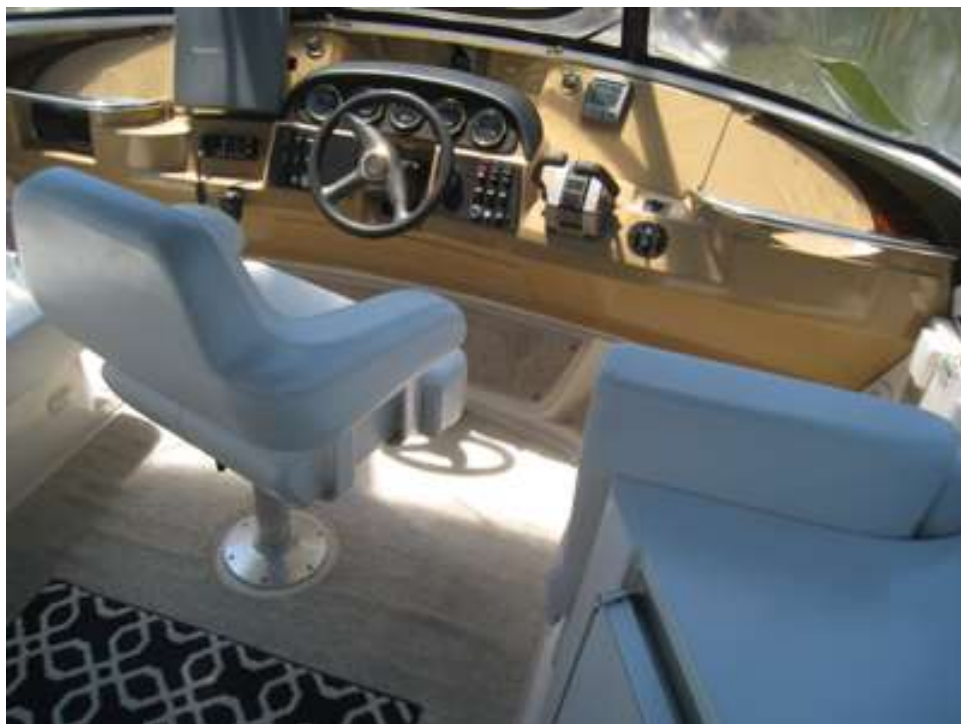
The anchor pulpit, (moulded into the hull structure), is secure and sturdy. The usual dings and scratches from anchoring are missing from this area.

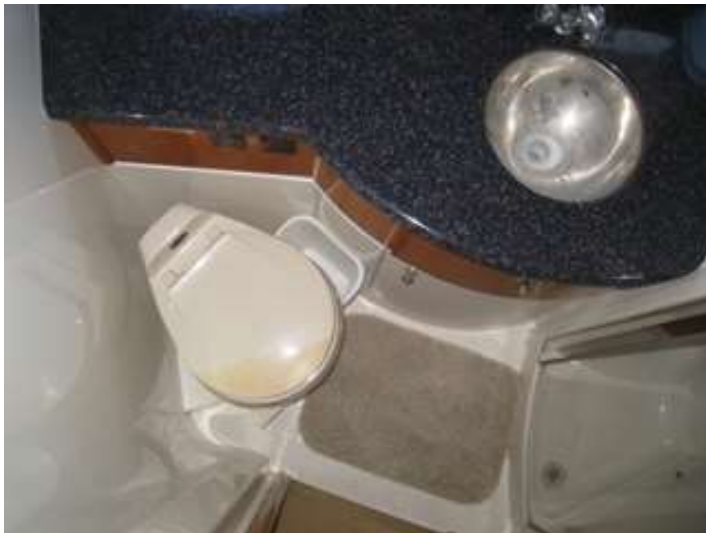
Aft Head

The head with separate shower stall is in good condition. The aft head is equipped with showers, hand basins and an electric Vaccu Flush standard toilet. The adjacent shower unit is an integral part of the inner liner. The shower stall is in good sized fiberglass enclosures. The shower is equipped with a sump pump and overboard drain. There are macerator units, Y-gates, and holding tank installed, all in functional condition. The entire area is free from rot, or any type of blistering and in good condition. All head devices were operational during the in water test. As you can see from the photos all interior jointer work is in good condition and brightly finished. All septic hoses may need replacement as they are slightly porous and dirty.

1. Install backup ground tackle.
2. Protect batteries from shorting.
3. Ensure that a complete Coast Guard Safety and Signalling package is aboard.
4. Replace septic hoses as needed.
5. As fuel lines appear original, they should be checked by the yard. Have fire suppression tank inspected.
6. All three engines should have the engine and reduction gear oil changed before heading to Florida.

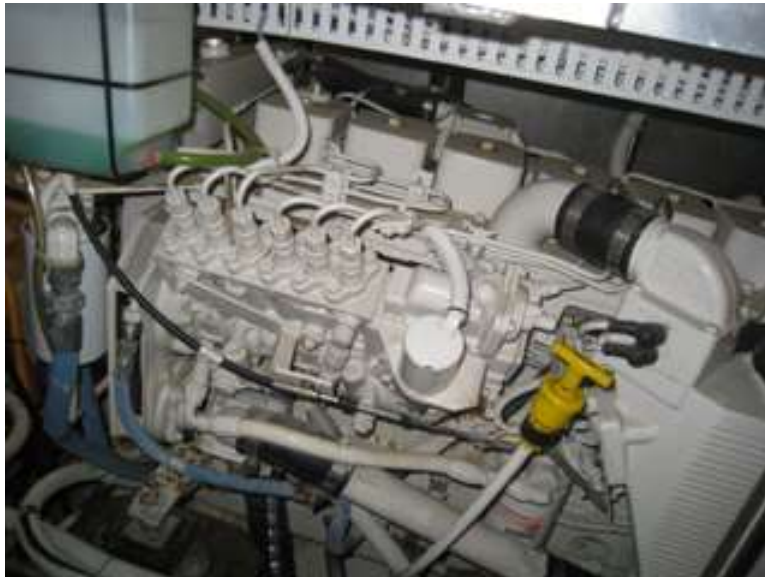
The fuel lines are properly supported and are in good condition. The stringers that support the engine mounts are heavily built and fiberglass covered and tabbed to the hull. The stringers also provide rigidity to the hull. The raw water intakes are equipped with a proper sea water strainer, and secure. The engines exhaust through an approved rubber composite hose through the transom. The exhaust system (as can be inspected) is in good condition. The Diesel powered 11 KW generator engine exhausts through approved rubber hose and silencer to overboard. The generator starts easily, runs well, and supports a full load without a problem. The fuel lines and filters to the generator set are in good condition. The raw water

intake which supplies the generator is in good condition. There are appropriate bilge pumps mounted. The fuel tanks are secured, inspection is limited.
