**JAMES CROSS, Certified Marine Surveyor**  
 19 Nooseneck Hill Rd, West Greenwich, RI 02817  
 Phone (401) 397-5040  
 Member Association of Certified Marine Surveyors / ACMS-USA.COM  
 Check us out on the web at [www.jimcross.net](http://www.jimcross.net)

Re: 2000 Luhrs 40 Tournament Fly Bridge "TUNA BE WARE"

This letter reports the results of a survey of the above vessel which was inspected on the 7th of June, 2018 while hauled and afloat for an "in water test" at Petis Marina in Warwick, Rhode Island. The inspection was completed to establish its condition and value.

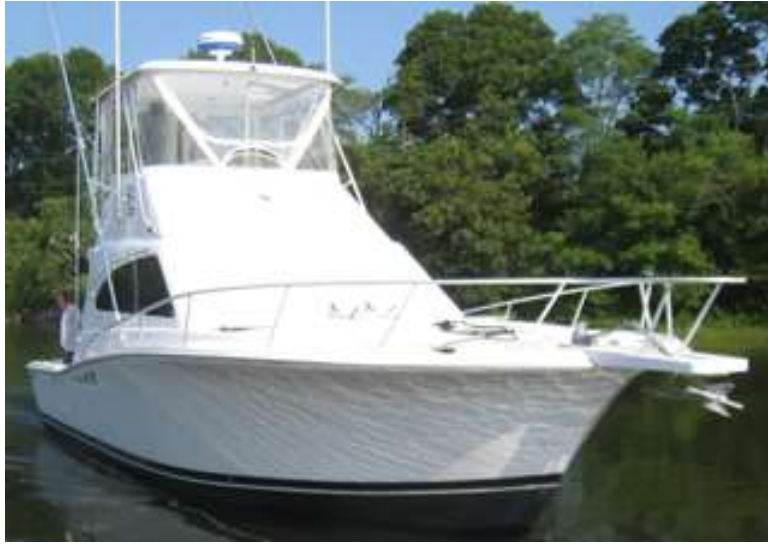
The vessel was built by the LUHRS CORPORATION, of MILLVILLE, NJ in 2000. The hull number on the transom is LHRLC190E900. The Official number is: 1088030. Pertinent dimensions of the vessel are: the LOA is 40' 10", the beam is 14' 1 1/2", and the draft is approximately 3' 7". The displacement, according to the book, is 30,000 pounds. The motor numbers are: Port 45832223, Stbd. 45827641, Kohler 0623373.

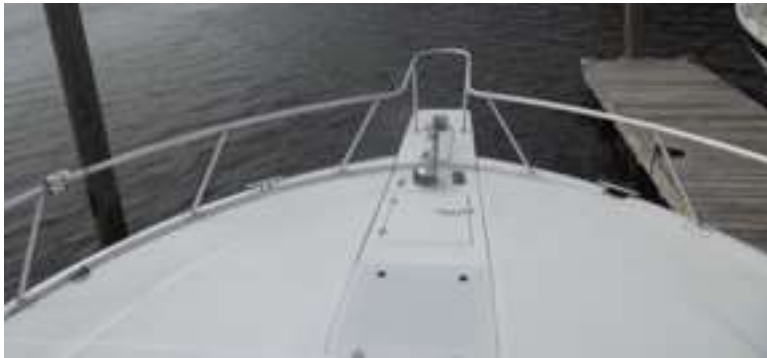
The hull is a fiberglass composite structure reinforced with various fiberglass material, resins, and core materials in a modified deep Vee configuration. The freeboard finish is the original white finish coat with stainless trim, and is in excellent condition, overall, with just a few minor scratches (both port and starboard). The hull - deck attachment is secure and reinforced by the rub rail structure. I was unable to locate any delamination or separating of glass in the hull to deck joint area.

The bottom (sections below the water line) was sounded with a metal mallet and found to be free from obvious damage or delamination.

All through hulls are in good condition and their related valves are working properly. Several are a bit stiff and need lubrication.

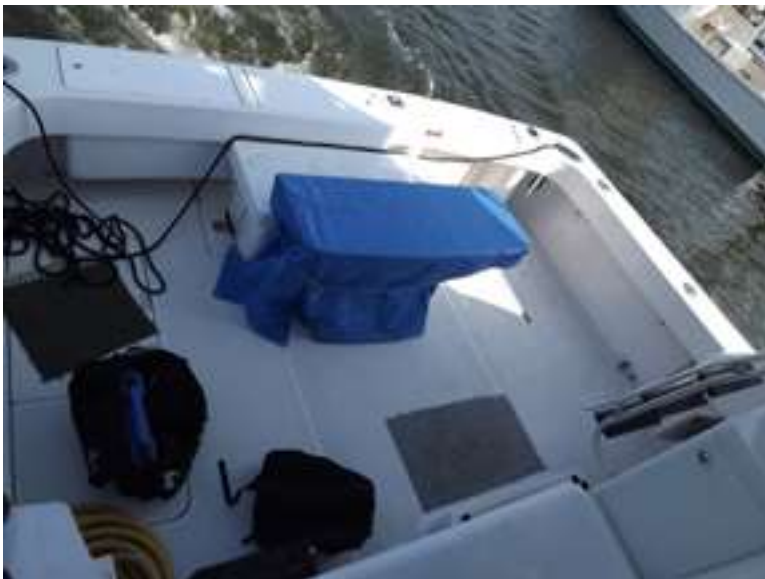
The topside finish is the original white gel coat with stainless trim, and is in excellent condition, overall, just a few noticeable mars or scratches. The entire deck was checked for excess laminate moisture. Fresh water infiltration to the deck core was not noted. The fiberglass anchor pulpit is well secured and sturdy. The usual dings and scratches from anchoring are missing from this area. The stainless bow pulpit and life rail continues all the way to the deck house walkway. The rail and stanchions are properly installed, and they are in good condition, backed, and secure. Deck hatches are tight to the weather.

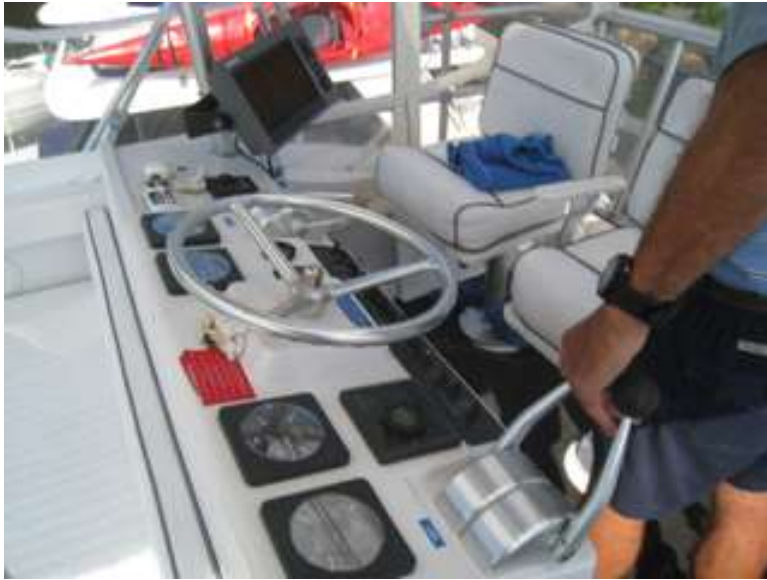
All deck hardware is properly backed. The bridge weather enclosure and related supports are in good condi-

tion and properly secured. All hatches and ports are in good condition and tight to the weather.

The transom entry door fits properly and is secure and sturdy.

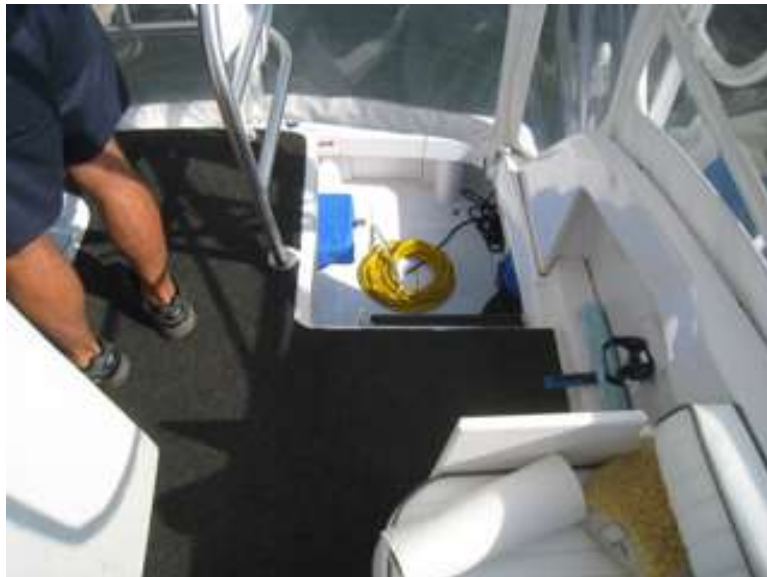
The operating station is well designed and the controls are easy to operate. The upholstery is in good condition overall. The compass is accurate on its present heading. The engines operating equipment, including shifts and steering are also smooth operating condition. Steering is hydraulic and the related lines are in good condition. The engines are not automatically synchronized. The engine temperature and oil pressure were accurate. The amp meters are functional. The radar, chart plotter, and two VHF transceivers are working properly.

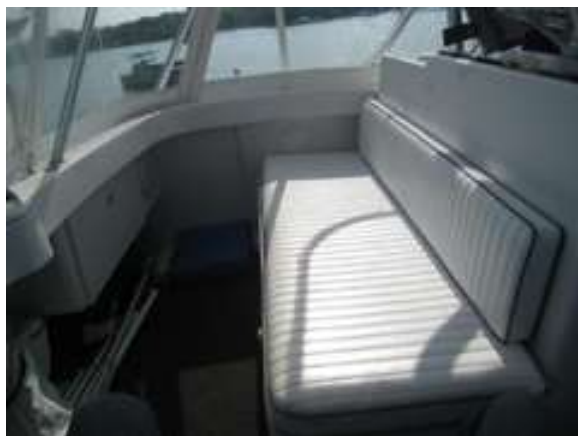
There is a complete color keyed canvas enclosure, that covers the entire operating station and deck area. The canvas enclosure, and supporting structure are in good physical and cosmetic condition. This area equipped with multiple settees and other seating that would accommodate a large group. Overall, this area, including the operating station and upholstery is in very good condition.

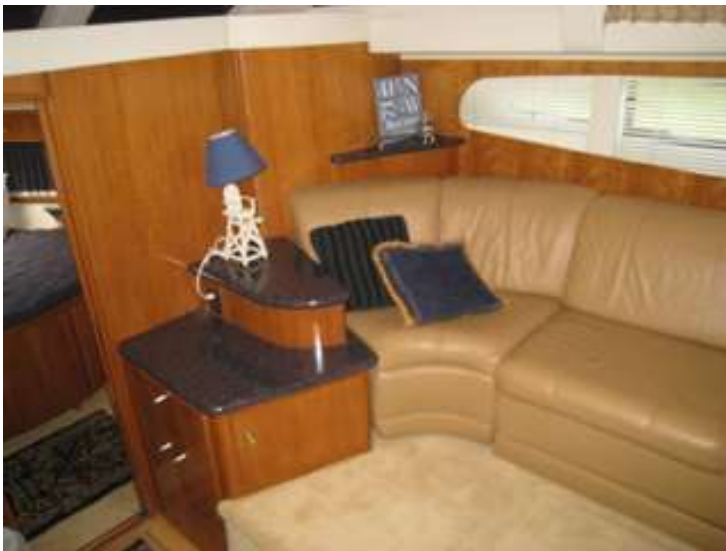
The main cabin houses the salon, galley, and dinette. This area is spacious, nicely finished and has been the subject of an extremely complete maintenance regime. This compartment is structurally sound, nicely equipped with up to date furnishings and has the original sole covering. The interior space now appears in lightly used condition. The jointer work is made up of solid hard wood and some laminates, and for the most part, looks very good.

The upholstered sections show very light use, good care, and maintenance. The doors and ports are in good condition and tight to the weather. Color adjustable fabric port covers also appear lightly used. The entire interior area is in good condition and bright. The overhead liner also appears in excellent condition. All deck supports were checked from below and all are secure. Lighting is good throughout the vessel.

The dinette converts to sleep two adults. The dinette folds to form part of a berth. This area is equipped the main AC/DC control panel which is secured in this area. The main salon, overall, is in excellent condition.

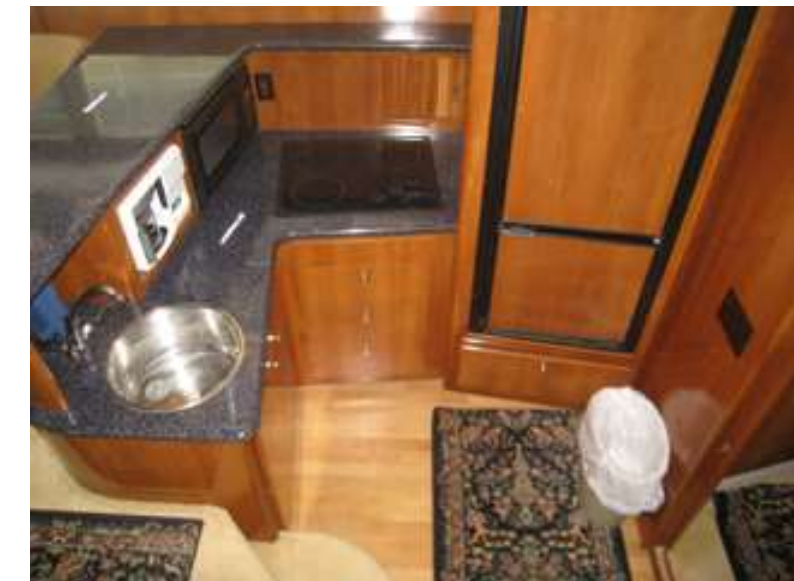
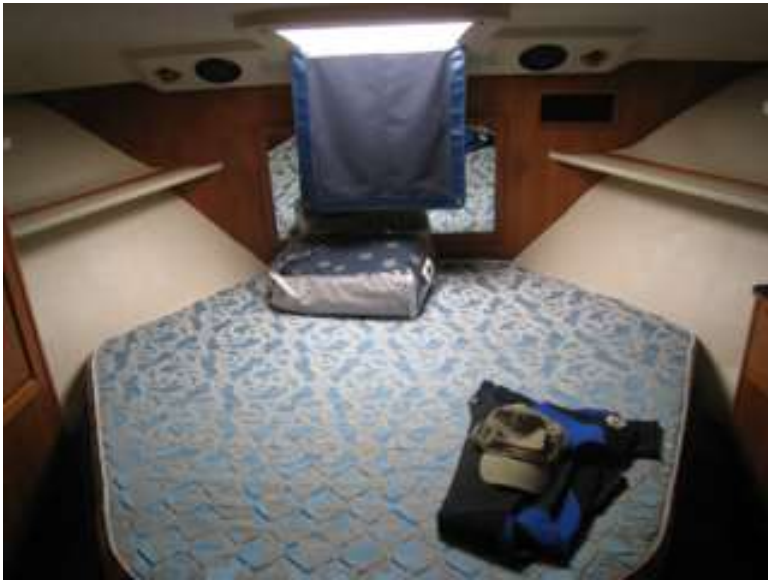
The 120/12 volt refrigerator with freezer and a cook top electric range with built in Microwave oven appear in lightly used condition. The Corian counter top is in good shape. There is a large sink and its related faucets and over board drain are in good condition and clean. The sole in the galley is brightly finished hard wood and is in good condition. All galley appliances are up to date and in operational condition.

No rot was found in any deck timbers or supports. The galley is

located just forward in the main salon just across from the dinette. The galley and dinette, overall, are in excellent condition.

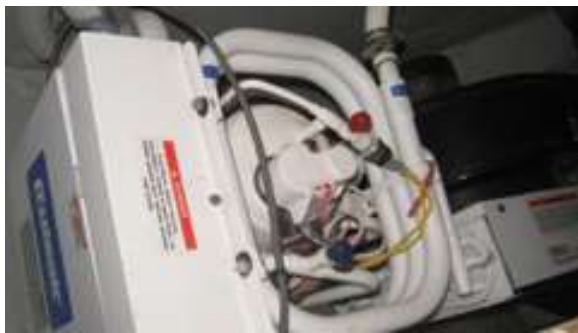
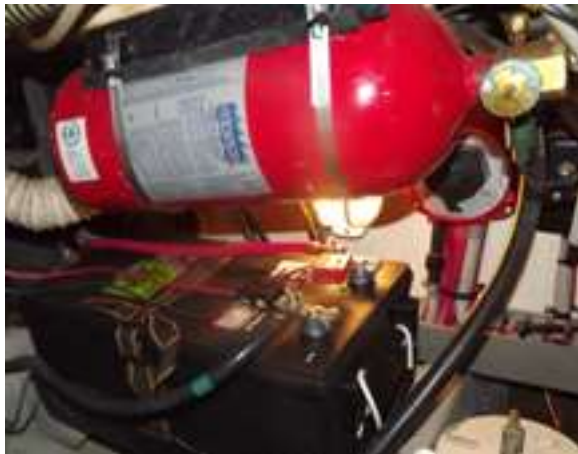
The electrical panels are in good shape. The 3 position battery disconnect switches mounted are in good condition and properly wired. DC circuits were rung out and found to be operational. The 120 Volt power panel, breakers, and circuits were found to be (original) and functional. All wiring is properly harnessed and secure, as can it be observed through out the vessel. The

shore power cable on board is in good condition. The running lights conform to the CFR and ring out okay. Electronics includes, Autopilot, Radar, Horn and Intercom, GPS with chart plotters. There is a VHF transceiver, a depth finder and knot log installed and operating. The electric motors which operate the toilet pumps and fresh water system are in working order. A bonding system is not installed.

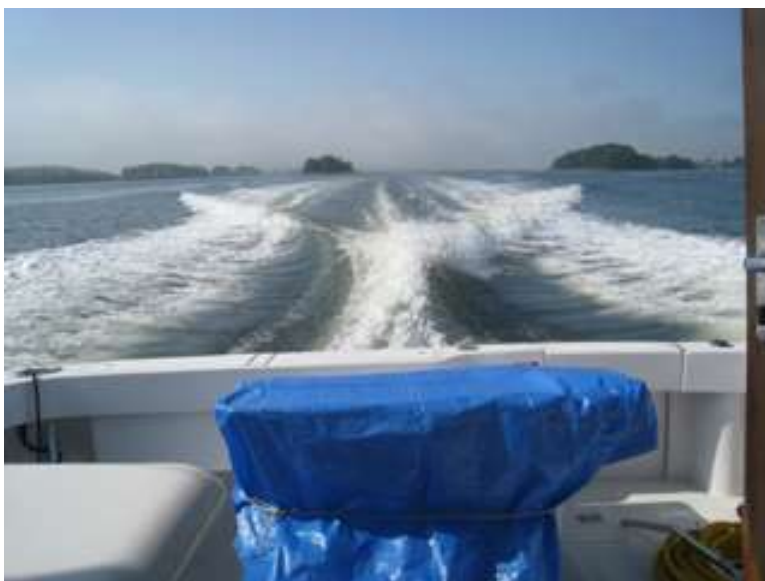
The in water test run went well. No unusual situations were noted. The exhaust was clean, the gen set performed under heavy load during the entire run, except for the stall out. The engine reached reasonable revs, oil pressure and temperature was within specs. All systems were working properly.
