Re: 1997 SeaRay Express Bridge 44

This letter reports the results of a survey of the above vessel which was inspected on the 8th of August 2020, at Silver Spring Marina in Narragansett, Rhode Island while afloat. You requested the inspection to establish its condition and value and to provide information helpful to you in selling the vessel.

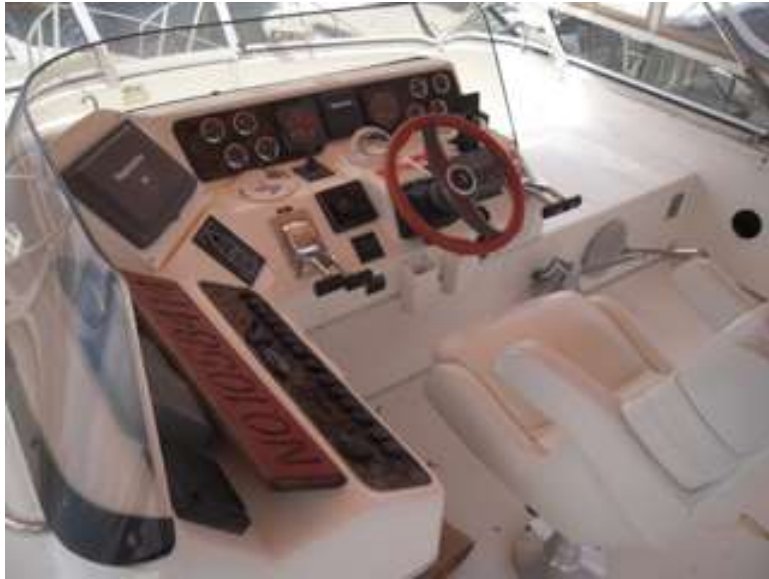
A factory installed fiberglass radar arch is properly installed and secure. The canvas (New, high quality installed this week) and supporting stainless structures are in good shape and secure. The bridge unit is properly secured to the main cabin. The built in stair to the bridge is in good, clean condition.

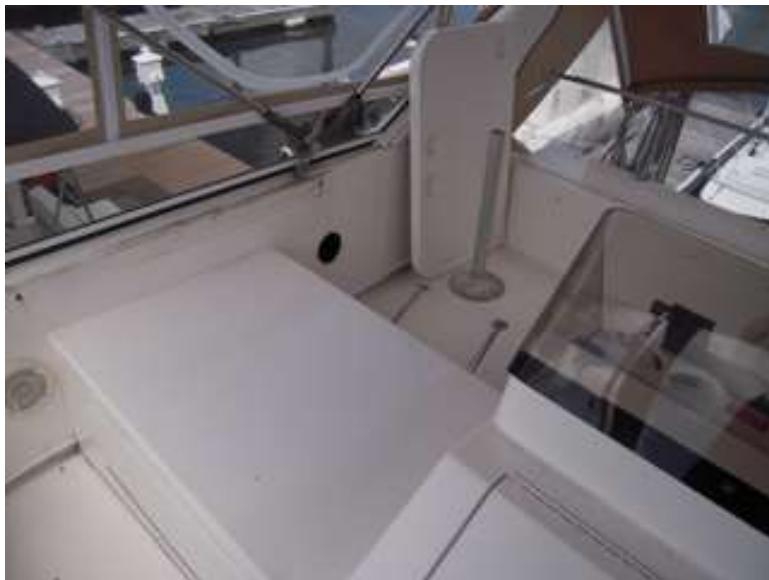
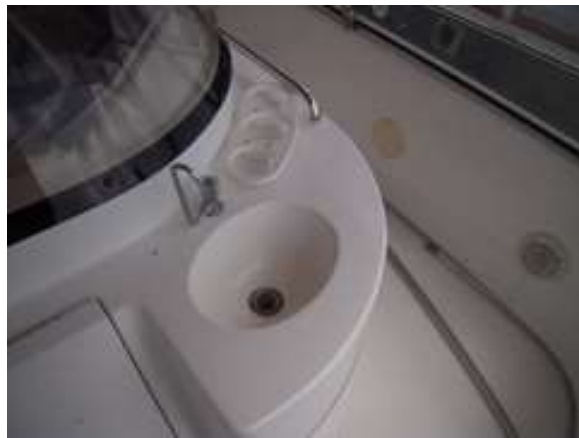
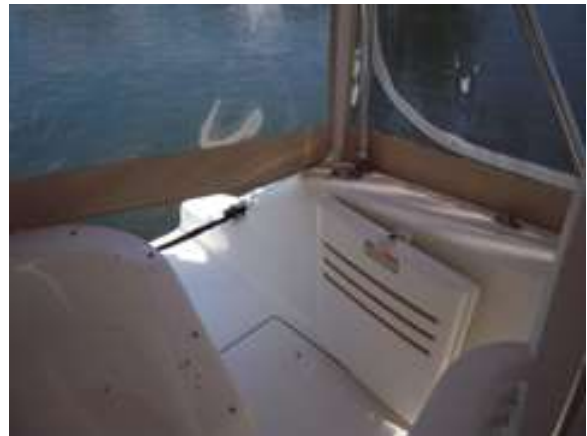
The operating station, at the bridge, is well designed and the controls easy to operate. The compass is accurate on it's present bearing. The throttles operate smoothly. The shifts and steering (steering is hydraulic Power) are also smooth operating.

The bridge vinyl upholstery is in the processed of upgrade at this time. Any worn or stained upholstery is being replaced. The bridge area is large and in overall excellent condition.

The plastic curved spray shield is in like new condition with no cracks or abrasions.

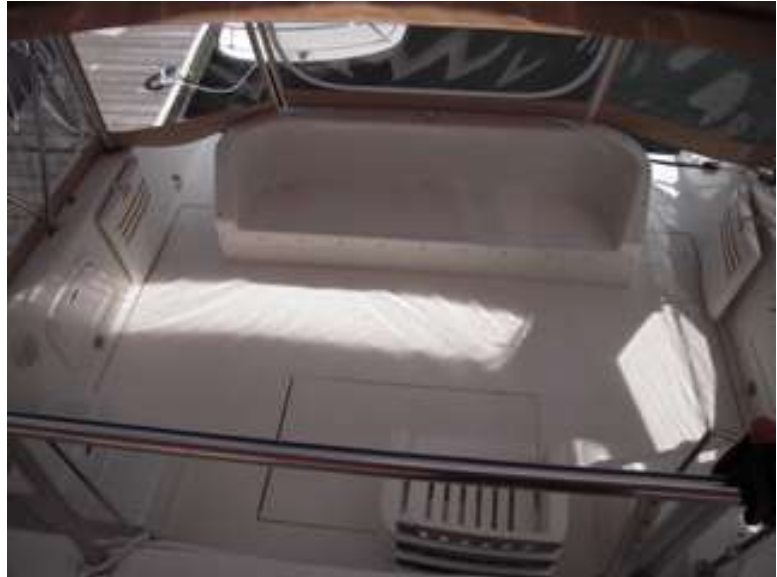
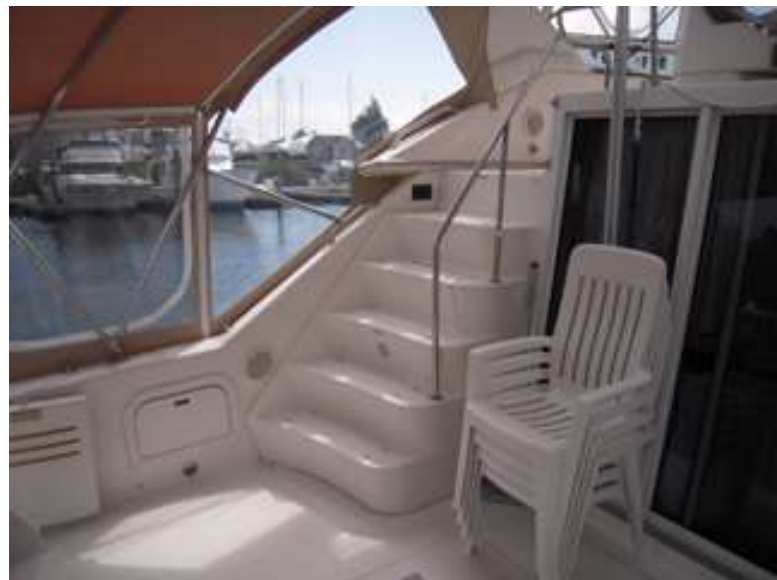
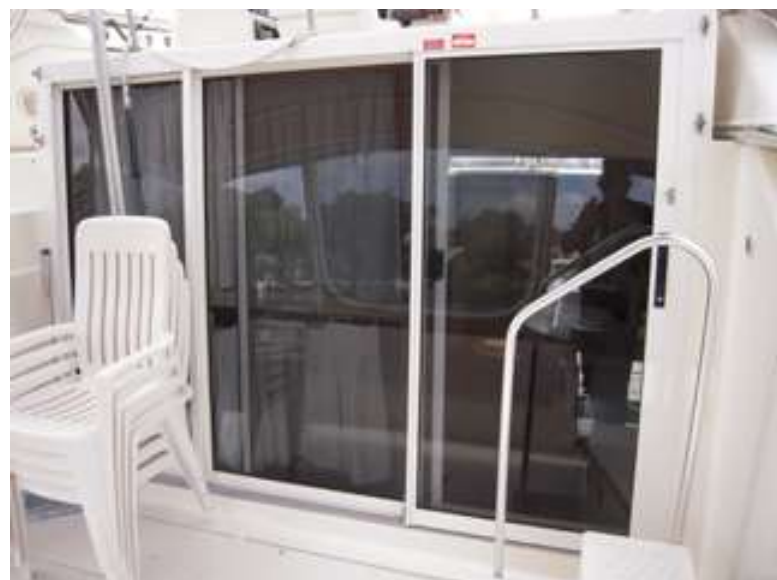
The cockpit area, including the deck, hatches, and upholstery is in excellent condition. Access to the engine spaces is gained through a large hinged hatch in the deck of the cockpit area. The main hatch is secure. The fiberglass deck is in good, properly supported condition. All aft deck accessories including the full canvas enclosure is either new or in lightly used condition. Some upholstery is being replaced.

The slider to the main salon is smooth operating and tight to the weather.

All stainless fittings including the mooring cleats are well secured and backed.

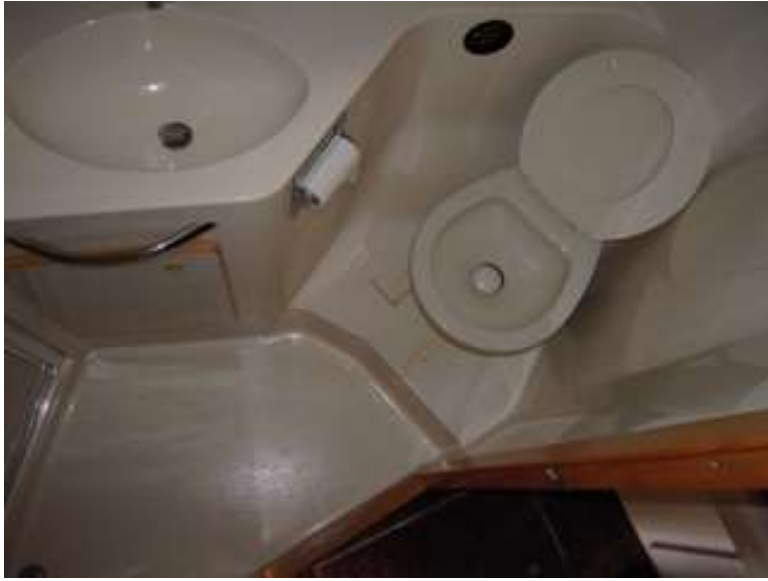
There are two complete heads, both also in very good condition. They are equipped with standard VacuFlush electric marine toilets, showers and hand basins. The shower units are an integral part of the inner liner. The showers drains into a sump pump arrangement and is then pumped overboard. From the appearance of the plumbing, carpet, and other fixtures, including the galley gear this vessel has been lightly used, and certainly not abused. Plastic holding tanks and related Y valves and plumbing are included. The hot and cold fresh water system is also in good shape.

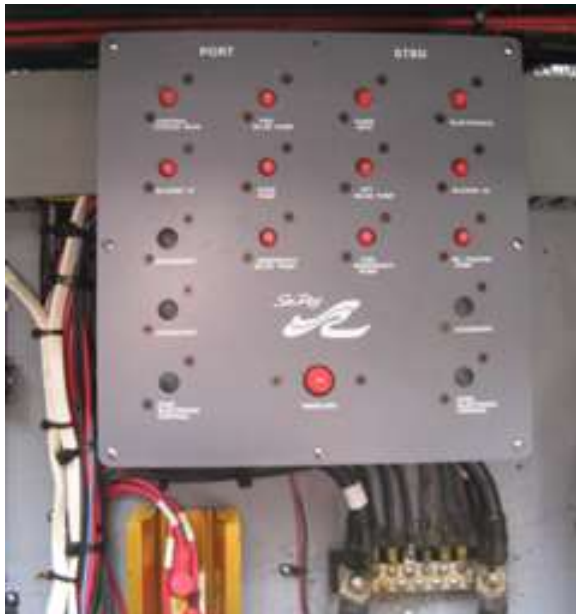
The electrical panel (combination AC and DC) is in good shape. There are two 2 position battery disconnect switches beneath the aft deck and are properly installed and protected. All of the battery terminals are in good condition and free from corrosion. Two 120 volt 35 amp shore power cables are in use. The cables are in good condition. There is a complete bonding system installed, along with a factory installed electrical isolation transformer system. The running lights conform to the CFR.

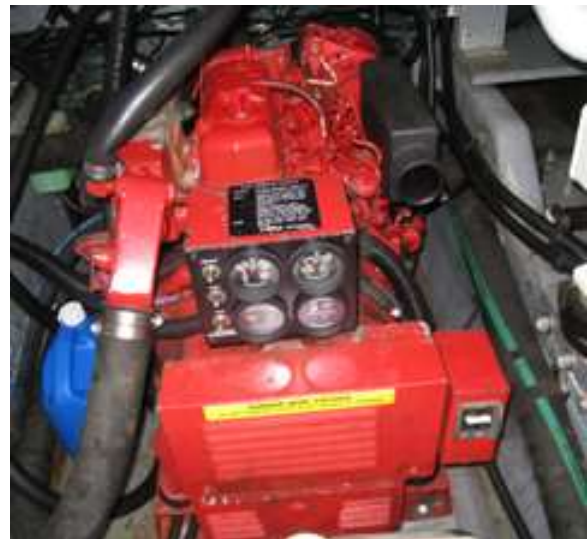
The fresh water cooled Diesel gen set is a good clean installation with no obvious faults. The raw water cooling input and exhaust systems are in good shape and secure. A complete entertainment system is installed, which includes television, and stereo with CD to all cabins including the bridge. A very nice setup.

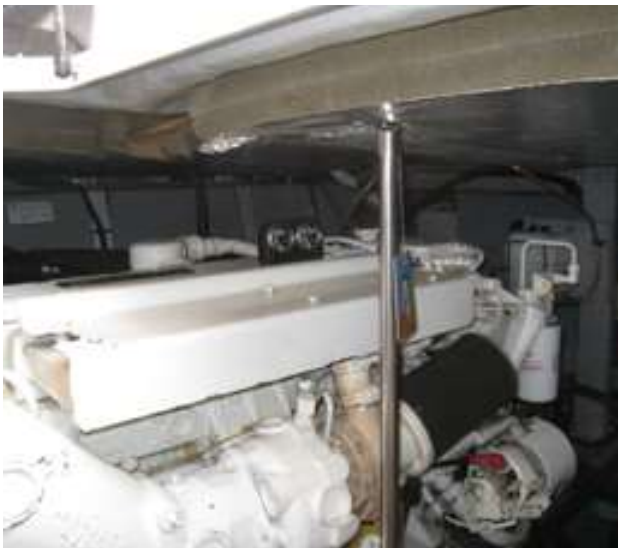
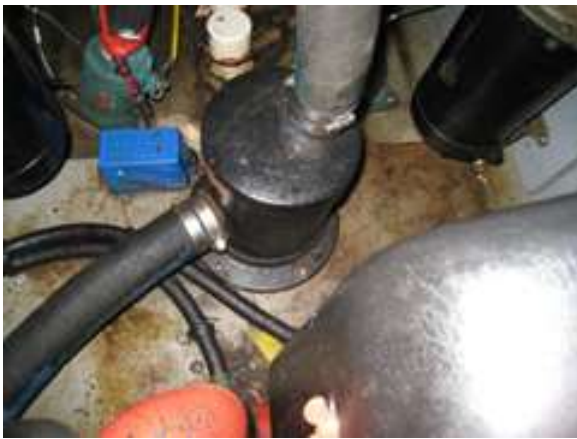
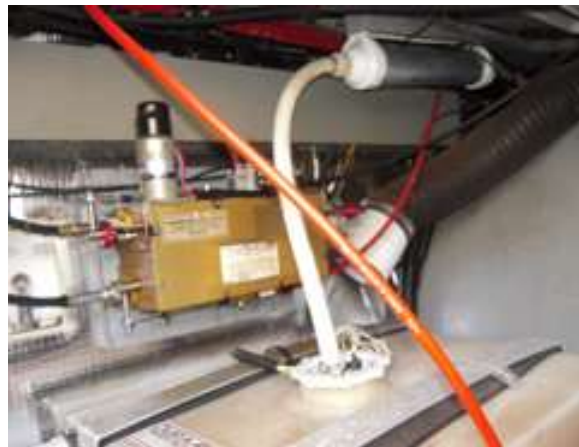
Propulsion is by a pair of fresh water cooled counter rotating Caterpillar 3116-350 Diesel engines with reduction gears. Visual inspection of the engines, oil, filters, coolant, and related connections show that a good maintenance regime is in effect.

The water cooled shaft logs are in good shape. The starboard log appear to be a recent upgrade.

Approved bilge blowers and hoses are installed and working. There are two bilge pumps mounted in the bilge, and functioning. . Electric/ hydraulic trim tabs are sized and installed. There is no trace of oil in the bilge, but the bilge is in need of cleaning.

The exhaust systems is also in good condition. All bronze valves and salt water devices in the engine compartment are in good condition and properly bonded. The intake and exhaust systems, including the silencers and sea water strainers are in good condition.
