**JAMES CROSS, Certified Marine Surveyor**  
 19 Nooseneck Hill Rd., West Greenwich, RI 02817  
 Phone (401) 397-5040  
 Member Association of Certified Marine Surveyors (ACMS) USA/COM  
 Check us out on the web at [www.jimcross.net](http://www.jimcross.net)

Re: 2016 Beneteau Oceanis 45 Sloop

This letter reports the results of a survey of the above vessel which was inspected on the 15th of October, 2019, while afloat at the Newport Shipyard in Newport, Rhode Island. You requested the inspection to establish its condition and value.

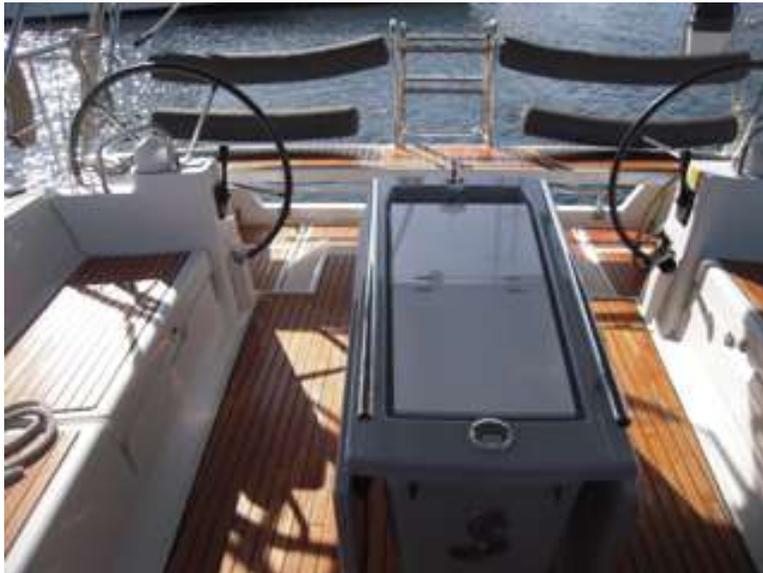
their associated stanchions and gates are in excellent condition. The cockpit area is self bailing, through large scuppers. This area is clean, and the finish is in excellent condition. There are a few scratches, but they are superficial and typical for this age vessel. Engine instrumentation is located on each pedestal, within easy reach, while operating under power. The overall condition of the cockpit is Bristol. There is a complete cockpit weather enclosure that is in excellent condition. There are compasses properly secured and the bearings are correct on the present heading. The gusher, a hand operated bilge pump, is installed and operated from the cockpit. All Teak trim is in excellent condition as is the Settee table pictured in above photo. The lazarette is uncluttered and houses fenders, dock lines, PFD's and cleaning material.

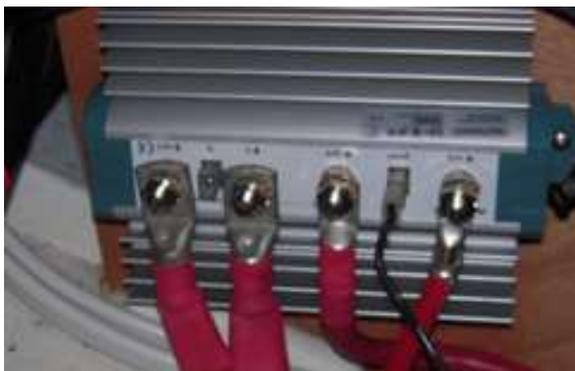
*On this page are samples of equipment and their very neat installation. All wiring observed is properly routed and harnessed. Terminals are well protected at the AC level and DC terminals at the batteries are well protected and secure.*

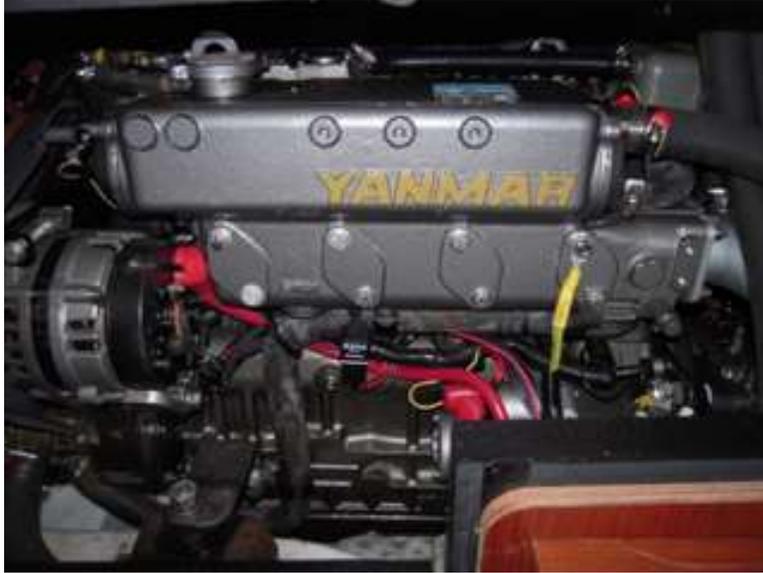
Propulsion is by a 57 HP fresh water cooled Yanmar diesel engine with Yanmar Sail Drive reduction gear.

The engine is model 4 JH 5CE Serial number E15276. The Sail drive is Model SD) with serial number 347742. The engine and upper gear case, as can be observed, are in very clean, well maintained condition. Ventilation to the engine spaces is adequate. The exhaust system could not be accessed.

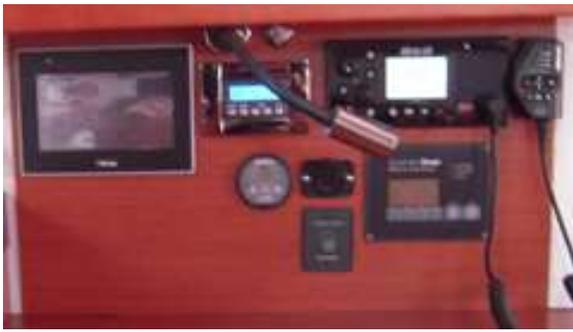
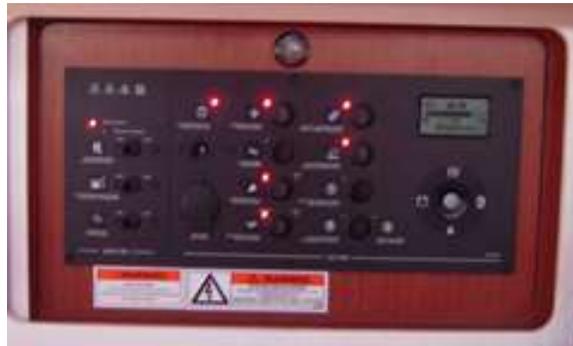
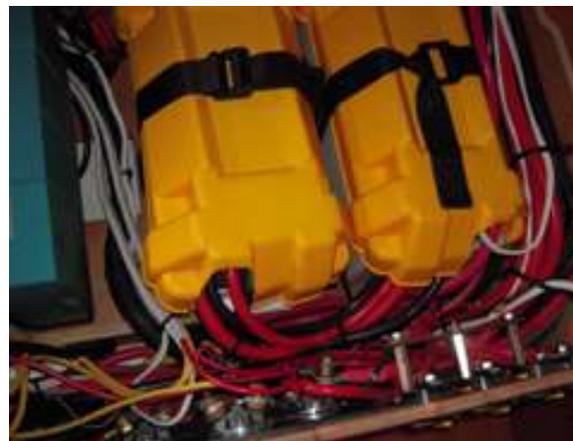
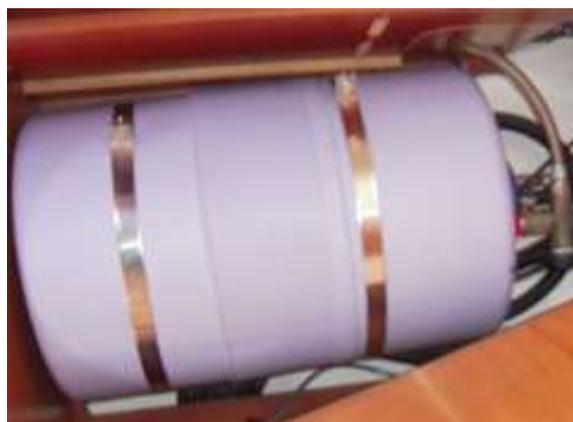
The batteries appear fairly new and are in good condition and properly connected to the approved three-way switches and then on to the custom breaker panel. The batteries are properly secured and covered below the salon sole. The wiring and terminals that could be observed are in good condition. All of the electrical wiring has been properly harnessed and is secure. The shore power system overall is in good condition as are the cables. The automatic battery charger was not checked out. The navigation equipment and electronics, was not checked out while operating. All of the electronics and navigating equipment is contemporary and appears lightly used. The electric anchor windlass is in excellent condition and secure. The Auto pilot hardware is properly installed and appears in good condition.
