**JAMES CROSS, Certified Marine Surveyor**  
 19 Nooseneck Hill Rd, West Greenwich, RI 02817  
 Phone (401) 397-5040  
 Member Association of Certified Marine Surveyors / ACMS-USA.COM  
 Check us out on the web at [www.jimcross.net](http://www.jimcross.net)

Re: 2005 Beneteau Oceanis 523 Cutter

"Flying High"

"Survey for Insurance, only, not pre-purchase"

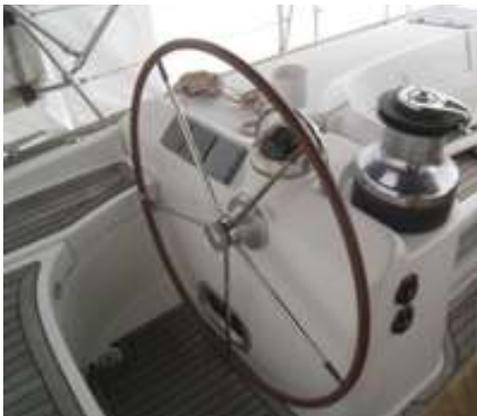
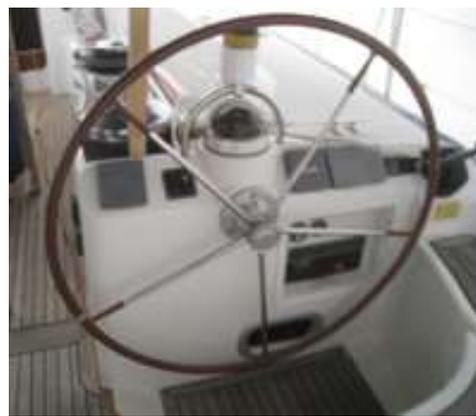
The life lines and their associated stanchions and gates are in excellent condition. The cockpit area is self bailing, through large scuppers. This area is clean, and the finish is in excellent condition. There are a few scratches, but they are superficial and typical for this age vessel. Engine instrumentation is located on the port cockpit seat, within easy reach, while operating under power. The overall condition of the cockpit is excellent. The appearance from on deck, including the teak trim, is much better than average. There are compasses properly secured and the bearings are correct on the present heading. The gusher, a hand operated bilge pump, is installed and operated from the cockpit.

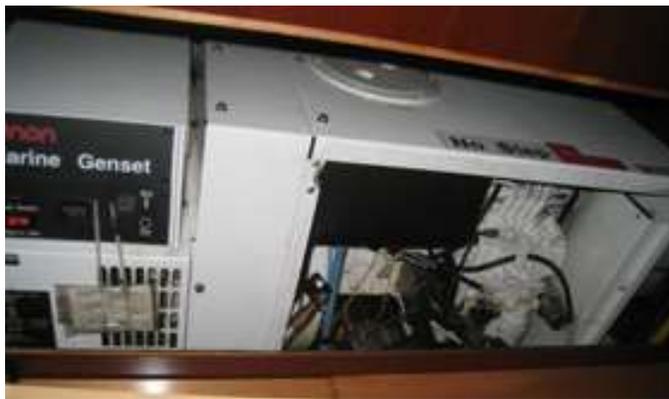
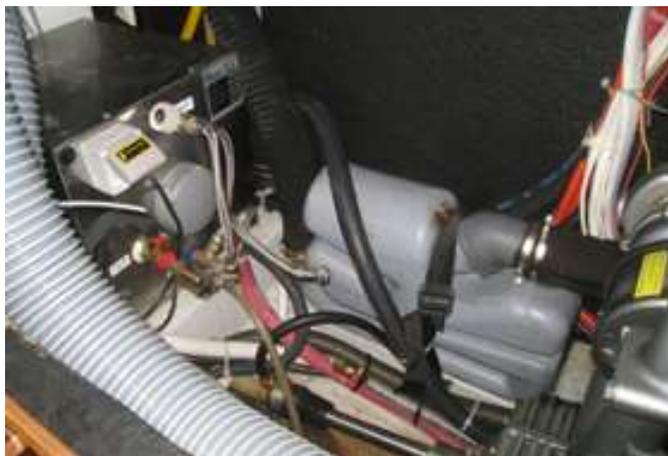
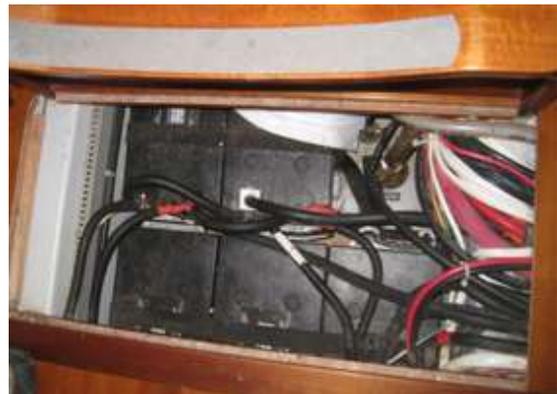
The gen set is an Onan Diesel powered eight KW and is in good shape. The bow thruster and related hardware appear lightly used. The wiring and connections to the thruster are of the appropriate size and are secure.
