JAMES CROSS, Certified Marine Surveyor
 19 Nooseneck Hill Rd., West Greenwich, RI 02817
 Phone (401) 397-5040
 Member Association of Certified Marine Surveyors/ACMS-USA.COM
 Check us out on the web at www.jimcross.net

Re: 2001 Bruckman Blue Star 29.9 "NO NAME"

This letter reports the results of a survey of the above vessel which was inspected while hauled on the 15 of May, 2018 at Wickford Marina in Wickford, Rhode Island. You requested the inspection to establish its condition and value in order to purchase insurance. Present during the inspection were you, myself, and my associate, Mr. Rob Nutt, MS.

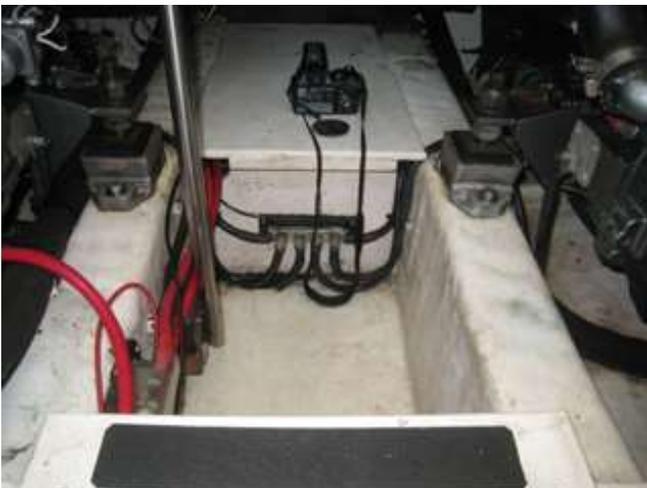
The stainless fuel tanks (as can be inspected) are in good condition, properly secured and grounded, as are the related fills and vents. There are proper fuel shut-off valves on all three fuel feed lines.

The potable water system appears in working condition. Only portions of the fresh water tank can be observed. It appears to be in good shape. The water heater is encased in a stainless steel jacket and is in good physical condition. The plastic thirty gallon holding tank (as can be inspected) is in good condition and secure. The related fills, vents, and feed lines show no signs of leaks and there was no septic odor in any bilge area. There is one Cruise-Air air conditioner installed that appear original and look in good shape. The wiring and plumbing to the units are original and well secured.
