JAMES CROSS, Certified Marine Surveyor
 19 Nooseneck Hill Rd., West Greenwich, RI 02817
 Phone (401) 397-5040
 Member Association of Certified Marine Surveyors/ACMS-USA.COM
 Check us out on the web at www.jimcross.net

Re: 1995 Catalina Islander 34 "FIRST ONE"

This letter reports the results of a survey of the above vessel which was inspected while hauled and afloat on the 18th of July, 2018 at Milford Boat Yard, Milford Connecticut.

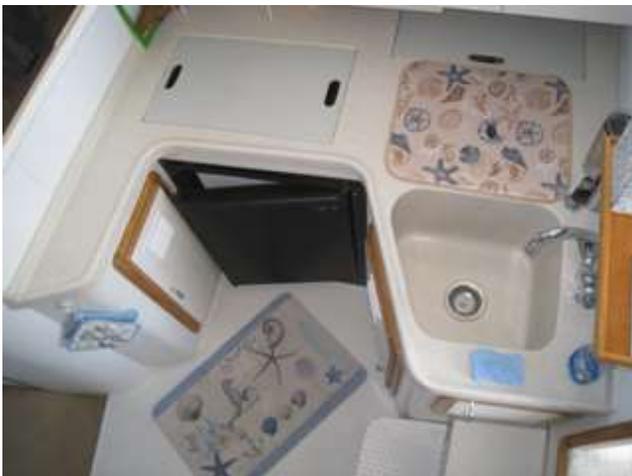
There is a large moulded in sink located as shown. The sink and its related faucets and over board drain are in good condition and clean. The sole in the galley and forward is also hard wood and is in excellent condition and secure. No rot was found in any deck timbers or supports. The galley is located a few steps forward of the main salon and dinette. The dinette (space for four), overall, is in excellent condition.

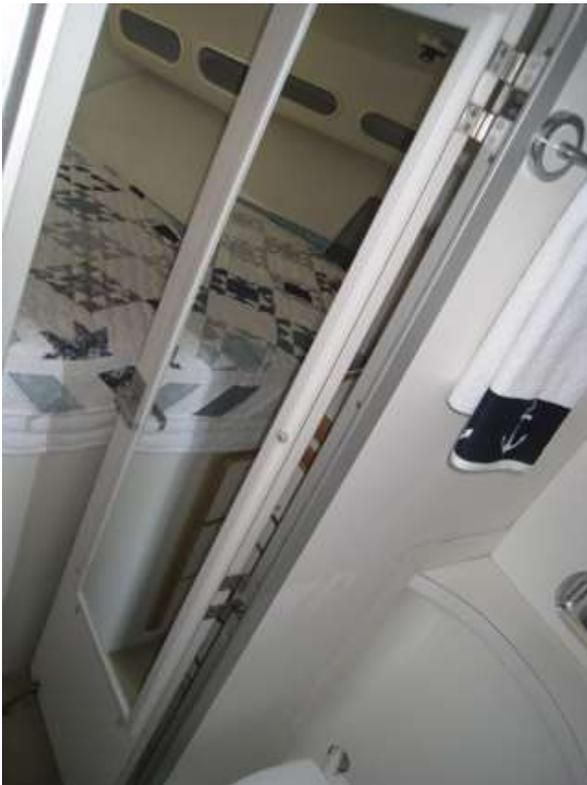
Dockside pump out was not checked out. The overall condition of this aft area is very good and is in the same condition as the forward areas. No septic odor was noted. The entire septic system (below deck) appears in original condition
