Re: 1985 Chris Craft Commander Sport 442

"MARTOONI"

This letter reports the results of a survey of the above vessel which was inspected while afloat, covered, and winterized on the 27th of February 2018, at the East Greenwich Yacht Club in East Greenwich, Rhode Island. You requested the inspection to establish it's condition and value.

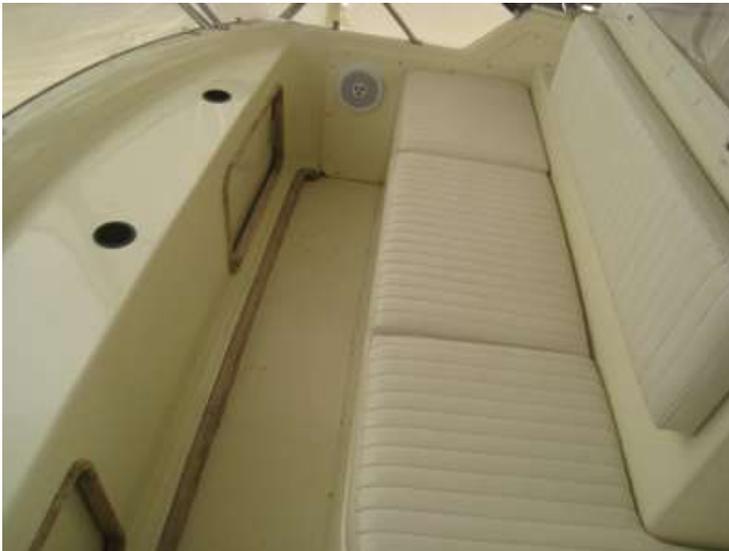
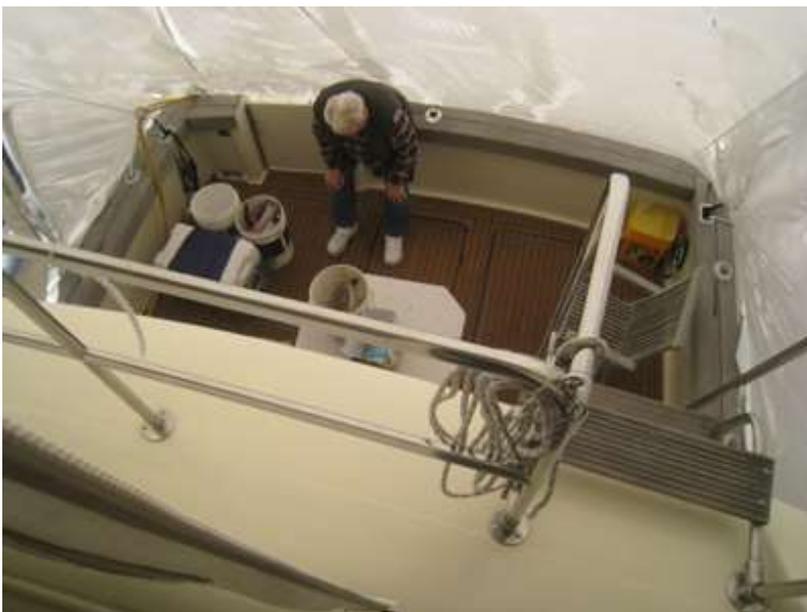
The semi ridged top along with its various antennas and radar dome is supported by the full enclosure structure. An aluminium welded web. (Very secure structure) The outriggers were off for the winter. The enclosure supports are in good condition. The bridge deck was checked for excess moisture and delamination and was found to be secure and sturdy. All wiring to the bridge and electronics enclosure (photo top of next page) is well harnessed and secure.

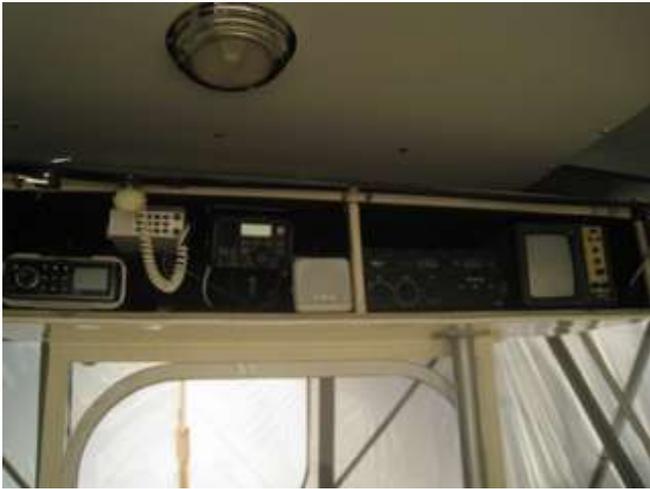
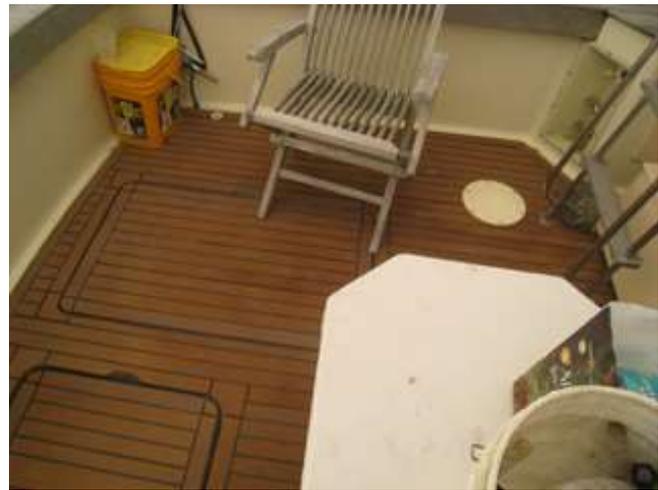
The cockpit area, sundeck, is clean and sturdy, The New teak deck (photo on next page) is well supported and in good shape. The Teak bolstering and trim are in excellent condition. The ladder to the bridge is properly installed and secure. The entry door from the swim platform is in good shape, works properly, and is secure. Several deck hatches provide good access to below deck hardware. Overall, this area is large, well supported, clean, and in like new condition.

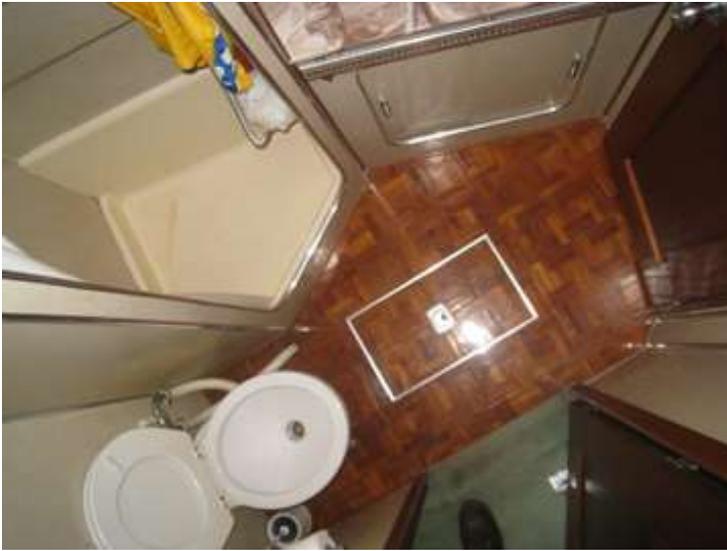
This area is clean, nicely finished and upholstered. There is adequate lighting and ventilation in this area. The deck in this area is properly supported, nicely finished and in overall good condition. I was unable to locate evidence any excess moisture on any surface or joint in this forward area. I double checked all assessable hull to deck joints and while the actual joint is not visible,

there did not seem to be any leaks or previous damage.

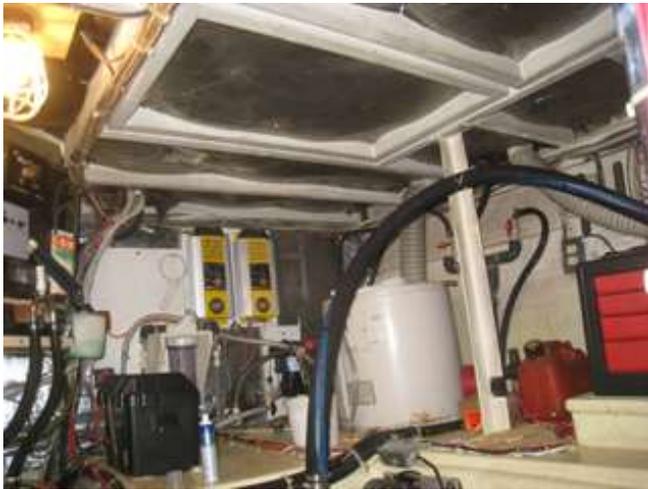
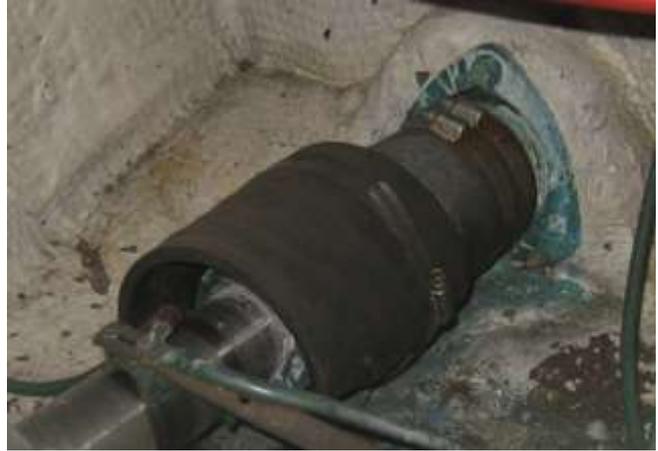
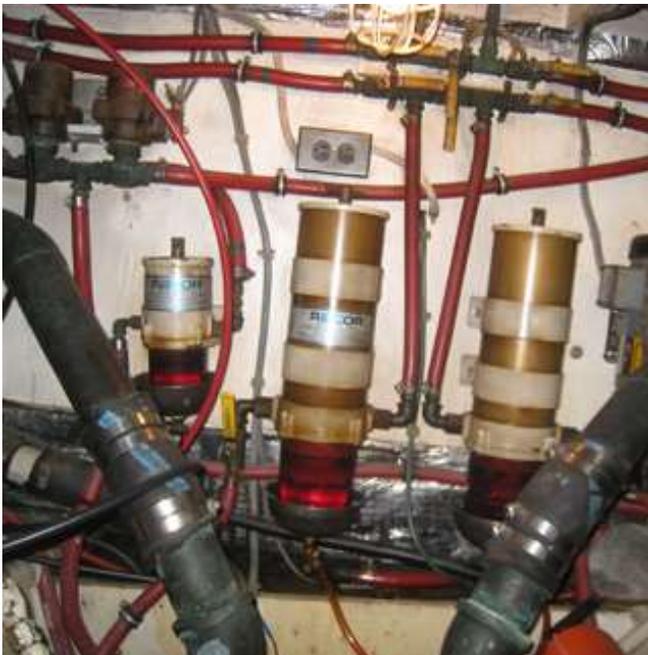
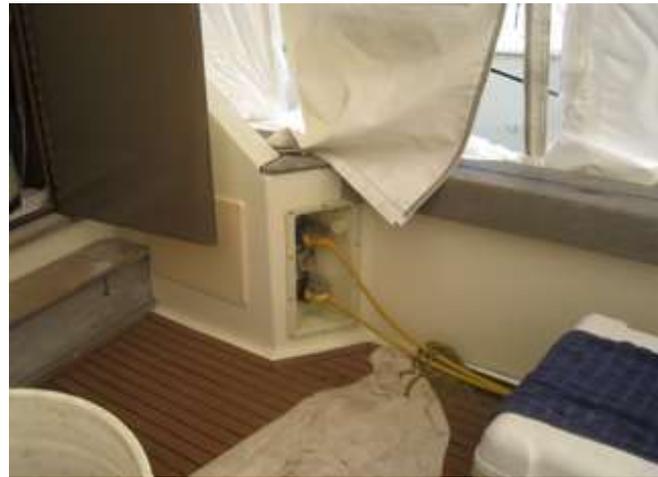
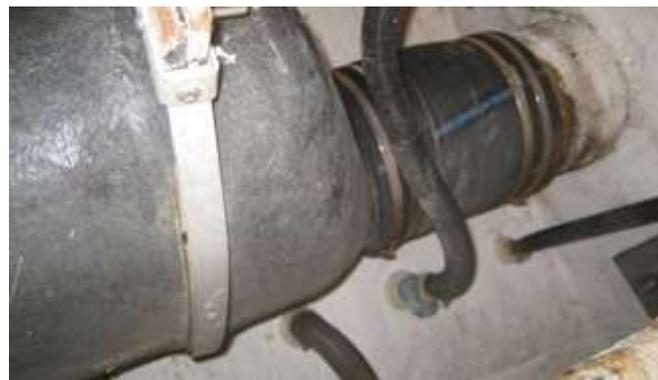
The batteries on board (recent upgrades) are properly secured and protected from shorting. Harnessing of battery system cables is appropriate and secure.

The wiring and terminals that could be observed are in good serviceable condition. The water tank, water heater, and holding tank as can be examined, are in good condition.
