JAMES CROSS, Certified Marine Surveyor
19 Nooseneck Hill Rd., West Greenwich, RI 02817
Phone (401) 397-5040
Member Association of Certified Marine Surveyors / ACMS.USA.COM
Check us out on the web at www.jimcross.net

March 19, 2019

Re: 1969 Concorde 47' MY Fly Bridge

This letter reports the results of a survey of the above vessel which was inspected while afloat on the 18th of March, 2019, at Brewers Coweset Marina in Warwick, Rhode Island. You requested the inspection to establish its condition and value.

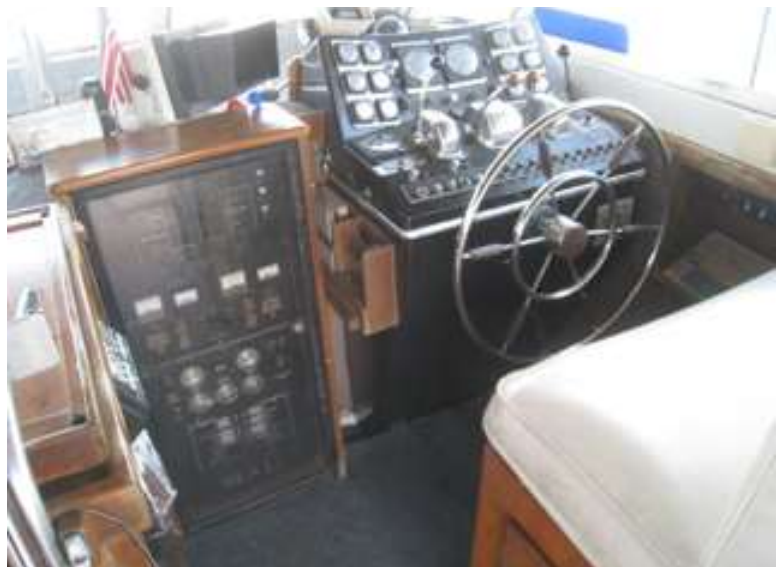
The operating station is well designed and the controls are easy to operate. The engine controls are the dual lever type and provide smooth operation through all ranges of the forward and reverse gears and full and idle throttle. A complete set of gauges and instruments are in original condition. There is a stainless steel rail and complete weather enclosure installed. The pilot house enclosure is structurally secure but in need of cosmetic maintenance. The vinyl upholstery is in good condition. The nylon carpet is in serviceable condition. All ports and glass are in good condition. A mahogany wet bar (photo on next page) in very good condition, is located on the aft deck.

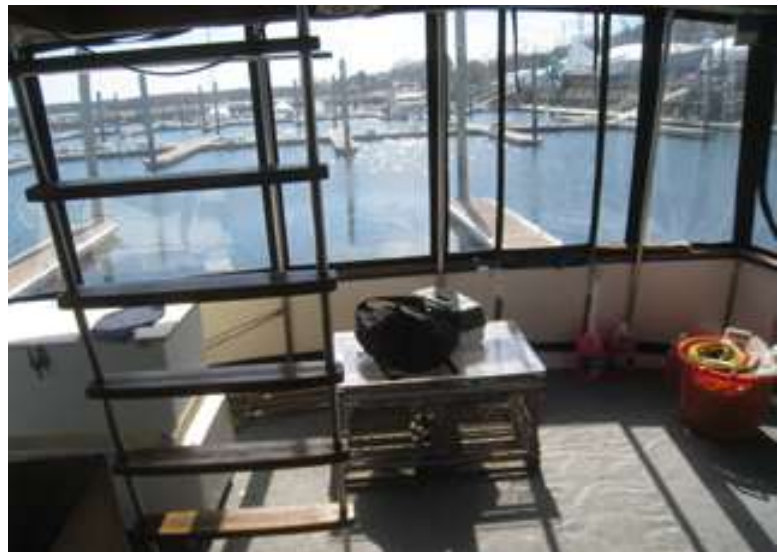
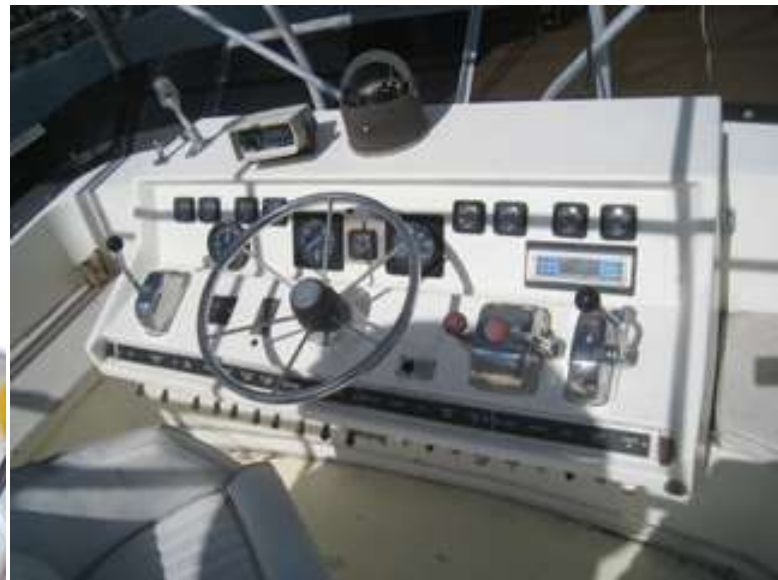
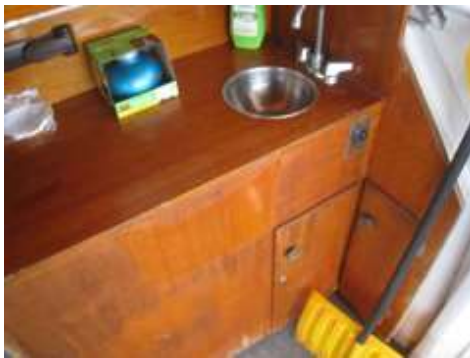
A complete set of gauges and instruments are in original condition. There is a stainless steel rail and complete weather enclosure (off for winter). The bridge pilot house enclosure is structurally secure but in need of cosmetic maintenance. The deck feels solid and secure. Life rails are well secured. Ladder attachments are in good shape as is the hatch cover to the lower station.

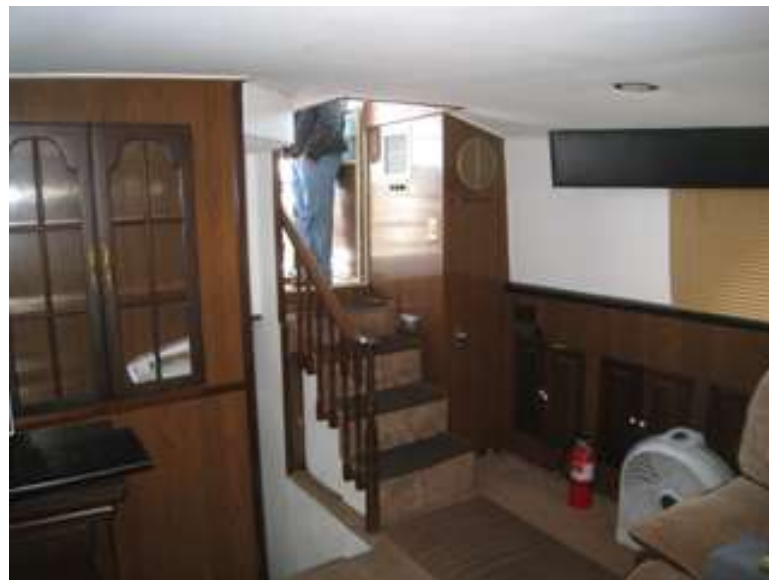
The main cabin houses the salon-dinette and galley. This area is spacious, and in good structural condition. The upholstered sections and furniture are in refit stage. You indicate the carpet is to be replaced. The joiner work (Formica over plywood and some solid mahogany) shows reasonable maintenance. Lighting is good throughout the vessel. The main salon couch converts to sleep two. The white vinyl headliner is in good condition, and well secured. The plywood deck is well supported and is carpeted. The ports and sliders are finished with curtains and blinds. Ventilation to this area is adequate. There are built in hinged engine room access hatches that also function as access stairs to this compartment. The main cabin, overall, is in good structural condition. All ports and sliders are tight to the weather.

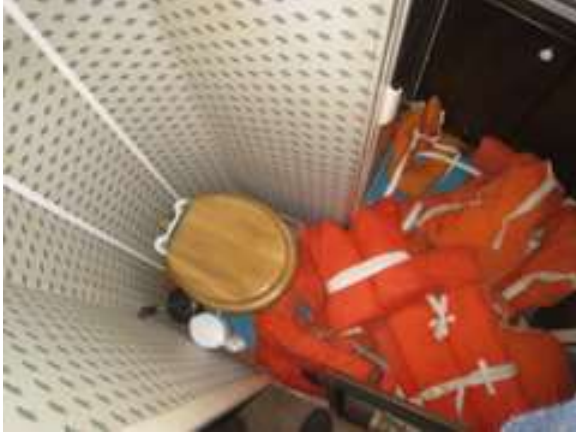
There are two heads aboard, one forward and one aft, both equipped with hand basins and walk in showers.

Both areas are equipped with standard electric marine toilets with macerators and hand wash basins. The toilets, hand basin, and their related fittings, including overboard discharges and through hulls, are in serviceable condition. There is a septic odor in the forward bilge indicating a leak from the head plumbing. You should check the overboard fitting for proper operation as the shutoff valves are very stiff and the hoses and related connections may be original equipment. These areas are clean and well kept. Both heads are functional.

No soft spots or wood rot were noted in any wood surface. The plywood decks are Parquet trimmed and well supported. The entire plumbing system was checked for leaks and odors. You should check all head plumbing and replace any original flexible hoses that appear original.

Inspect and tag the engine room auto CO2 system. Secure portable fire extinguishers. Ensure that a complete Coast Guard safety and Signalling package is aboard. Service all raw water intake valves and hoses. Remove unused wiring from engine room. Harness wiring as needed. Install GFI and AC/DC isolation device. Have yard check all fuel lines and filters and all exhaust systems. Secure and protect batteries. Air/Hear system needs service. Determine port engine oil leak and repair. Remove all extraneous material from engine room. Clean bilges prior to getting underway. Service bonding system terminals. Determine septic odor source and repair.

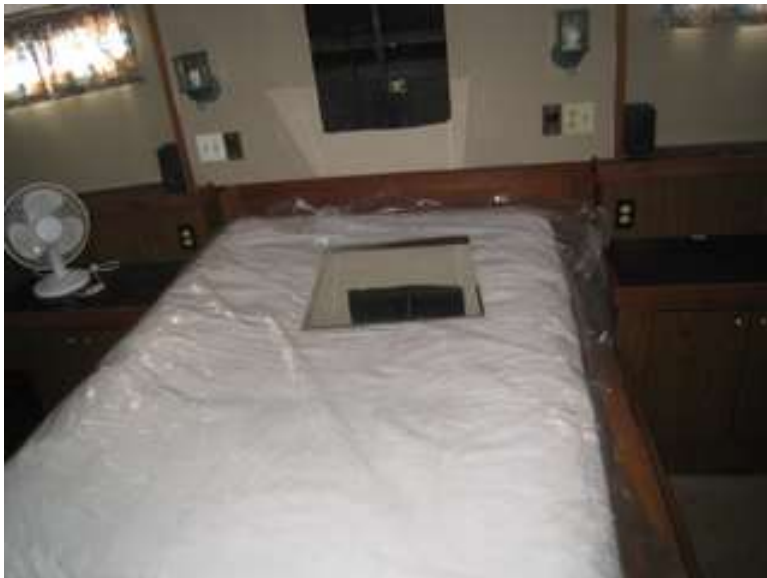
A double size bed is located beneath the after deck. This area is in good structural condition needing only minor cosmetic maintenance.

There is adequate lighting and ventilation in this area. The plywood deck in this area is properly supported. Some of this area is painted and all surfaces are in need of cleaning. No wood rot was detected. The jointer work is solid mahogany. I was unable to locate any excess

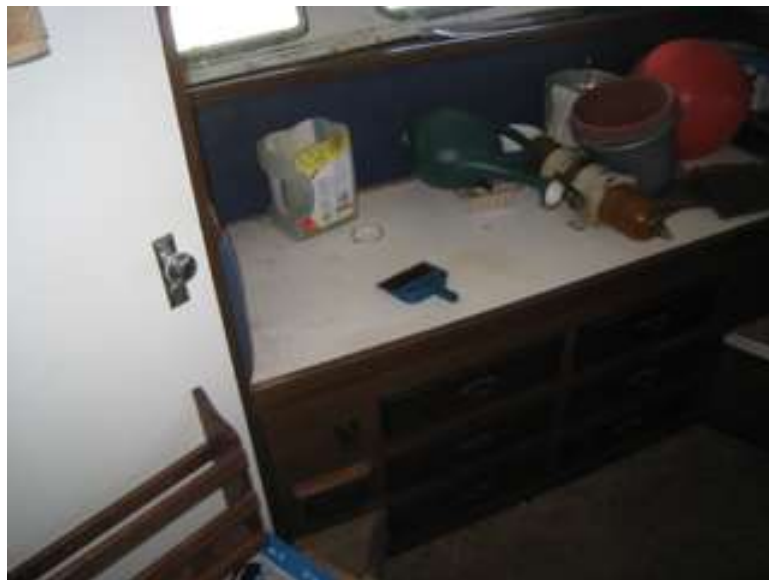
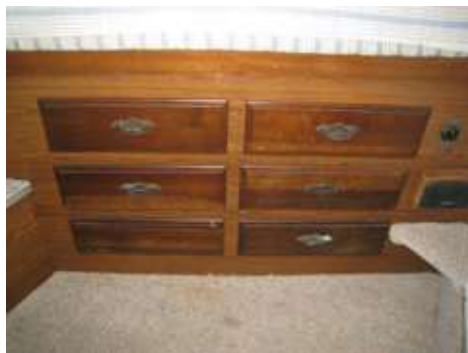
There are three separate berth cabins. The owners stateroom, located aft and crew quarters spaces located forward along with the standard forward, large v-berth. The forward berths are located beneath the forward deck. These area will sleep six. There is adequate lighting and ventilation in this area. Also, housed in the forward berth area are several PFD's, several lockers and rode storage. The forward berth compartments are structurally sound, but in need of cosmetics and clean up. The bright work needs attention and the carpet should be replaced. The overhead liner is secure as is the plywood deck. There is adequate lighting and ventilation in this forward berth area. Much of the forward area is sheathed, and the

portions of the hull and frame work that I could observe are in good condition. The bilge in this area is also in need of cleaning.

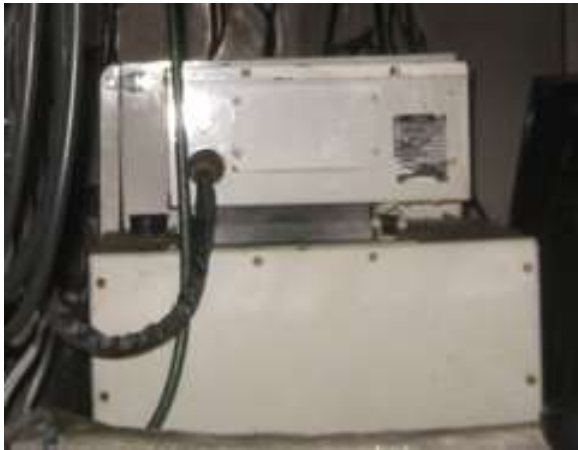
The electrical panels (main and breaker) are in good shape. There are two 2 position battery disconnect switches beneath the aft deck near the properly installed fuel shut-off valves.

The marine type batteries on board are not properly secured. They are covered, but the covers are not secure. All of the battery terminals are in need of cleaning.

Two 120 volt 50 amp shore power cables are in good shape. There is a complete bonding system installed that needs service. There is no GFI system on the AC line and no isolation transformer is installed.
