**JAMES CROSS, Certified Marine Surveyor**  
19 Nooseneck Hill Rd., West Greenwich, RI 02817  
Phone (401) 397-5040  
Member Association of Certified Marine Surveyors / ACMS.US.A.COM  
Check us out on the web at [www.jimcross.net](http://www.jimcross.net)

Re: 1973 Grand Banks 48

This letter reports the results of a survey of the above vessel which was inspected on the 27th of September, 2019, at Fort Rachael Marina in Pawcatuck, Connecticut while hauled. The inspection was completed to establish its condition and value.

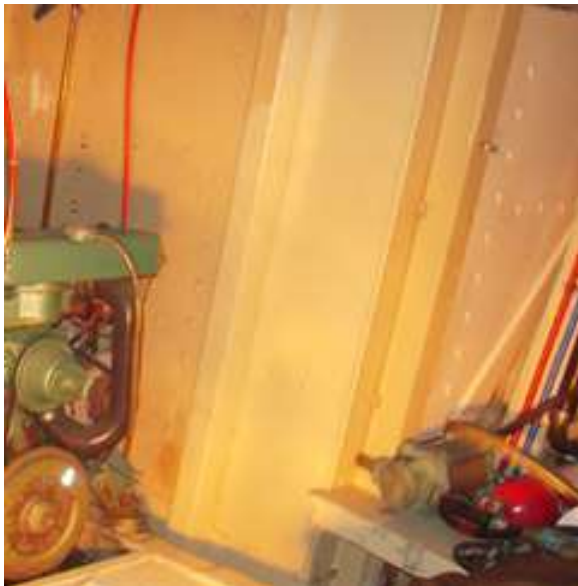
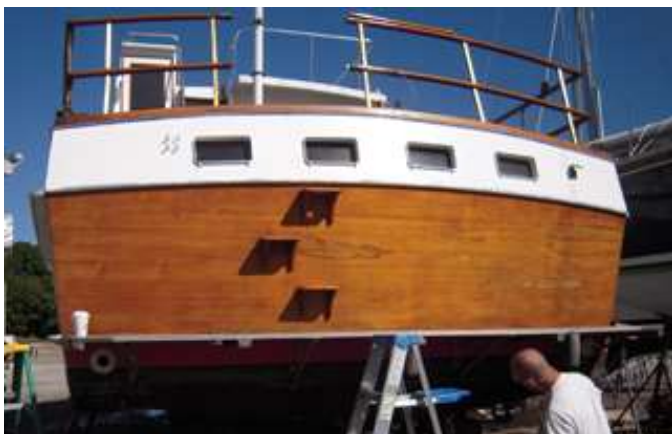
*Views of a sampling of the several fasteners that were removed for inspection*

*Fasteners were removed from the hull, below the engines, below the toilets, and a few from both garboard planks. There was no noticeable material missing from any of the fasteners. No oxidation or corrosion was noted on any fastener.*

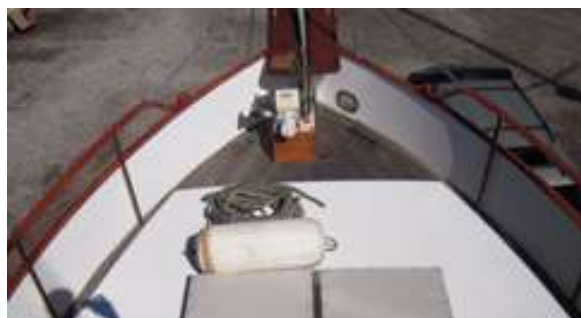
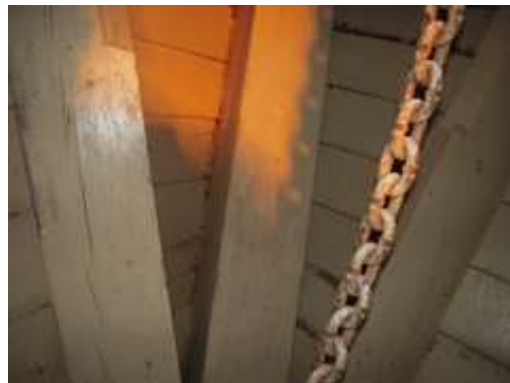
The teak anchor pulpit is also complete, well supported and brightly finished. The windlass is now in working condition and properly secured. Note view of bow section structure as viewed from the inside. Heavy duty and very secure.

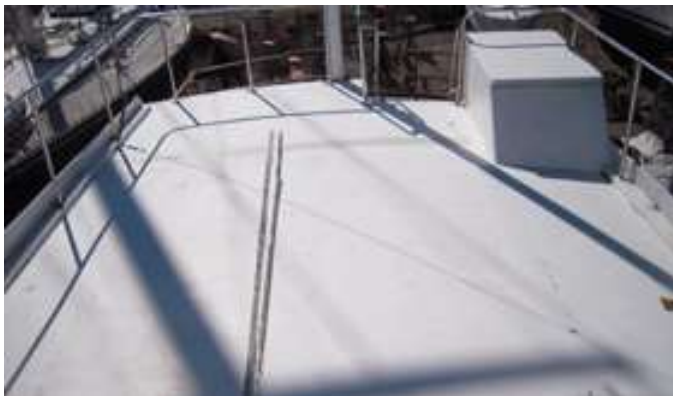
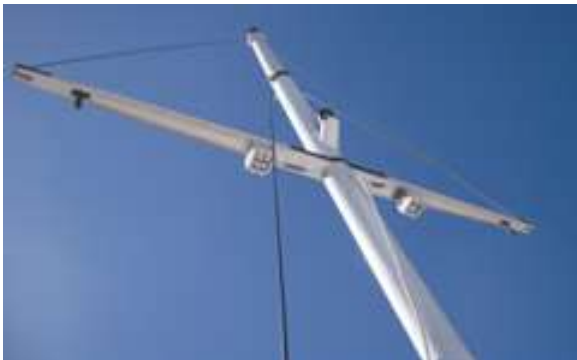
The operating station at the bridge, pictured at left (sans the wheel), has been upgraded and is operational at this time. All upholstery has yet to be refitted. The compass is accurate on its present heading. The shifts and steering are also smooth operating and in good condition. Steering is the original mechanical chain to stainless cable.

The deck is the original plywood over mahogany frames. The entire bridge deck has been stripped and coated with Biaxial fiberglass cloth and epoxy resin and finished in white epoxy paint.

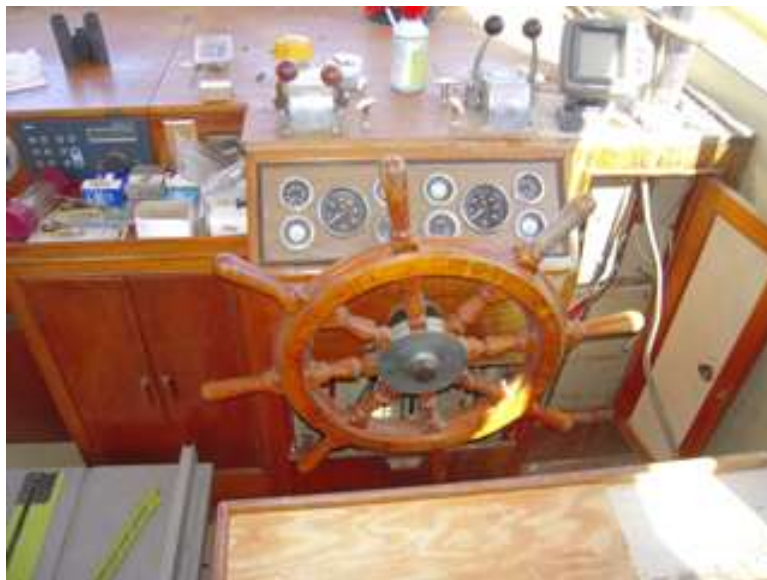
Galley and Dinette

Pictured at left is the main salon that houses the galley, dinette, and lower operating station. This area is partially finished and in very good, dry condition. Ports and hatches are tight to the weather. While construction is ongoing the vessel remains in operational condition. During the last weeks it was delivered to Mystic from Westerly for haul out and winter storage under its own power.

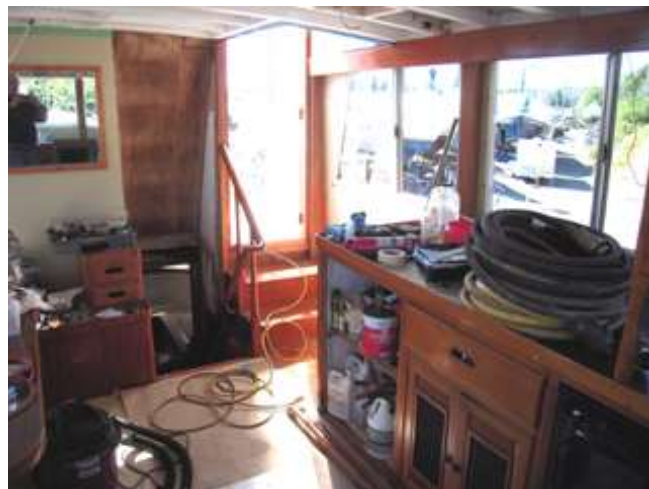
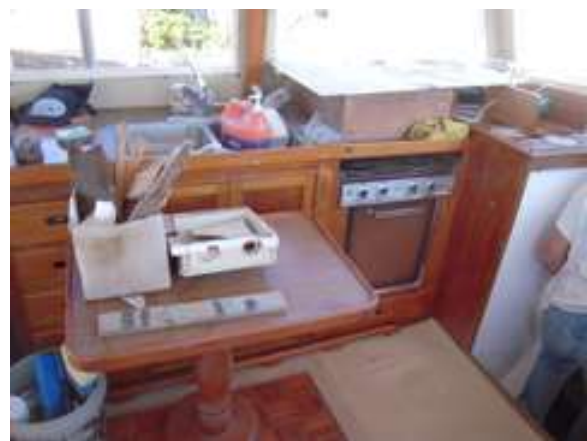
The Parquet sole has been mapped and the tiles have been reassembled in their original positions. The Parquet tiles have been secured with epoxy and now secure and refinished and appear original. The three quarter inch plywood decking is well secured to solid mahogany framework. All deck hatches are secure, fit properly, and are nicely finished.

The remaining jointer work in the salon is in good solid condition.

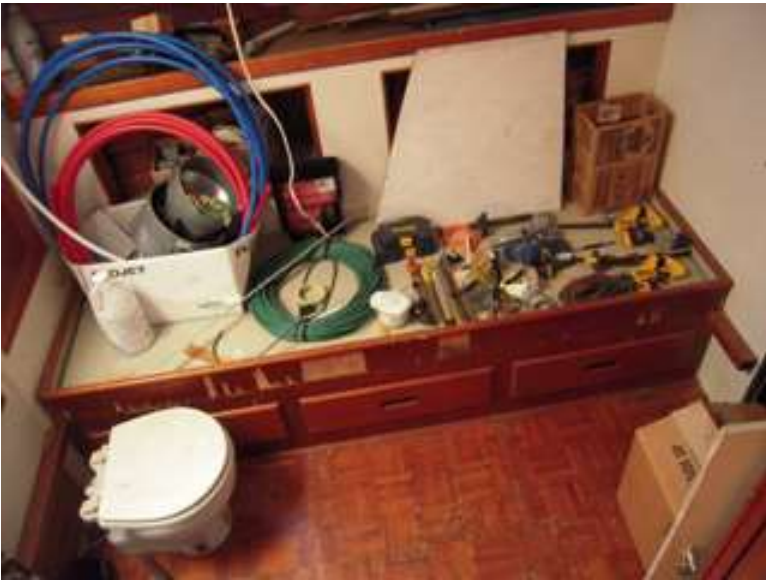
The forward berth area (V-Berth), pictured at left, is also clean and in excellent condition. (Very close to completion) No fresh water leaks were noted in any berth area. Also, housed in the V-berth area are several lockers and rode storage. Head liners in both areas were clean and in good condition and secure. All berth areas are equipped with adequate lighting, locker, and drawer space. Adjacent heads with showers are provided forward and aft.

These areas are clean, nicely finished and upholstered. (Upholstery is off at present) There is adequate lighting and ventilation in this area. The Parquet deck in this area is properly supported, nicely finished and in overall good condition. I was unable to locate any excess moisture on any deck surface. This area also appears "close to original" condition.

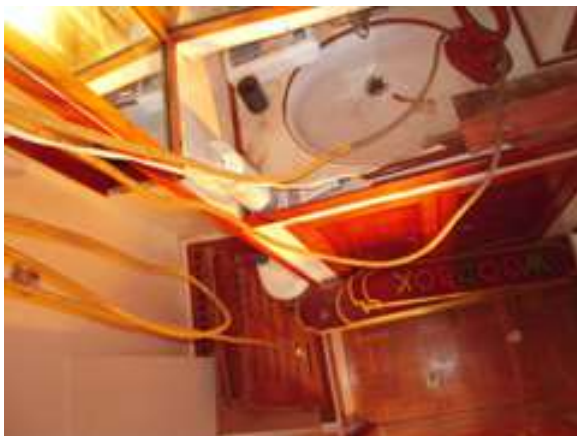
The heads (one forward and one in the master stateroom, aft) are in good condition. The heads are equipped with showers, hand basins and manual Wilcox-Crittenden standard toilets with new plastic holding tanks. The shower units are an integral part of the inner liner. The shower stalls are in good shape. Each shower is equipped with a sump pump and over-board drain. There are macerator units, Y-gates, and holding tanks installed, all in working condition. No septic odor was noted in any area.

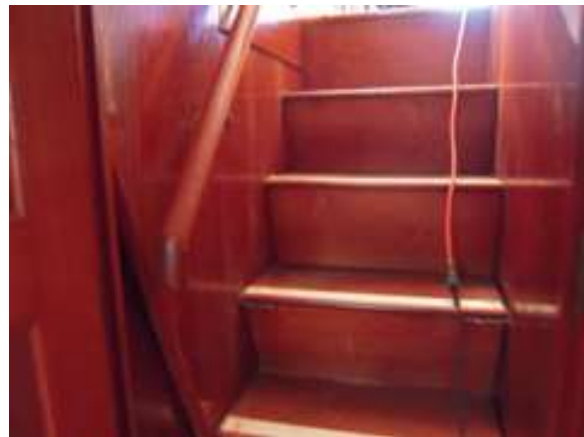
*Ladder to aft area*

A large berth (Owners stateroom) is located aft and down from the main Salon. This area is clean, nicely finished and upholstered. There is adequate lighting and ventilation in this area. All jointer work is in lightly used condition and brightly finished. There are numerous lockers and closets in this aft birth space. The deck (sole) in this area is properly sup-

ported, nicely finished with original Parquet wood tiles and in overall good condition. All ports, including the escape hatch are tight to the weather.

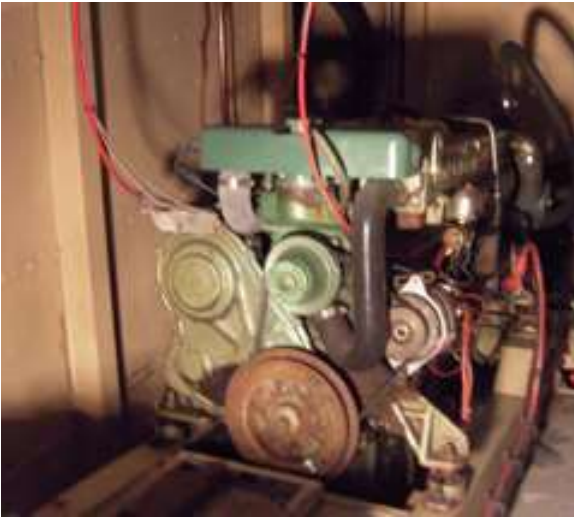
Propulsion is by a pair of original, naturally aspirated, six cylinder, counter rotating fresh water cooled, Ford Diesel engines with reduction gears.

Visual inspection of the engines, oil, filters, and related connections indicate a good maintenance regime has been ongoing.

The fuel lines, also new a few years ago, are properly supported and are in good condition. The solid three by ten mahogany stringers that support the engine mounts are heavily built and properly bolted to the frame work. (All original construction). The longitudinal members also provide rigidity to the hull.

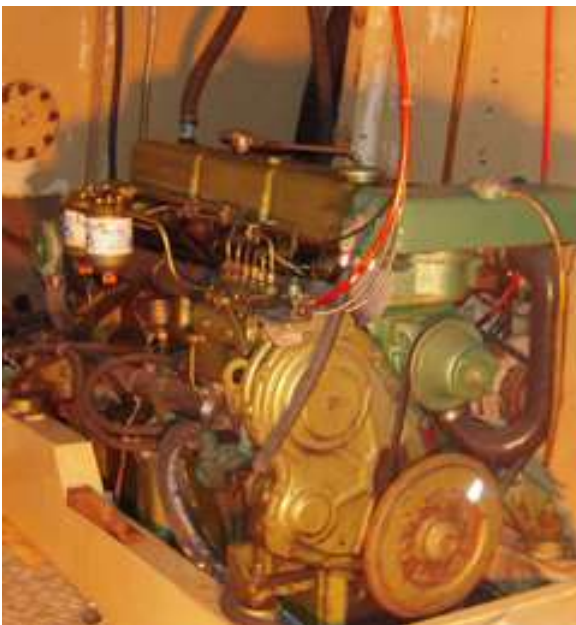
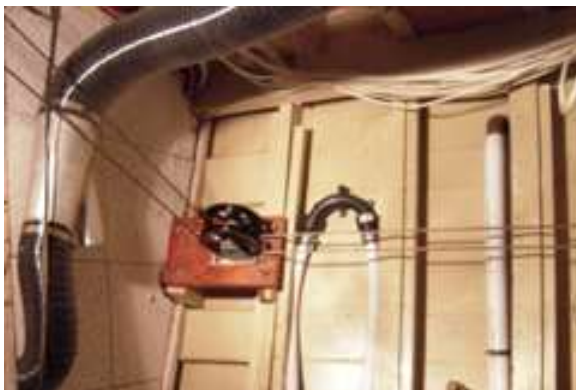
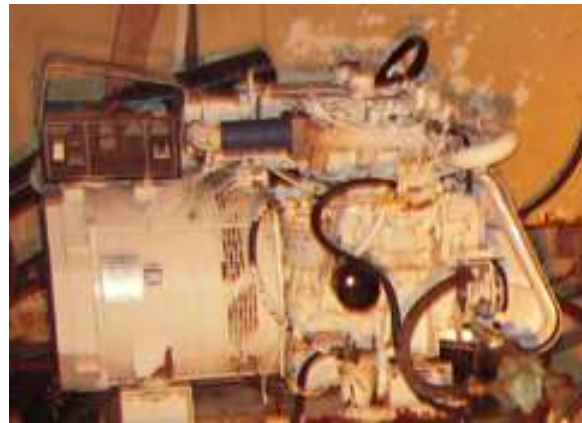
The raw water intakes are equipped with a proper sea water strainer, and secure. The engines exhaust through approved rubber composite hoses to recently installed fiberglass silencers and on through the transom. The entire exhaust system is in good condition. The 8 KW Kohler generator (a recent upgrade) engine exhausts through approved rubber hose to recently purchased fiberglass silencer to overboard. The fuel lines and filters to the generator set are in good condition. The raw water intake which supplies the generator is in good safe condition. There are appropriate bilge pumps mounted.

The fuel tanks are secured, inspection is limited.

There are water cooled Cruise Air air conditioners properly installed that provide heat and air-conditioning to all living spaces. The units were not checked out while operating but do look good.

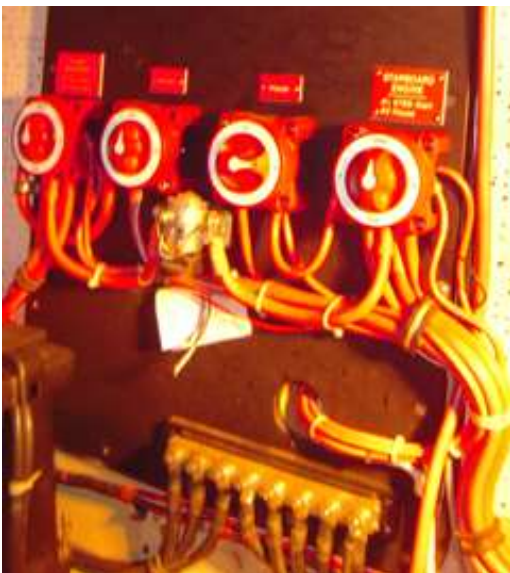
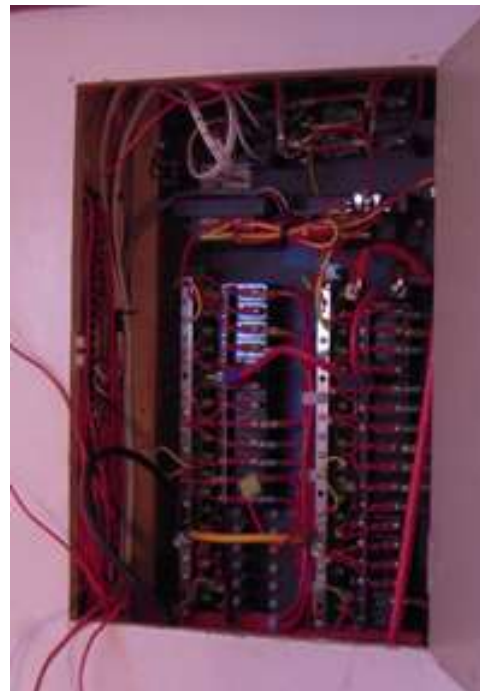
The electric motors which operate the fresh water system are in good working order. The bonding system, (partially installed) is in good condition. There are no traces of oil in the bilge, and the bilge is clean overall. The batteries on board (Four fairly new 8 D's) are properly boxed, secured, and connected. DC circuits are properly connected and harnessed (note photo at left).
