JAMES CROSS, Certified Marine Surveyor
19 Nooseneck Hill Rd., West Greenwich, RI 02817
Phone (401) 397-5040
Member Association of Certified Marine Surveyors / ACMS-USA.COM
Check us out on the web at www.jimcross.net

Re: 1986 Hunter "LEGEND" Sloop "NO NAME"

This letter reports the results of a survey of the above vessel which was inspected on the 14th of May, 2018, while hauled at Wharf Marina in Warwick, Rhode Island. You requested the inspection to establish it's condition and value.

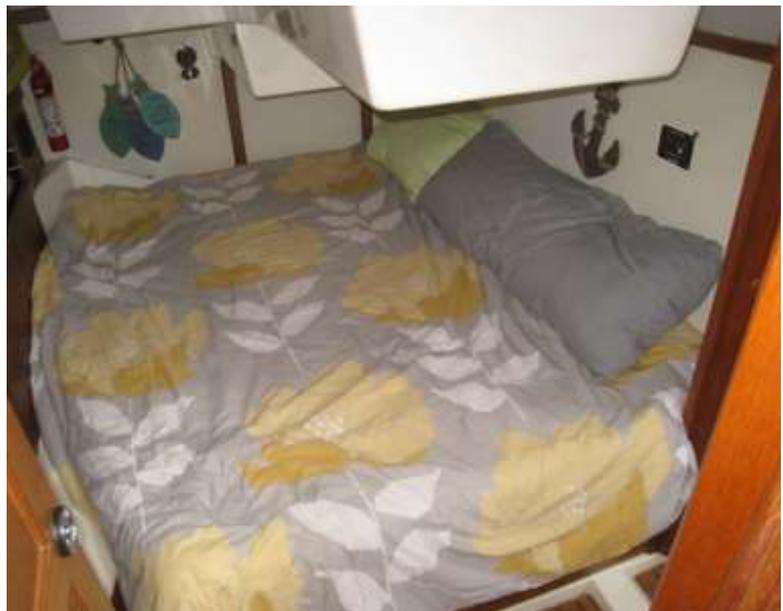
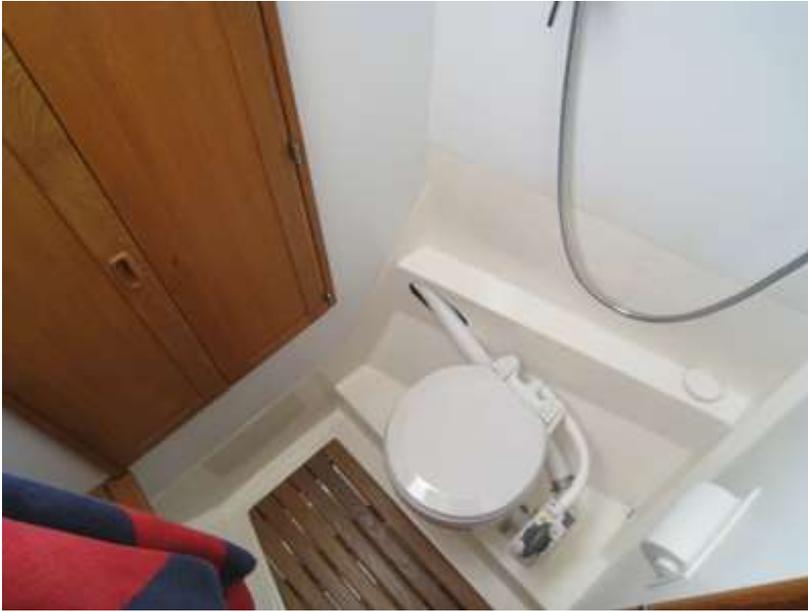
Heads

The heads (two, fore and aft) are good sized and also in very good structural condition. Both heads are equipped with New manual marine toilets, showers, and hand wash basins. Both head areas are clean and odor free. All plumbing was found to be in very good condition and free from any leaks. The related plumbing and holding tanks are in good shape and no septic odor was noted below deck in any area.

View of Forward head

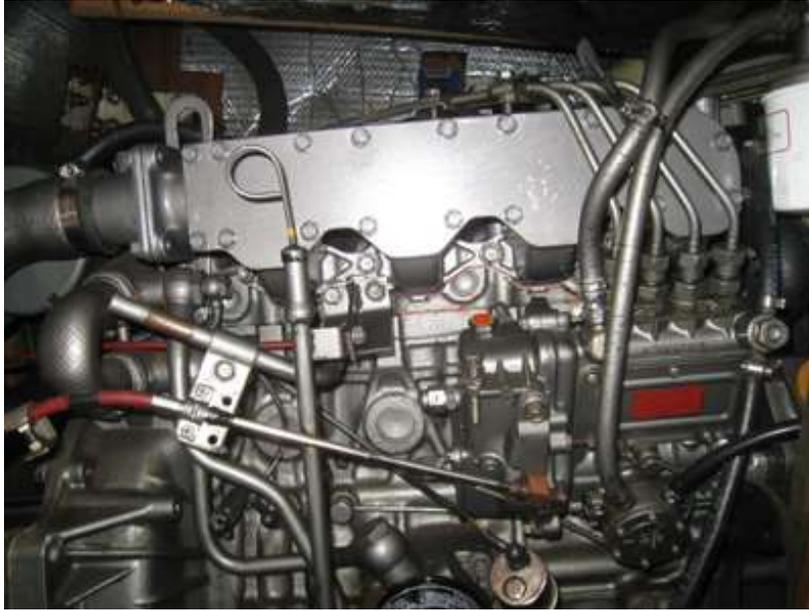
Propulsion and Controls

Propulsion is by a four cylinder Yanmar 55 HP Turbo fresh water cooled diesel engine and Hurth reduction gear, mounted under the companionway. The engine oil is clean, as is the coolant. Engine instrumentation, consisting of oil and heat lights are positioned just port of the pedestal. The engine was run at the dock during inspection. The engine shows signs of good care and proper maintenance. I was unable to locate an hour meter, but from outward appearances this vessel is sailed more often than motored.
