JAMES CROSS, Certified Marine Surveyor
19 Nooseneck Hill Rd, West Greenwich, RI 02817
Phone (401) 397-5040
Member Association of Certified Marine Surveyors / ACMS-USA.COM
Check us out on the web at www.jimcross.net

March 31, 2019

Re: 1996 Mainship 47 Motor Yacht

This letter reports the results of a survey of the above vessel which was inspected on the 31st of March 2019 at the Riverside Marina in portland, Connecticut while hauled, winterized, and shrink wrapped. You requested the inspection to establish its condition and value. It should be noted that I have surveyed this vessel three times over the past twelve years.

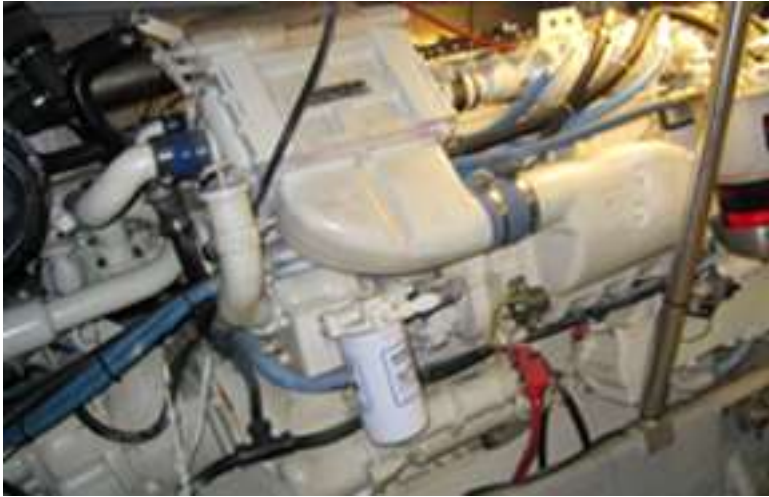
Propulsion is by a pair of fresh water cooled , turbo charged, 671 Detroit Diesel engines with reduction gears , coupled to monel shafts and on to bronze four blade propellers. The shaft logs are in good condition.

The engines are rated at approximately four hundred and fifty horsepower each. Visual inspection of the engines, oil, filters, and related connections show no signs of abuse. The fuel lines are recent upgrades. The stringers that support the engine mounts are heavily built and fiberglass covered and tabbed to the hull. The stringers also provide rigidity to the hull. The stringers are in good condition. The raw water intakes are equipped with a proper sea water strainer, and secure. The engines exhaust through an approved rubber composite hose on to fiberglass silencers and then through the transom. The entire exhaust system is in good condition. The Westerbeke generator engine exhausts through approved rubber hose and steel silencer to overboard. The fuel lines and filters to the generator set are in good condition. The raw water intake which supplies the generator is in good safe condition. There

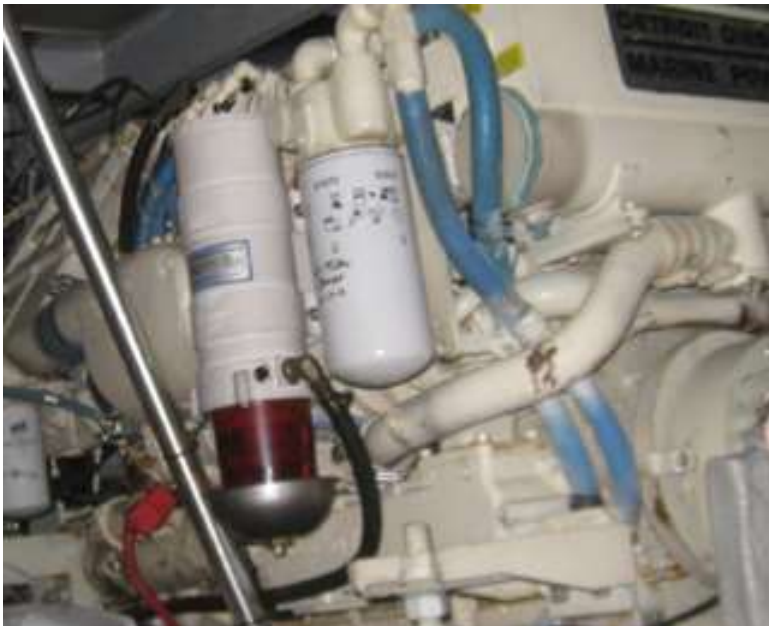
are appropriate bilge pumps mounted. The fuel tanks are in good, clean condition, as can be observed. There are three water cooled Cruise Air conditioners properly installed that provide heat and air-conditioning to all living compartments. The units were not checked out while operating.

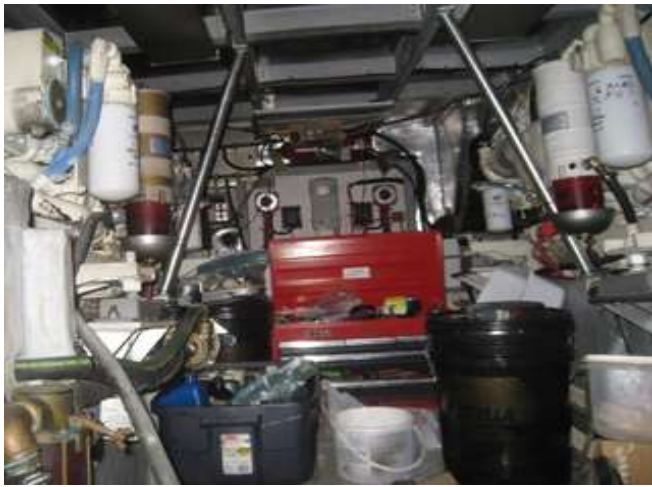
One of three CruiseAir, Heat Air units
