**JAMES CROSS, Certified Marine Surveyor**  
19 Nooseneck Hill Rd., West Greenwich, RI 02817  
Phone (401) 397-5040  
Member Association of Certified Marine Surveyors / ACMS-USA.COM  
Check us out on the web at [www.jimcross.net](http://www.jimcross.net)

March 31, 2020

Re: 1996 Mainship 47 Motor Yacht

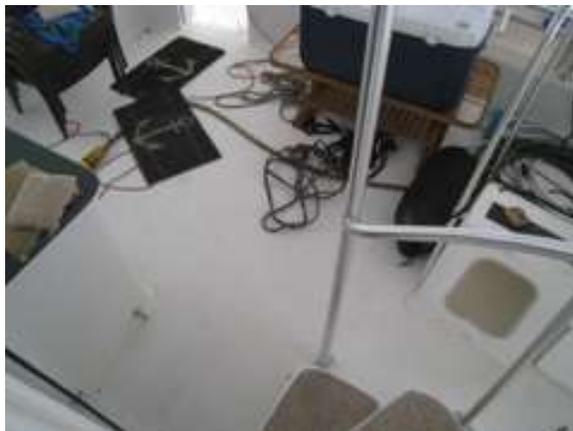
The moulded in ladder (pictured at right) to the bridge is secure and no blemishes were noted.

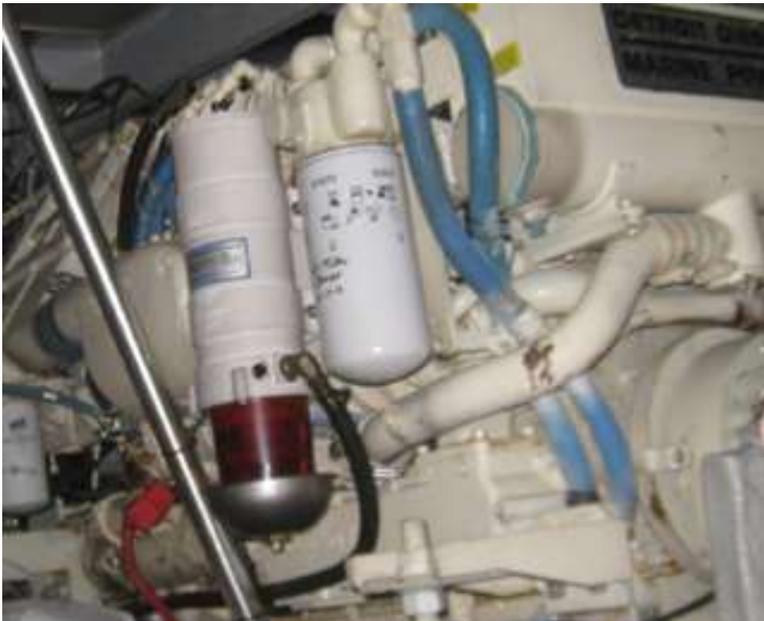
Propulsion is by a pair of fresh water cooled , turbo charged, 671 Detroit Diesel engines with reduction gears , coupled to monel shafts and on to bronze four blade propellers. The shaft logs are in good condition.

The engines are rated at approximately four hundred and fifty horsepower each. Visual inspection of the engines, oil, filters, and related connections show no signs of abuse. The fuel lines are recent upgrades. The stringers that support the engine mounts are heavily built and fiberglass covered and tabbed to the hull. The stringers also provide rigidity to the hull. The stringers are in good condition. The raw water intakes are equipped with a proper sea water strainer, and secure. The engines exhaust through an approved rubber composite hose on to fiberglass silencers and then through the transom. The entire exhaust system is in good condition. The Westerbeke generator engine exhausts through approved rubber hose and steel silencer to overboard. The fuel lines and filters to the generator set are in good condition.

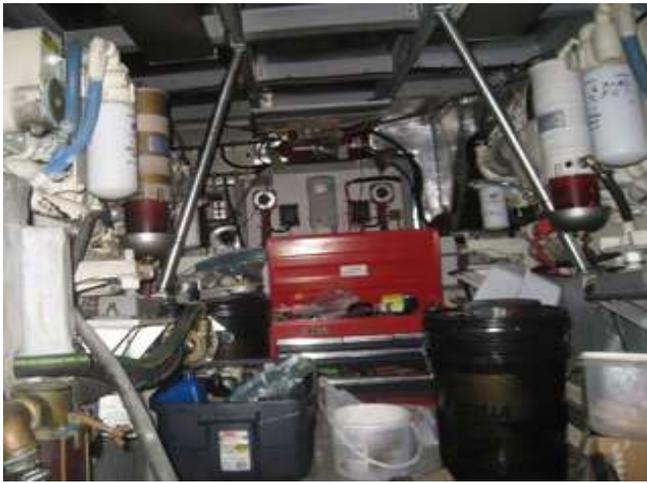
One of three CruiseAir, Heat Air units

The raw water intake which supplies the generator is in good safe condition. There are appropriate bilge pumps mounted. The fuel tanks are in good, clean condition, as can be observed. There are three water cooled Cruise Air conditioners properly installed that provide heat and air-conditioning to all living compartments. The units were not checked out while operating.
