Re: 1989 Marine Trader 38 Fly Bridge Sedan Europa

This letter reports the results of a survey of the above vessel which was inspected while afloat at Greenwich Cove in East Greenwich, Rhode Island on the 11th of August, 2020. This survey is a resurvey, as I have surveyed this vessel in the past. This vessel has been in ocean use for several years and very little has changed since the previous inspection. You requested the inspection to establish its condition and value.

Addendum to Pages One through Ten on August 20th, 2020

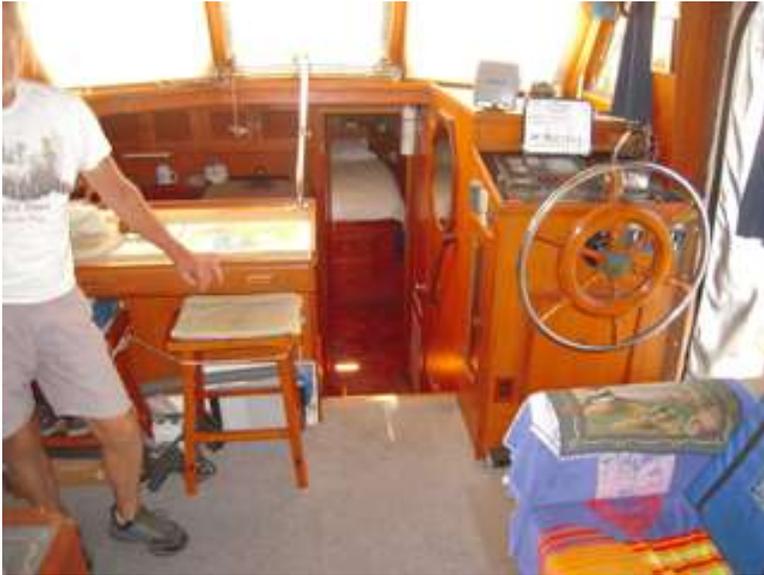
The operating station (at the bridge) is well designed and the controls are easy to operate. The upholstery is in excellent condition. There is a tinted splash shield installed. The bridge compass is also accurate on its' present heading. The controls operate smoothly. Again, all surfaces were checked out and no problems were found. The boat deck, (aft of the control station) had a few gel coat scratches and dings, about the usual amount for a vessel of this age. The Bimini and bridge enclosure canvas appear to be recent upgrades. The supports are in good condition. All teak and stainless life rails are in good condition and secure.

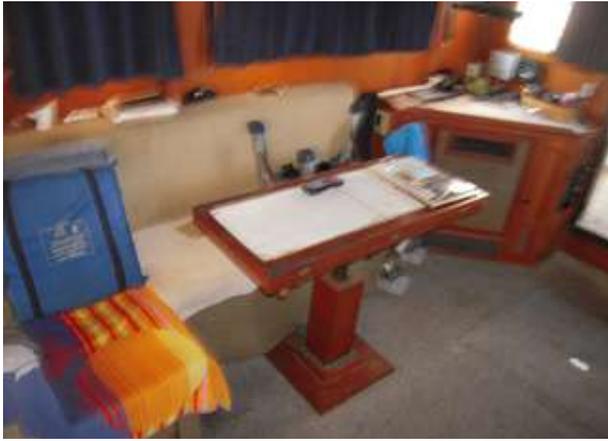
The main cabin houses the salon and galley. This area is large, nicely finished in Formica, teak, and mahogany and in good condition. No rot was detected at any location. This area was checked for excess moisture content in all partitions and the overhead. All checked out fine. The propane stove and Nor Cold refrigerator are in good condition. The propane system is equipped with proper safety devices. The stainless sink and hardware are in good condition. The upholstered sections are in good condition and show average use. The teak Parquet deck in this area is properly supported and in good condition. Lighting is good throughout the vessel. The main salon, overall, is in excellent condi-

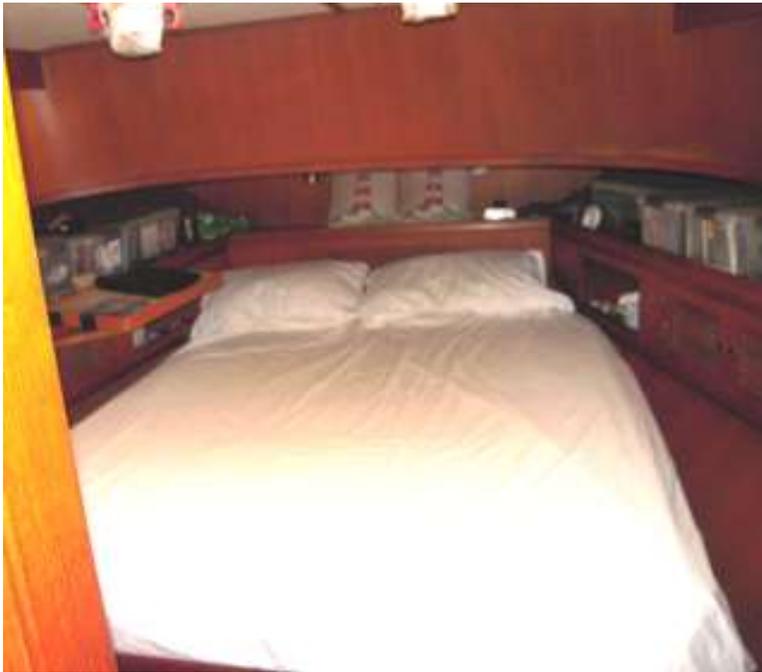
The V-Berth is located beneath the forward deck. This area will sleep two. Much of the forward area is sheathed, but the portions of the hull and frame work that I could observe are in good condition. The bilge in this area is clean. There is a head with shower located in this area. The toilet, hand basin, and their related fittings, including overboard discharges and through hulls, are in good shape and are equipped with macerators, holding tanks, y-gates and proper pump-out gear. All head related plumbing is in good condition and no unusual odors were noted.

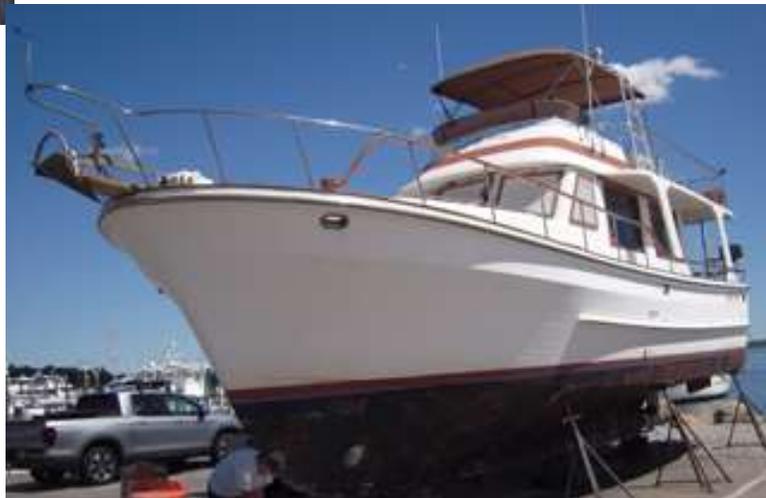
I sounded the bottom with a metal mallet and found it to be in good condition, free from any soft areas, or delamination. The keel is solid and in good shape.

The stainless propeller shaft and log are secure and in good condition. The Trim Planes are well secured. The rudder and rudder post are secure and feel

tight, indicating security at the shaft log.
