JAMES CROSS, Certified Marine Surveyor
19 Nooseneck Hill Rd., West Greenwich, RI 02817
Phone (401) 397-5040
Member Association of Certified Marine Surveyors / ACMS, U.S.A. / C.O.M.
Check us out on the web at www.jimcross.net

Re: 1992 Ocean 42 Super Sport

This letter reports the results of a survey of the above vessel which was inspected on the 16th of January 2019 while hauled, winterized, and shrink wrapped, at Brewers Ferry Marina in Old Saybrook, Connecticut. You requested the inspection to establish its condition and value.

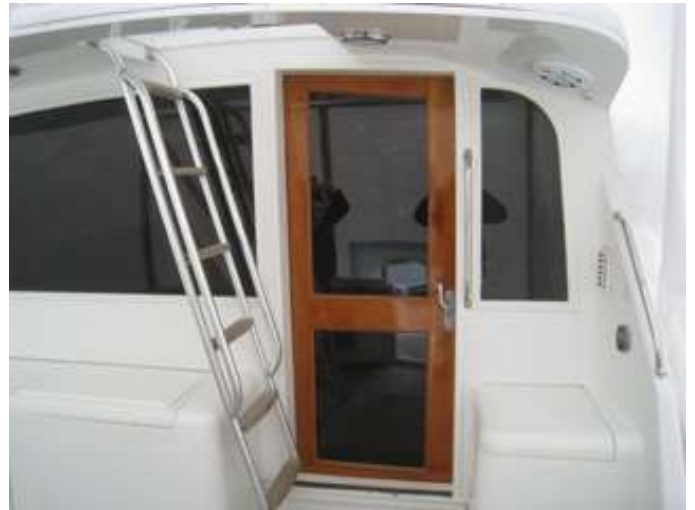
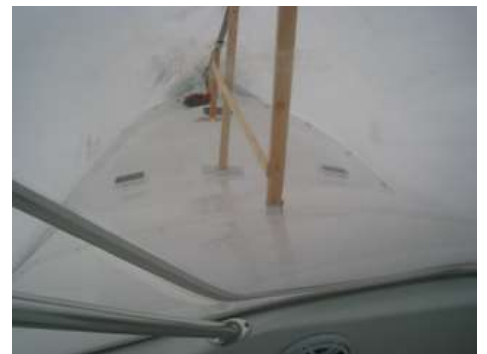
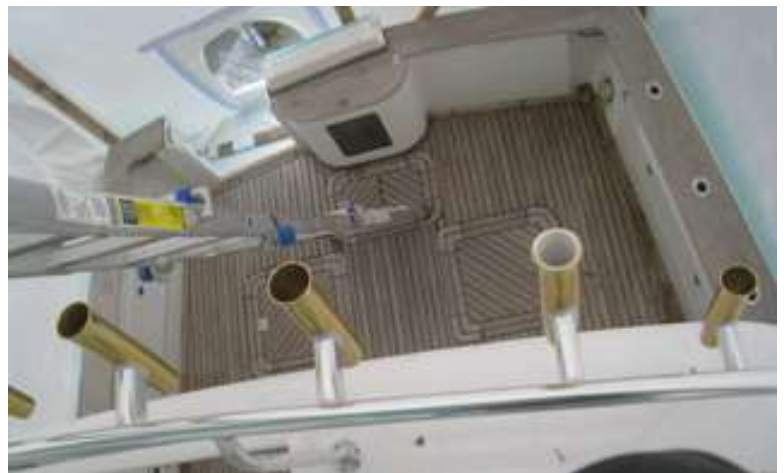
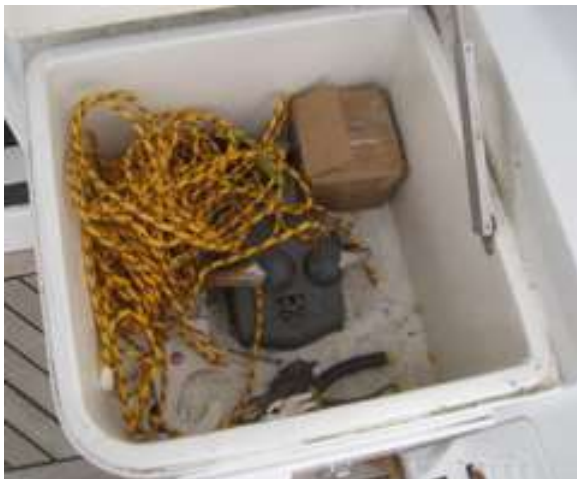
is also in like new condition and well secured.
