April 12, 2020

Re: 1975 Nautor Swan 38 Sloop

This letter reports the results of a survey of the above vessel which was inspected on the 10th of April, 2020, while hauled and winterized at Stanley's Boatyard in Barrington, Rhode Island. You requested the inspection to establish its condition and value in order to acquire insurance. The vessel owner was present during the survey.

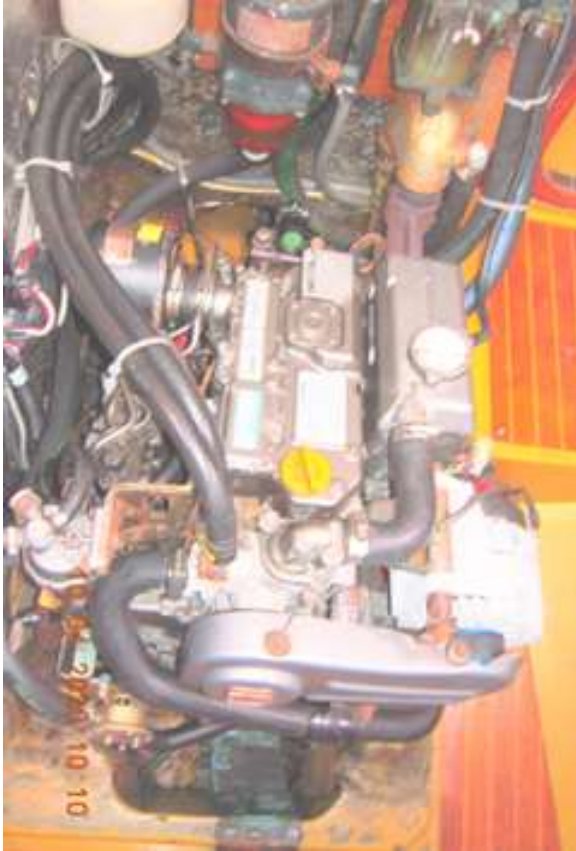
Propulsion is by a 100 HP turbo charged fresh water cooled Yanmar diesel engine with Hurth reduction gear, coupled to a monel shaft and then to a three blade bronze propeller. The shaft and shaft log, are in good condition. The engine and gear appear in well maintained condition, very clean. The engine is approximately eight years old. Ventilation to the engine spaces is adequate. The exhaust (most can be inspected) system is cast and rubber, heavy duty, and in good condition. The system clamps are now all doubled and have had recent service. All through hull fittings including the valves are secure. The engine controls and cables are smooth operating. The engine compartment bilge is epoxy painted, sound and sturdy. The bilge in this area is clean. There are adequate bilge pumps installed and working in this area. There is no oil in the bilge. All fuel and water tanks are in good condition as can be inspected. The fuel lines, including a Racor filter are approved type and in good condition. The flex fuel line appears to be a recent upgrade. The fuel fills, vents and shut-off are in good order.

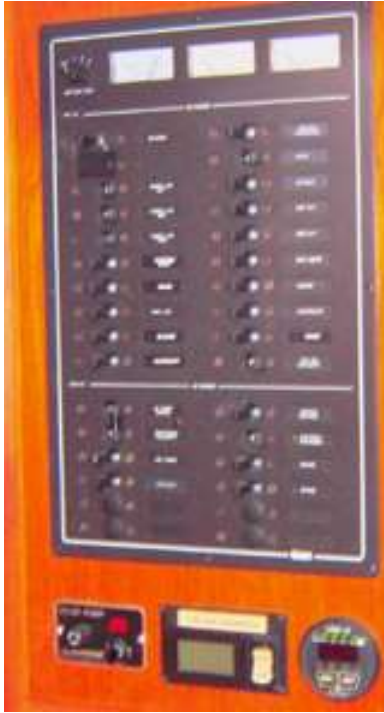
The batteries appear fairly new and are in good condition and properly connected to the approved three-way switches and then on to the custom breaker panel. The batteries are properly secured and covered below the salon berths. The wiring and terminals that could be observed are in good condition. All of the electrical wiring has been properly harnessed and is secure. The shore power system overall is in good condition as are the cables. The automatic battery charger was not checked out. The navigation equipment and electronics, was not checked out while operating. All of the electronics and navigating equipment is contemporary and appears lightly used. The anchor windlass is in excellent condition and secure. The Auto pilot hardware is properly installed and appears in good condition. The radar display is mounted on the steering pedestal.
