R048

June 11, 2020

Re: 1990 Viking 45 Convertible | Flybridge

This letter reports the results of a survey of the above vessel which was inspected on the 11th of June 2020 at the Pleasure Marina in Warwick, Rhode Island while afloat. You requested the inspection to establish its condition and value.

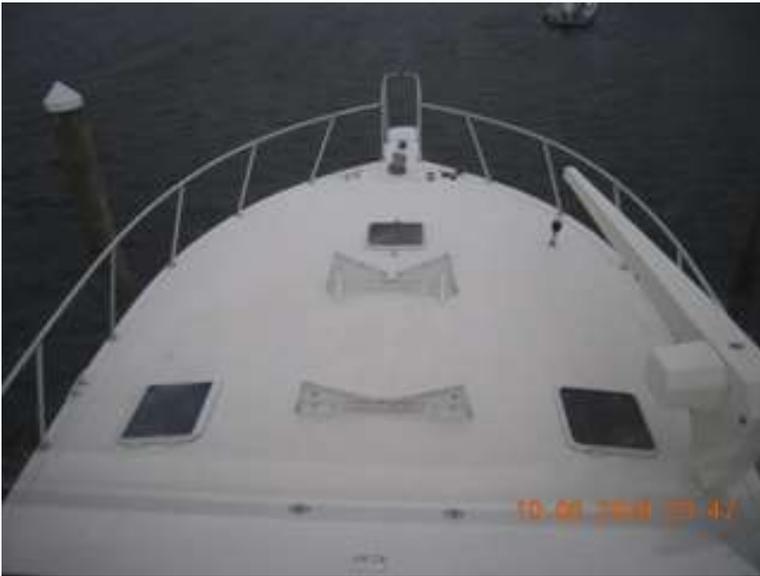
This vessel was designed for off-shore yacht service. She was heavily built to withstand years of off shore service. The hull is a heavily laid-up polyester laminate reinforced with fiberglass matt and woven roving in a modified "V" configuration. The finish is off white Epoxy Paint. The finish is in very good condition, overall, with just a few noticeable mars or scratches. There are no serious structural abrasions on the free-board part of the hull. The hull-deck attachment is secure, and trimmed with a stainless rub rail. I was unable to locate

any delamination or separating of glass, including the engine bearers and stringers. The hull below the waterline is solid fiberglass. A closed cell PVC foam along with Balsa core is used in the topsides and superstructure. There is an adequately sized anchor with appropriate line properly mounted along with the electric windlass at the bow. The ground tackle is more than adequate and in good condition. The electric windlass is in good shape and operational. The bridge and forward deck are constructed of cored fiberglass. The structural integrity of the hull is good. The bulkheads and interior tabbing are in good condition and secure. All bulkheads are marine grade plywood. All stringers and frames are in good condition. The bulkheads are properly tabbed and rigid. The interior surface of

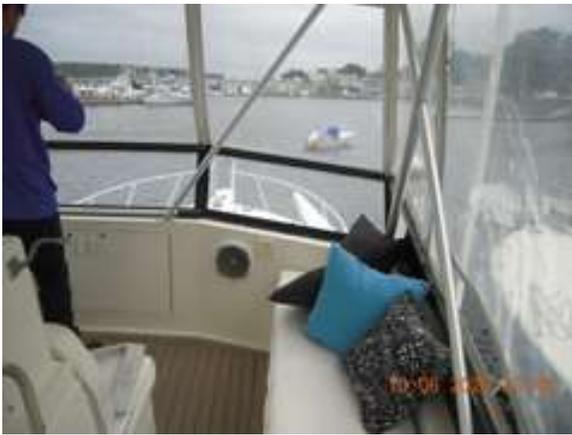
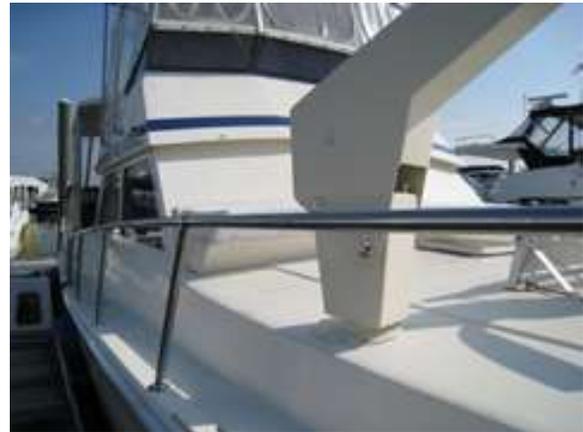
The bridge operating station is well designed and the controls are easy to operate. The upholstery is in very good condition, some new this year. The compass is accurate on its present heading. The shifts and steering are also smooth operating and in good condition. Steering is hydraulic to manual and the related lines and connections are in good condition. There is a complete color keyed canvas enclosure that covers the entire operating station and bridge

area. The canvas enclosure, and supporting structure appear to be a recent upgrade. The bridge is equipped with stainless life rails which are secure and properly backed. Overall, the bridge, including the operating station and upholstery is in excellent condition. The top of the bridge is solid fiberglass and well secured and sturdy.

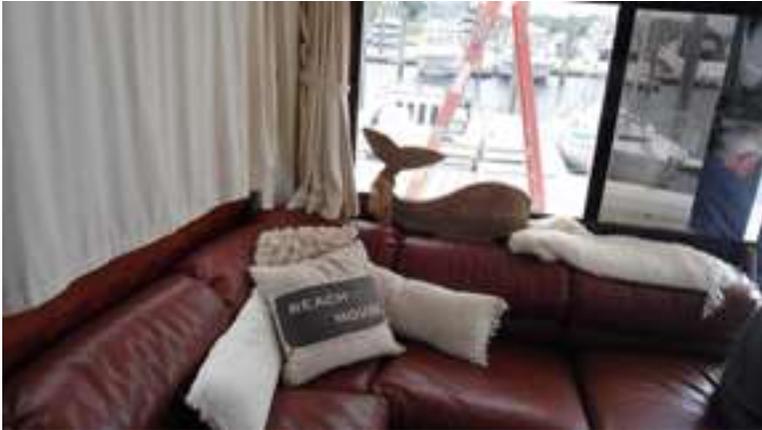
The main cabin houses the salon, galley, and dinette. This area is spacious, nicely finished and in better than average condition. The jointer work is made up of solid Mahogany, teak, and vinyl, and for the most part, appears lightly used.

Note that new color keyed Nylon carpet is on board, cut and ready for installation this week. The main salon plywood deck is well supported and sturdy. All deck supports were checked from below and all are secure.

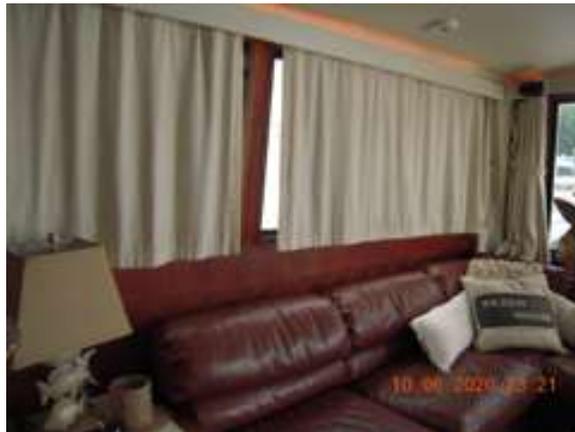
The upholstered sections show light use, good care, and maintenance.

The doors and ports are in good condition and tight to the weather. The entire interior area is in excellent condition and bright. The overhead vinyl liner also appears in excellent condition, clean, and well secured. Blinds, and miscellaneous furnishings are all in very good taste and condition. The furniture appears to be recent upgrades and is also in lightly used condition. The audio and video systems are contemporary.

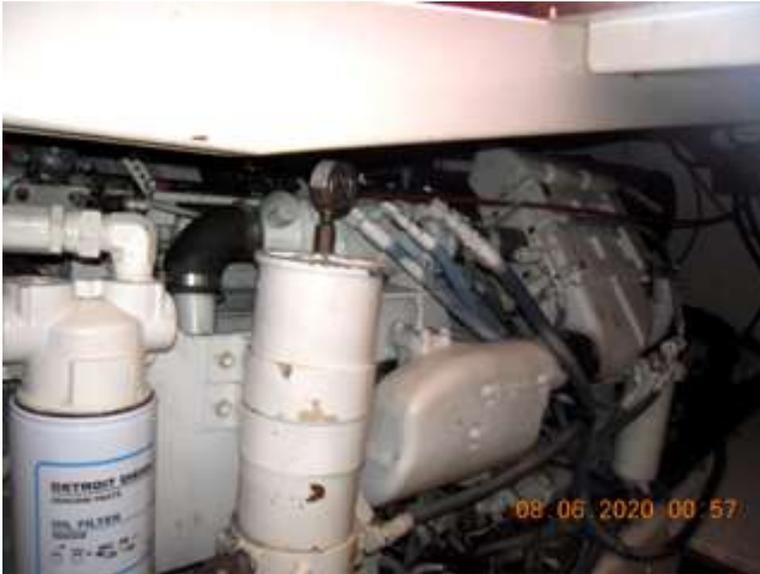
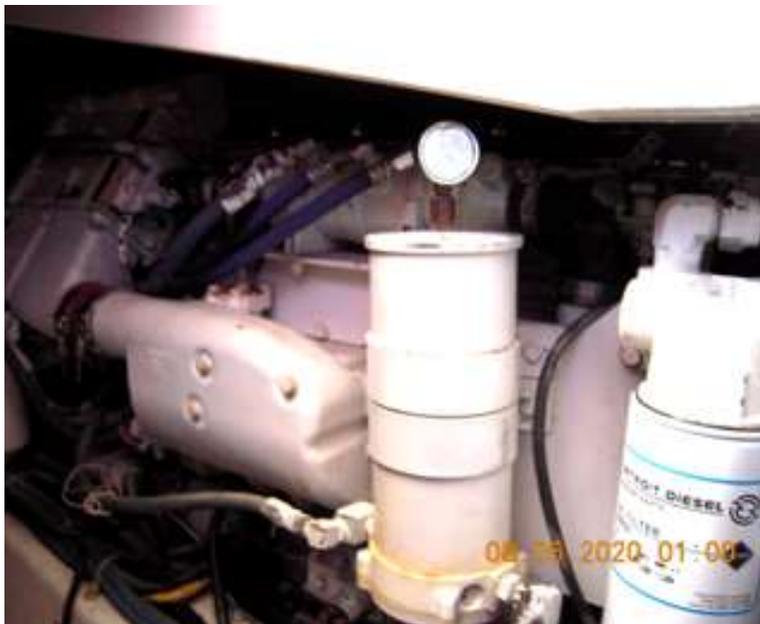
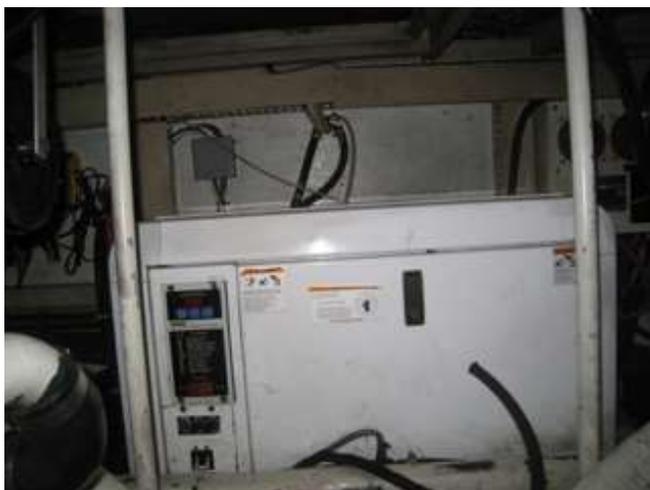
Propulsion is by a pair of fresh water cooled, turbo charged, 671 Detroit Diesel engines with Twin Disc reduction gears, coupled to monel shafts and on to bronze propellers. The shaft logs are in good condition. The engines and gen set were not operated as you just returned from a trip.

The engines are rated at approximately four hundred and eighty horsepower each. Visual inspection of the engines, oil, filters, and related connections show no signs of abuse. The fuel lines are of the approved type and are in good condition. The stringers that support the engine mounts are heavily built of fibreglassed wood beams and properly secured to the structure. The stringers also provide rigidity to the hull. The stringers are in good condition. The raw water intakes are equipped with a proper outboard sea water strainers. The engines exhaust through an approved rubber composite hose on to fiberglass tubes and silencers and then through the transom. The exhaust system (as can be inspected) is in good condition. The AC generator engine exhausts through approved rubber hose and silencer to overboard. The fuel lines and filters to the generator set are in good condition. The raw water intake which supplies the generator is in good condition. There are appropriate bilge pumps mounted. The fuel tanks (as can be inspected) are in clean condition. There are two water cooled Cruise Air conditioners properly installed that provide heat and air-conditioning to all living compartments. The units were checked out while operating.
