JAMES CROSS, Certified Marine Surveyor
 19 Nooseneck Hill Rd., West Greenwich, RI 02817
 Phone (401) 397-5040
 Member Association of Certified Marine Surveyors / ACMS.USA.COM
 Check us out on the web at www.jimcross.net

June 10, 2019

Re: 1988 Wellcraft Portafino 430

This letter reports the results of a survey of the above vessel which was inspected on the 10th of June, 2019, at your property in Warwick, Rhode Island while hauled, partially covered, and winterized. You requested the inspection to establish its condition and value.

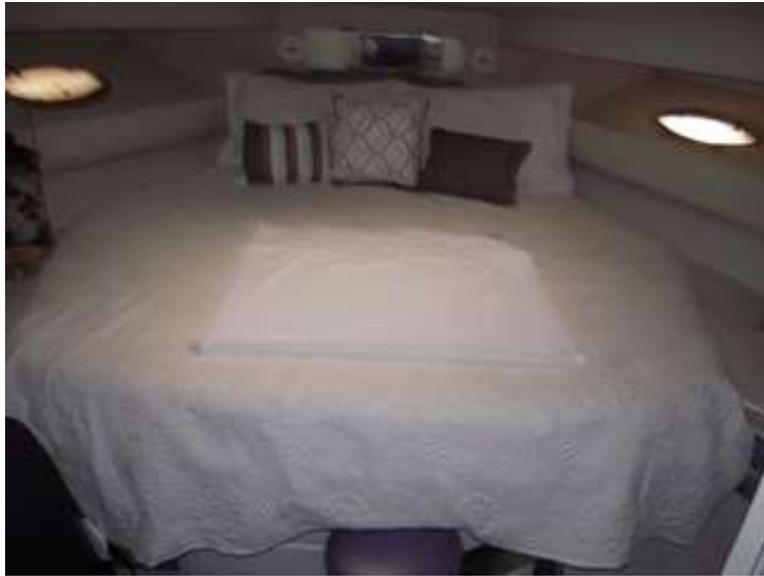
A large berth (Owners State-room) is located forward from the main Salon. This area is structurally sound and also cosmetically in excellent condition. There is adequate lighting and ventilation in this area. The deck in this area is properly supported, and the new carpet has been installed. The old carpet has been replaced in this area. Otherwise this area is in excellent condition. I was unable to locate any excess moisture on any surface in this forward cabin.

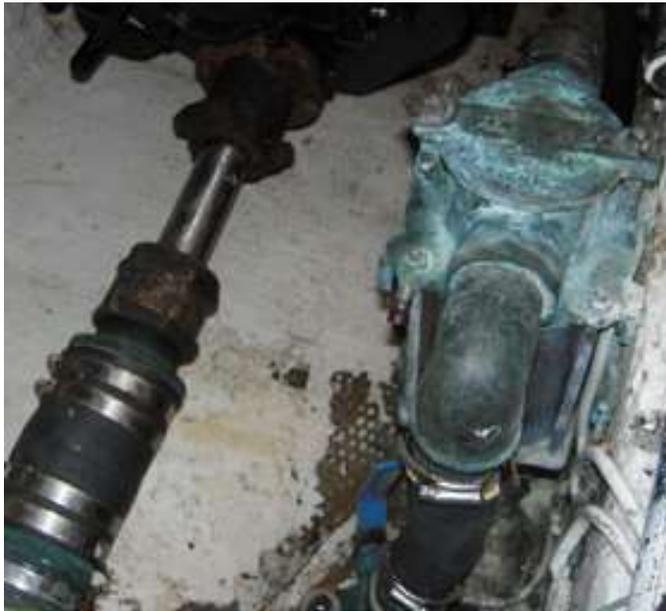
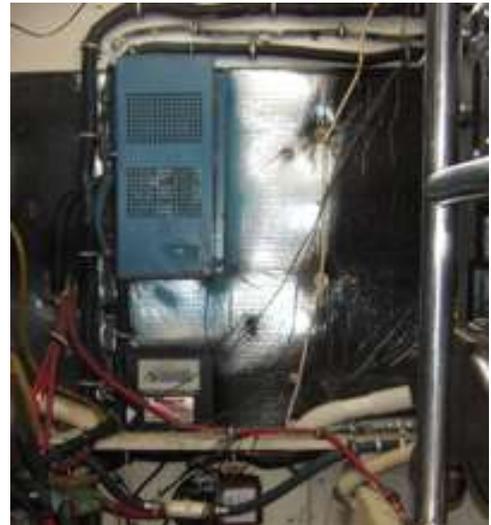
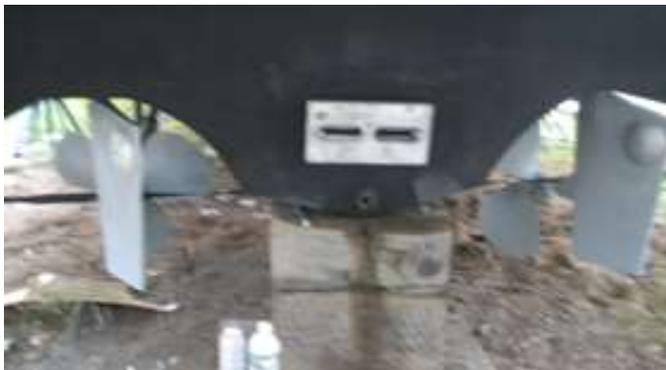
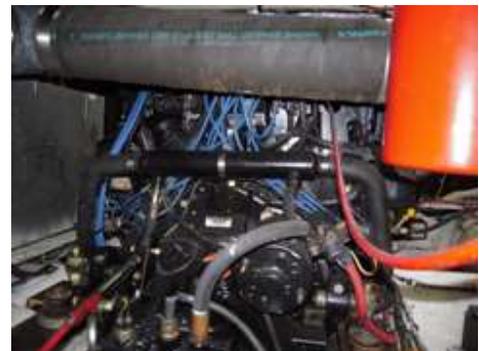
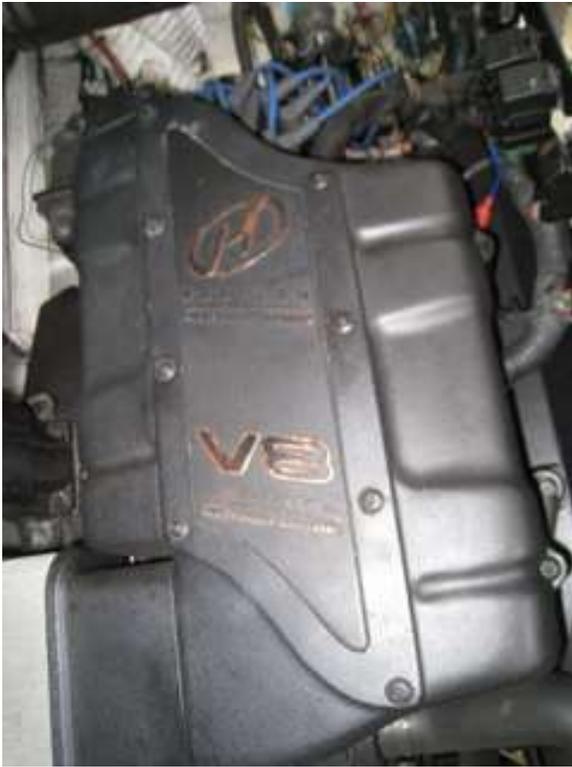
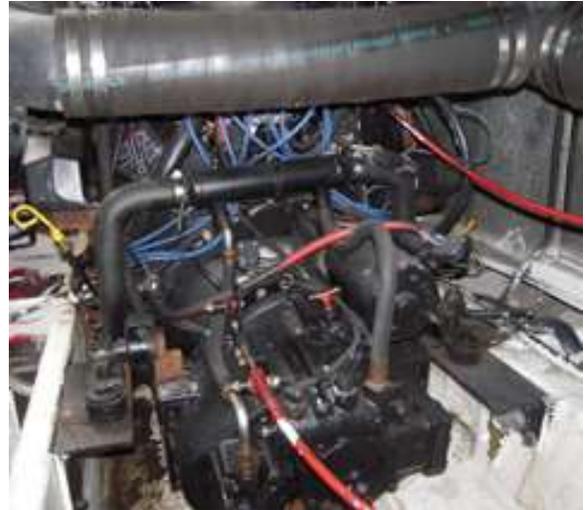
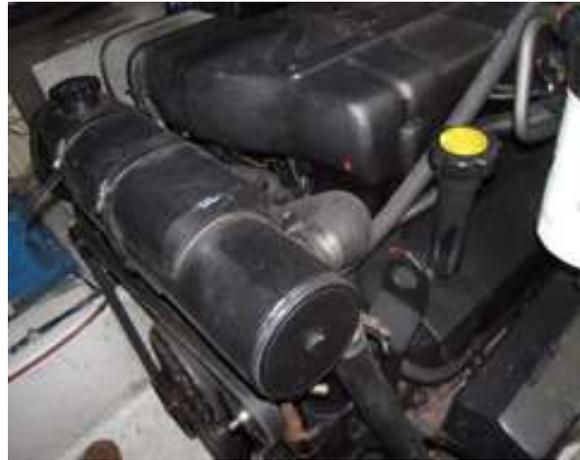
Propulsion is by a pair of counter rotating fresh water cooled MerCruiser Fuel injected V8 engines (454 CID GM) gasoline engines with reduction gear. The engines are replacements, one in 1999 and the other in 2003. The engines are rated at approximately three hundred and fifty horse power each. Visual inspection of the engines, oil, filters, and related connections show no signs of abuse. The fuel lines are Coast Guard approved reinforced rubber and in good shape. The stringers that support the engine mounts are heavily built, fiberglass covered, and tabbed to the hull. The stringers also provide rigidity to the hull. The stringers were sounded and are in good condition. The raw water intakes are equipped with a proper sea water strainer, and the rubber hoses to the intakes have been recently replaced and are in good shape. The engines exhaust through approved rubber composite hoses, fiberglass tubes and then overboard at the sides. The entire exhaust system is in basic good condition. There are appropriate bilge pumps mounted. The fuel tanks are aluminum and only partially visible, but are very clean and free from oxyditation.

The bonding system installed is in need of service, (clean terminals). The bilge is clean and freshly painted in some areas. The batteries should be secured and the terminals cleaned and protected from shorting. As this vessel is just getting ready for launch, the batteries should be a priority.

1. Secure and protect all batteries.
2. Install backup ground tackle.
3. Install CGFI and 120 volt system isolation device.
4. Have the Automatic engine room fire extinguisher inspected.
5. Ensure that a complete Coast Guard Safety and Signalling Package is aboard.
6. Protect batteries from shorting
