JAMES CROSS, Certified Marine Surveyor

June 4, 2013

Re: 1988 Irwin 44 Center Cockpit Sloop

This letter reports the results of a survey of the above vessel which was inspected on the 4th of June 2013, at Tiger Marina in Warwick, Rhode Island while afloat. You requested the inspection to establish it's condition and value.

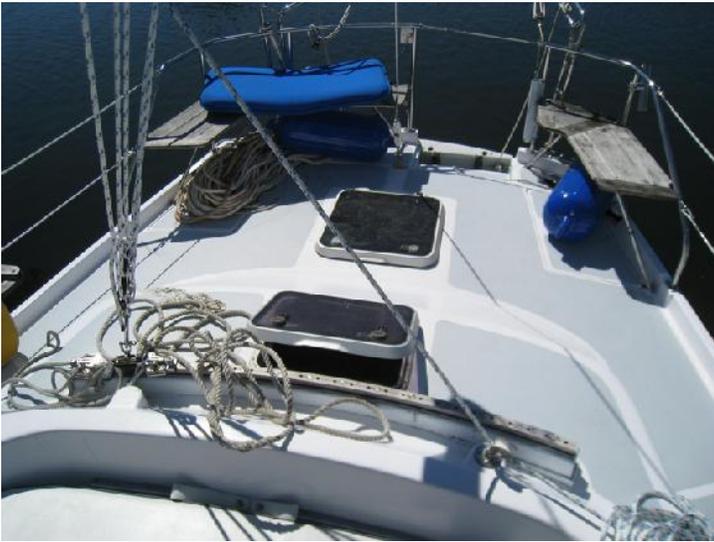
The hull is a typical polyester laminate, reinforced with various fiberglass matt materials. Hull stiffeners are made up of heavy duty foam and fiberglass boxed structures through out the entire length of the vessel. Chainplate frames run continuously through the hull sole to ring the chainplate landings together. A very secure structure. The chainplates are in good condition The hull is in overall good condition, sturdy and does not show signs of major damage or repair. The hull finish, between the boot top and gunwale, is dark blue

Epoxy paint finish with hand painted white boots and cove trim. The hull freeboard finish is New. There are no abrasions to note. The freeboard section of the hull was sounded and found to be solid. All through hull fittings are new bronze and properly installed and secure. The shaft log and shaft are in good condition. The hull, below the waterline, was previously inspected and found to be free from and soft spots or delamination. The propeller, propeller shaft are in new condition. Access to the centerboard structure is limited, but what can be inspected looks good. The rudder, and rudder post are in good condition. Excess play was not noted at the rudder. No oxidation was noted. Excess laminate moisture did not exist in any location. A new bow thruster has been installed this year.

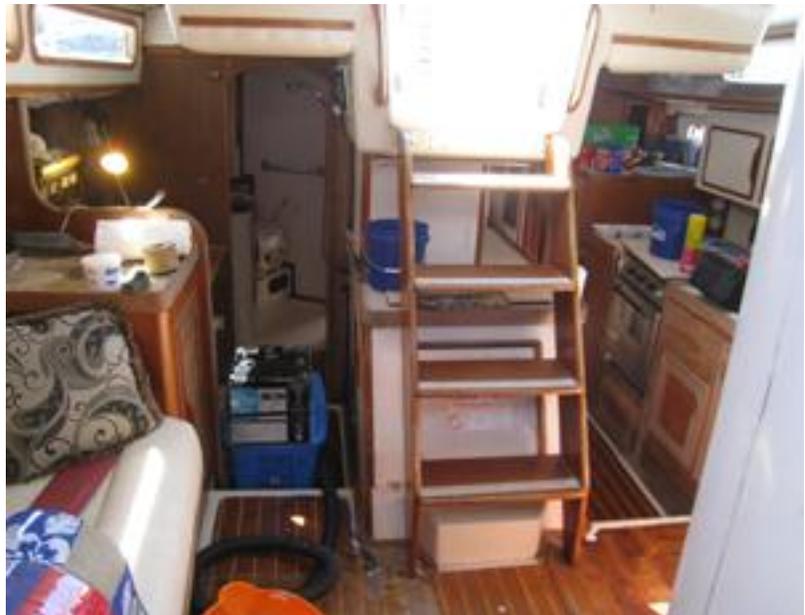
Lighting is good throughout the vessel. The dinette table is large and properly secured to the structure. There is adequate locker and drawer space in the main cabin. There is hanging locker and cabinet space between the main cabin and the v-berth. These interior areas, overall, appear in good, solid condition.

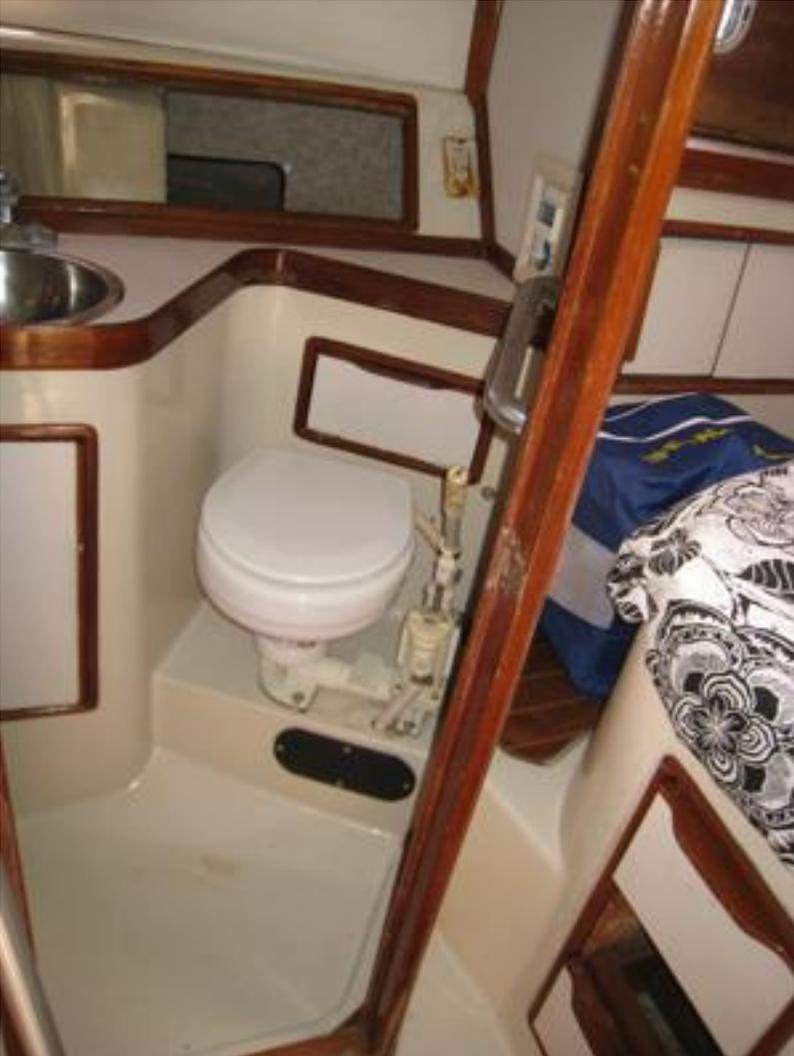
The heads (one forward and the other aft) are in good condition. The heads are equipped with showers, hand basins and Standard manual marine toilets. The shower units are an integral part of the inner liner. The shower stalls are good sized fiberglass enclosures. Each shower is equipped with a sump pump and overboard drain. There are macerator units and holding tanks installed which are in good shape.
