JAMES CROSS, Certified Marine Surveyor

Re: 1987 43 Morgan Sloop

This letter reports the results of a survey of the above vessel which was inspected while hauled on the 15th of May 2013 and then again on August 15, 2013 while afloat, at Nortons Shipyard, in Warwick, Rhode Island. You requested the inspection to establish its condition and value.

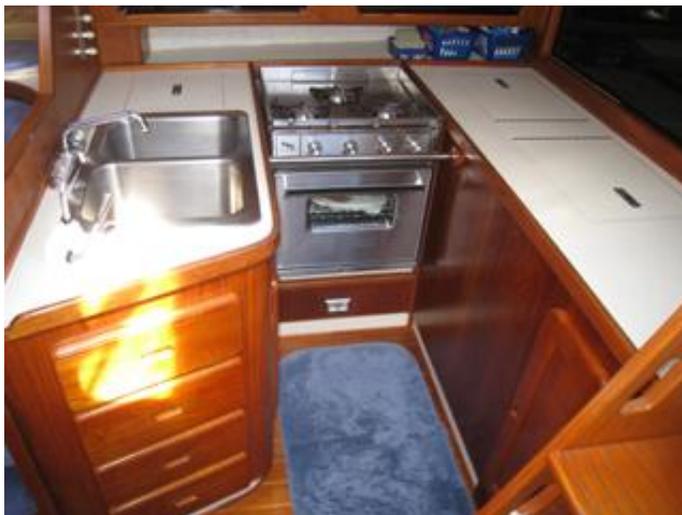
There is proper ventilation to the main cabin area through vents and ports. Access to the bilge is gained through several well designed sole sections which can be removed to reveal, most of the bilge, the tanks and below deck systems. Good access to the engine is available just behind the companionway ladder.

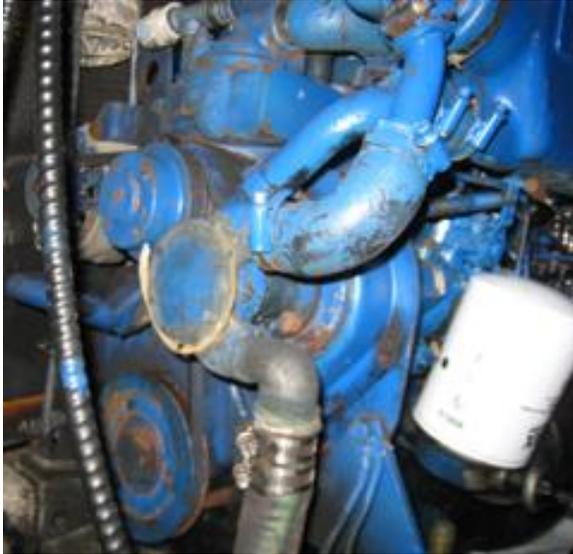
- 11A. Engine compartment ventilation.....one Coast Guard Approved type 12 volt blower along with appropriate flexible ductwork to hull .
12. Rudder shaft logs.... needs service
13. Rudder tower.... NA...fiberglass tube to quadrant, all secure
14. Steering gear and controls.... Stainless wheel on binicle, lines and hardware, and quadrant in good condition
15. Overboard fittings...all nylon fittings below the water line, shut-off valves are working , appear original. Related hoses US Coast Guard approved type and are double clamped.
Overboard fittings are plastic above the waterline and in serviceable condition
16. Backup ground tackle.....Complete equipment

Recommendations: Tighten gland nut on rudder shaft log.
