JAMES CROSS, Certified Marine Surveyor

Re: 2004 Rosborough RF 246' Wheelhouse

This letter reports the results of a survey of the above vessel which was inspected while hauled and during a sea trial on the 28th of May, 2013 at Lynch's Marina in Saugerties, New York. You requested the inspection to establish its condition and value.

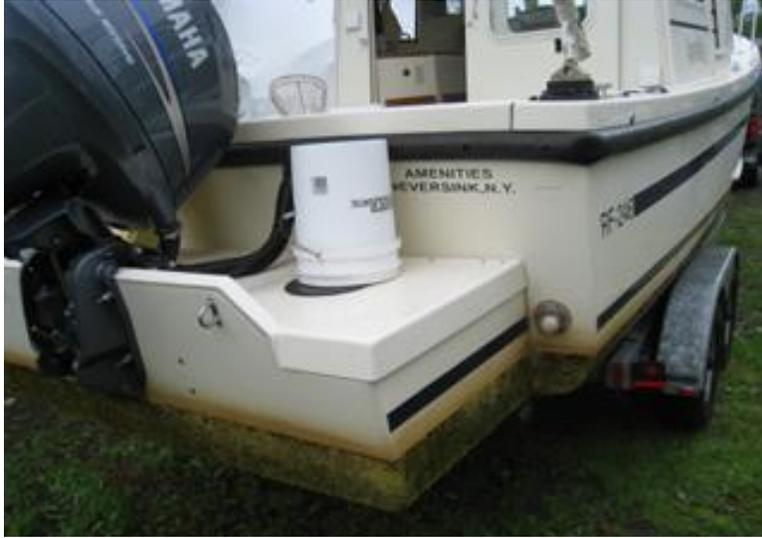
The vessel was built by ROSBOROUGH BOATS LTD, BEECHVILLE, NS, CANADA in 2004. Molded into the hull at the transom is the hull ID number (ZRL25357F404). Pertinent dimensions of the vessel are: The hull length is 25', the beam is 8' 6", and the draft is approximately 2'. The displacement is approximately 6,200 pounds. The engine number is 63P X 1016602.

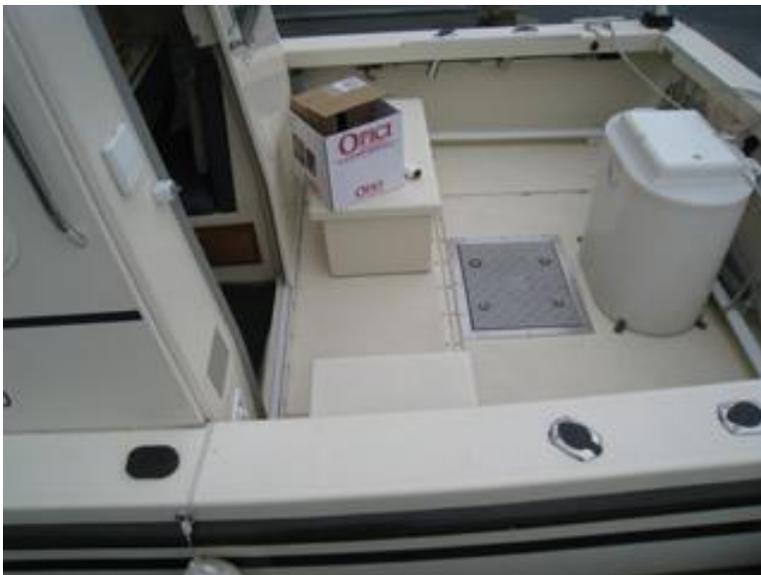
The hull is a hand laid-up polyester laminate reinforced with fiberglass matt and woven roving in a modified Vee with keel configuration. The hull is structurally secure. The free-board finish is the original white gelcoat with teak and rubber trim, and is in good condition, overall, with just a few minor mars and scratches. I was unable to locate any delamination or separating of

glass, including the engine fiberglass bracket. The bottom was percussion sounded and found to be in good, solid condition. No soft spots were noted. The bulkheads and stringer tabbing through out is roving and matt and properly installed. The stringers could not be inspected as the entire area below the work deck is secured. The entire inside surface of the laminate has been painted with an epoxy finish. No serious hull stress situations were observed. The topside (deck is reinforced) is also white gelcoat

and in good condition. The toe rail is also in good shape. All of the deck hardware including the pilot house is properly backed and secure. The stainless bow pulpit is secure. The deck house ports are in good condition and secure.
