JAMES CROSS, Certified Marine Surveyor

Re: 2000 Viking V55 Express Cruiser

This letter reports the results of a survey of the above vessel which was inspected on the 25th of November, 2013, at Louis Boatyard in Warwick, Rhode Island while hauled. The inspection was completed to establish its condition and value.

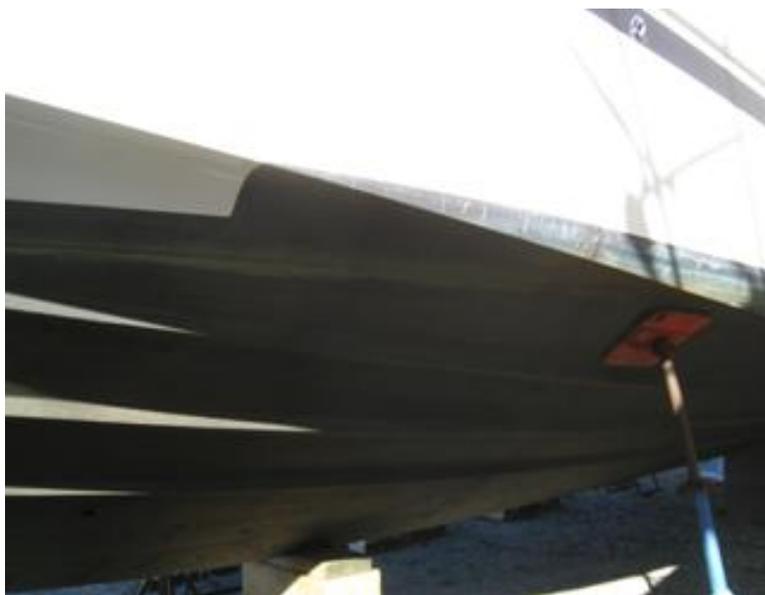
Hull and Structures

The hull is a typical polyester laminate reinforced with fiberglass matt and woven roving in a modified deep Vee configuration. The freeboard finish is the original white gelcoat with stainless trim, and is in excellent condition, overall, with no mars or scratches. The swim platform is properly secured and is sturdy.

The hull - deck attachment is secure and reinforced. I was unable to locate any delamination or separating of glass, including the engine bearers and stringers.

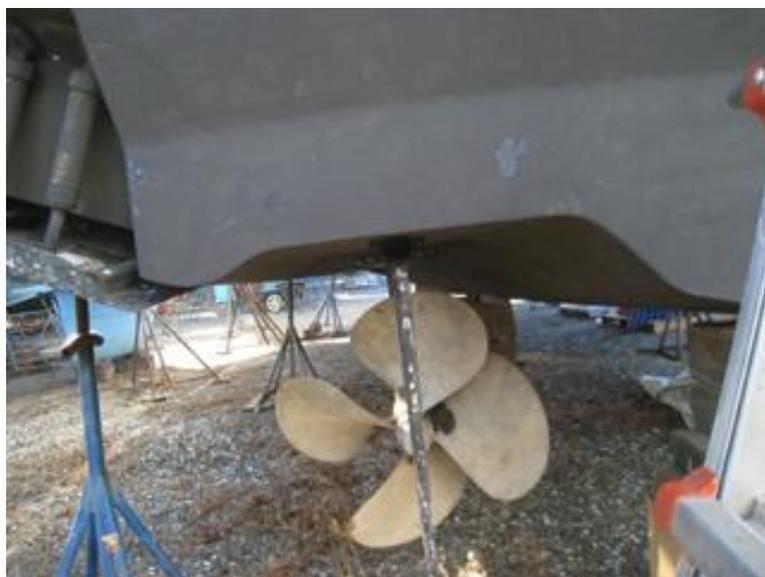
The bottom (sections below the water line) was sounded and found to be in solid condition also with a recent application of hard anti fouling paint. The two inch propeller shafts are in good condition as are the shaft logs, cutlass bearings and struts. The bronze

four blade propellers are in good condition. The rudder posts are secure and properly packed. The trim planes are well secured and look good. The ground plates and all zincs are in serviceable condition.

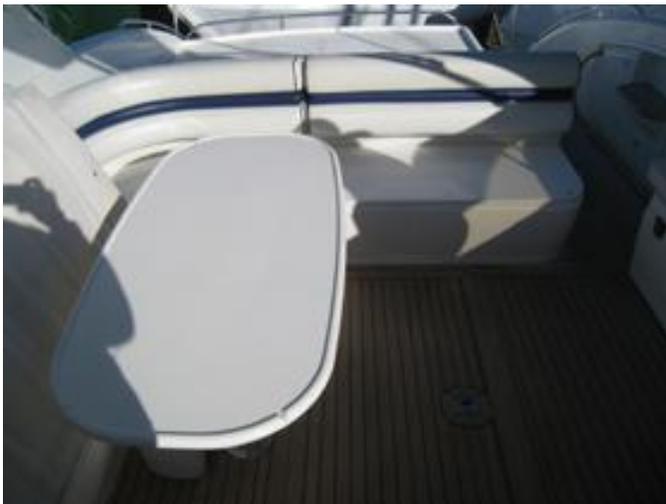
The aft deck is equipped with a transom entry door which is in good shape and functional. The aft deck is provided with scuppers, port and starboard, that drain overboard at the stern. Their related hoses and fittings are in good condition. Built in reefer with ice maker and barbecue are in clean condition as is the wet bar sink. Overall the cockpit and all walkways are secure and in excellent

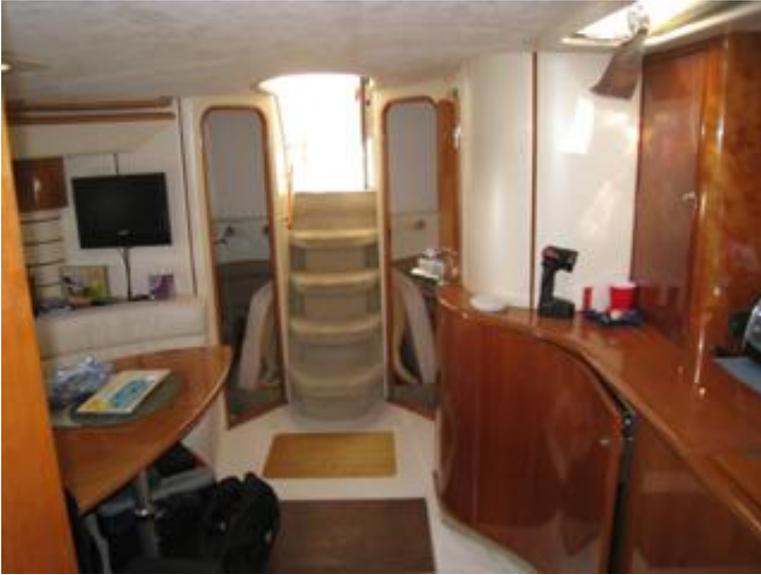
Main cabin

The main cabin houses the salon, galley, and dinette. This area is spacious, nicely finished and is in excellent condition, both cosmetically and structurally. The upholstery appears in lightly used condition. The jointer work is made up of solid hard wood, Cherry finish, and for the most part, looks new.

The upholstered sections show very light use, good care, and maintenance. The doors and ports are in good condition and tight to the weather. Color keyed carpet also appear lightly used. The overhead vinyl liner also appears in excellent condition. All deck supports were checked from below and all are secure. Lighting is good throughout the vessel. The entire interior area is in excellent condition and bright.

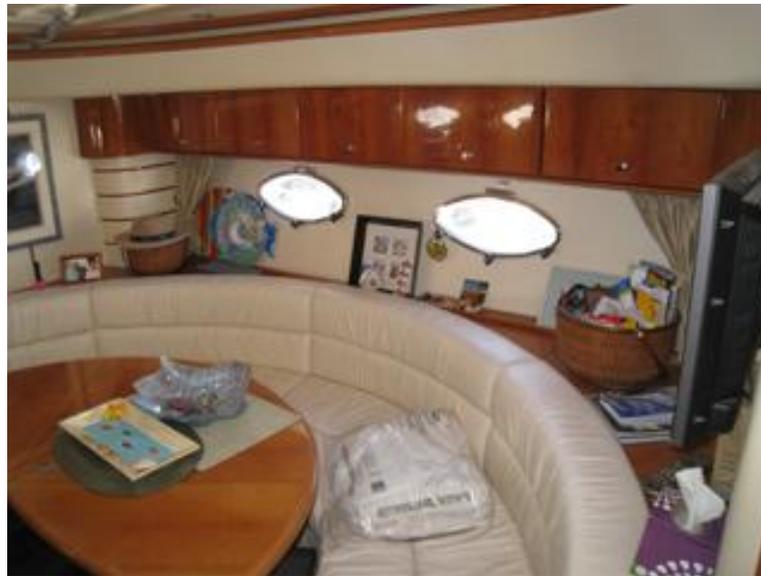
Galley and Dinette

The 120/12 volt refrigerator with freezers and an EEF two burner electric counter top stove, which are in lightly used condition. A Sharpe Carosel microwave oven is also in good shape. The Corian counter top is in good shape. There is a large sink and its related faucets and over board drain are

in good condition and clean. The sole in the galley is also carpeted and is in excellent condition and well supported. No rot was found in any deck timbers or supports. The galley is located just forward in the main salon across from the dinette. The galley, overall, is in excellent condition. (A De Dietrich barbeque is built in at the aft deck station along with a Raritan icemaker, and stainless sink).

The dinette converts to sleep two adults. The solid dinette table folds to form part of a berth. This area is equipped with a vacuum system and the main AC/DC control panel is secured in this area. A large flat screen TV along with a contemporary sound system is built in. The entire main cabin, overall, is in excellent condition.

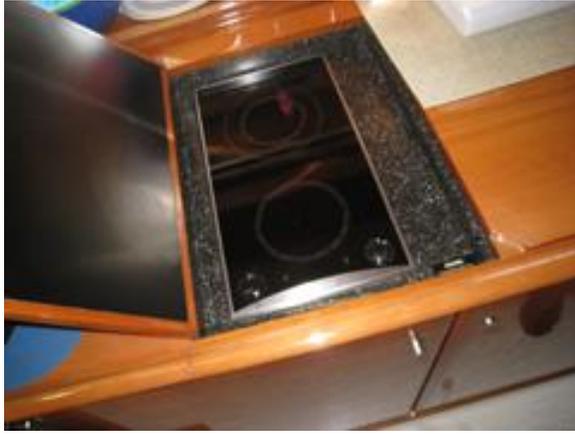
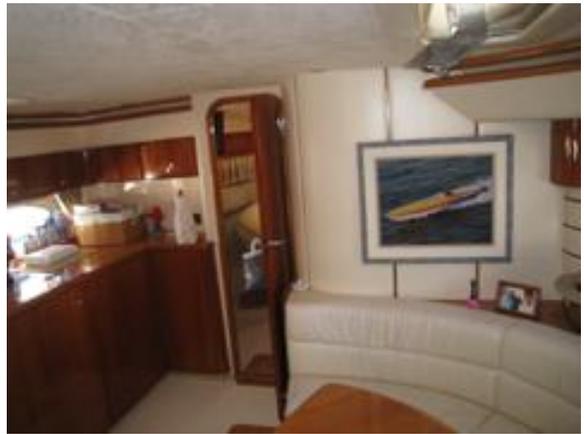
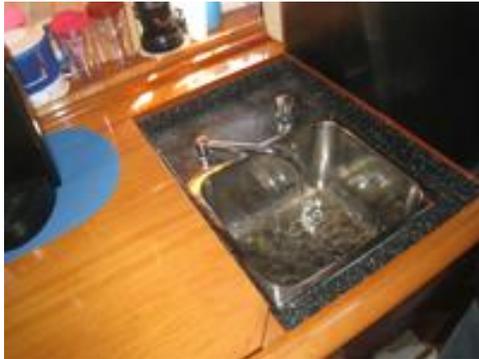
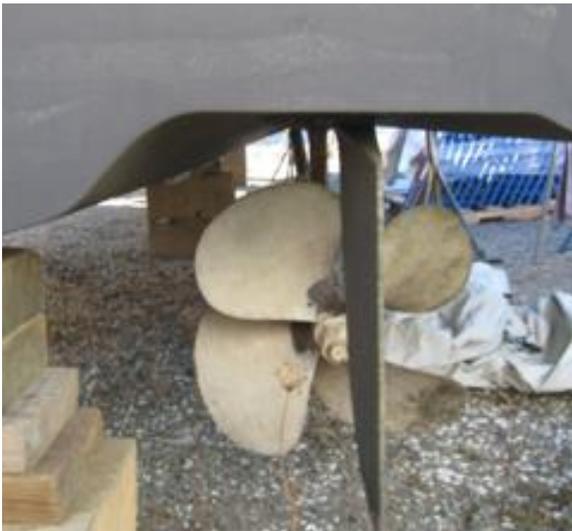
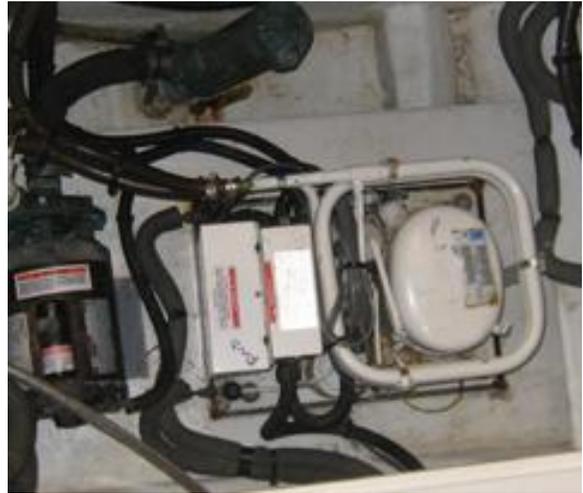
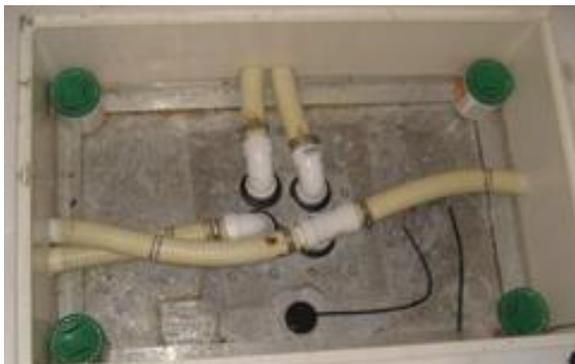
Other photos page

Pictured on this page are additional views of the galley, starboard propeller, one of three Cruisair units, and components of the septic system. All photos indicate neat and clean spaces.

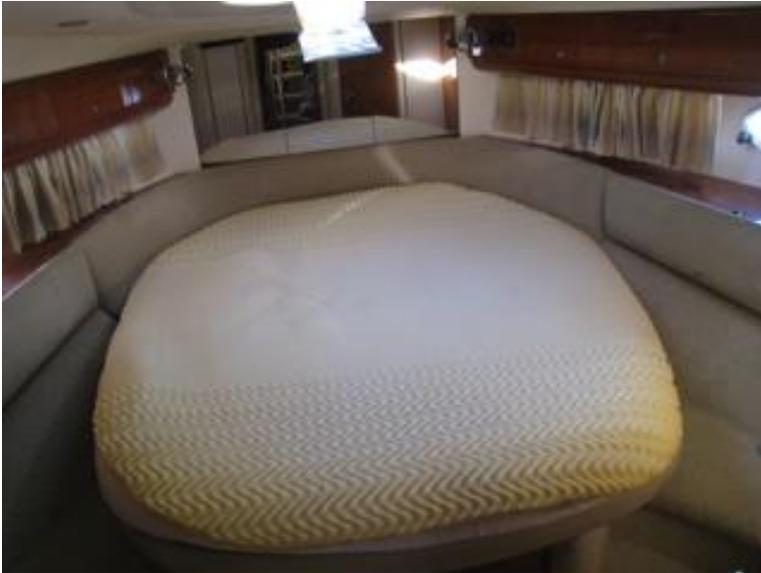
Forward area, Berth and Head

A large berth (Owners Stateroom) is located forward of the main Salon. This area is clean, nicely finished and upholstered. There is adequate lighting and ventilation in this area. All jointer work is in lightly used condition and brightly finished. There are numerous lockers and closets in this forward area. The forward deck (sole) in this area is properly supported, nicely finished with color keyed mold resistant carpet and in overall excellent condition. I was unable to locate any excess moisture on any surface in this forward cabin. Individual climate control, flat screen TV and sound system are installed in this area. This area also appears lightly used.

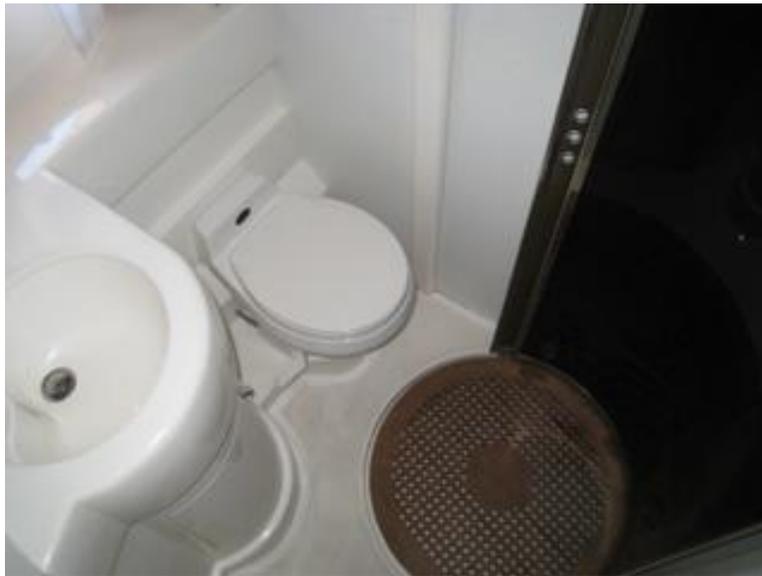
Heads

The heads (one aft and one in the master stateroom) are in good condition. The heads are equipped with showers, hand basins and an electric/manual standard marine toilets. The shower units are an integral part of the inner liner. The shower stalls are good sized fiberglass enclosures. Each shower is equipped with a sump pump and overboard drain. There are macerator units, Y-gates, and holding tanks installed, all are excellent condition.

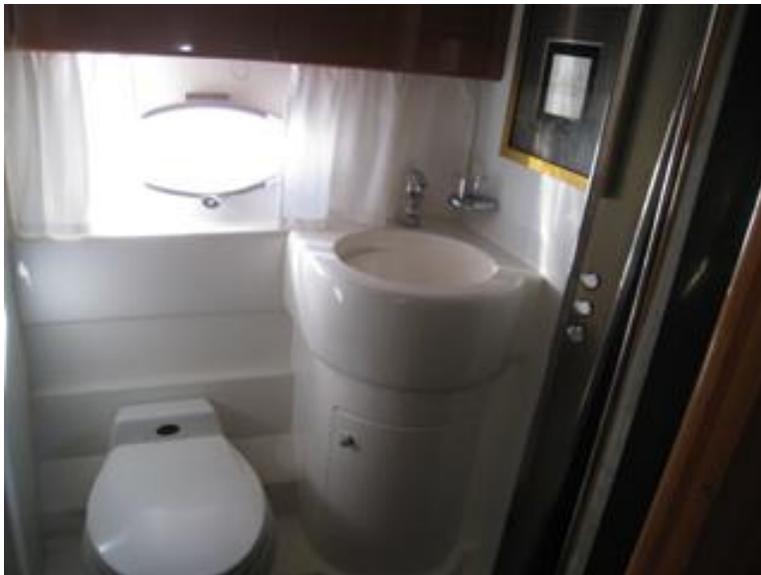
Aft quarter berths, with head

Two large quarter berth compartments are located aft of the main Salon. These areas are clean, nicely finished and upholstered. They provide berthing for four adults. There is adequate lighting and ventilation in this area. All jointer work is in lightly used condition and brightly finished. There are numerous lockers and closets in these aft areas. The fiberglass deck (sole) in this area is properly supported, and

clean, and in overall excellent condition. The vinyl headliner is in good shape. I was unable to locate any excess moisture on any surface in these aft cabins. These areas also appear lightly used. All aft living spaces are provided with heat and air conditioning controls.

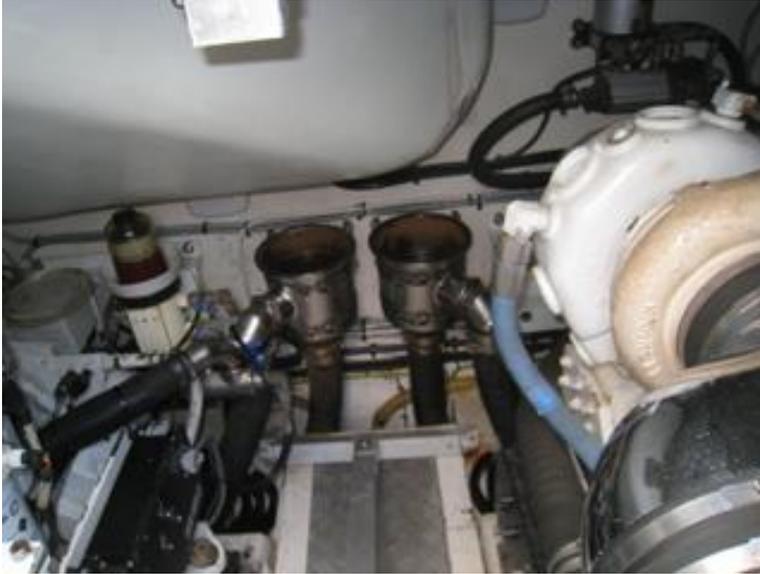
Engines and mechanical spaces

Propulsion is by a pair of counter rotating fresh water cooled Turbo charged Detroit

Diesel, Model 60 Series six cylinder engines with Detroit reduction gears. The engines are rated at approximately seven hundred horsepower each. Visual inspection of the engines, oil, filters, and related connections indicate a meticulous maintenance regime is in effect.

The fuel lines are properly supported and are in good condition. The stringers that support the engine mounts are heavily built and fiberglass covered and tabbed to the hull. The stringers also provide rigidity to the hull. The stringers are in good condition.

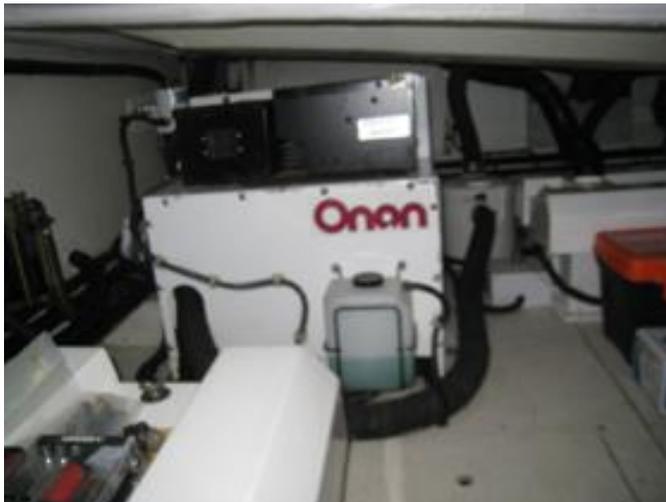
The raw water intakes are equipped with alloy sea water straines with sight glasses, and are secure as are the through hull devices and hoses. The engines exhaust through approved composite hoses, on to a fiberglass silencers and then through the hull at the rear quarters. The entire exhaust system is in good condition. The Onan generator engine exhausts through approved rubber hose and silencer to overboard. The fuel lines and filters to the generator set are in good condition. The raw water intake which supplies the generator is in good safe condition. There are appropriate bilge pumps mounted. The aluminum fuel tanks are properly secured outboard of each engine. This installation does not allow complete inspection of the fuel tanks.

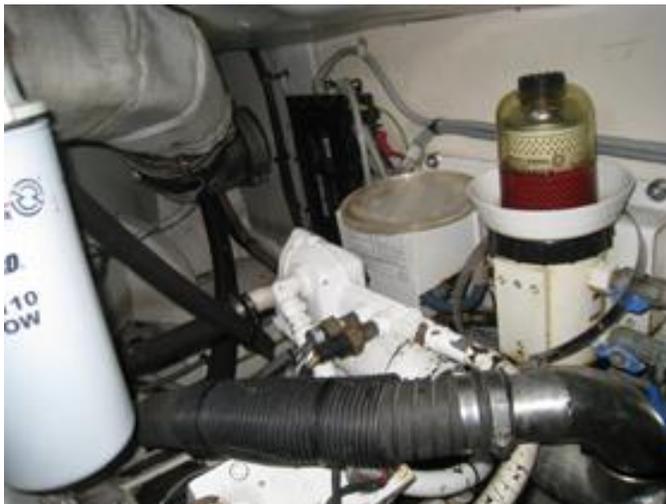
There are water cooled Cruise Air air conditioners properly installed that provide heat and air-conditioning to all living compartments. The units were not checked out while operating but look very good. There are no traces of oil in the bilge, and the bilge is clean overall. The batteries (all new gel cells) on

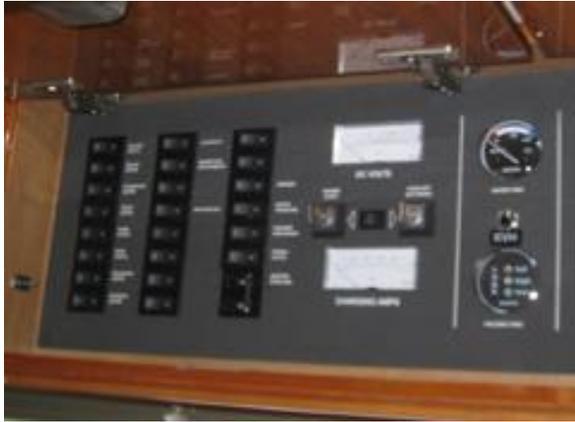
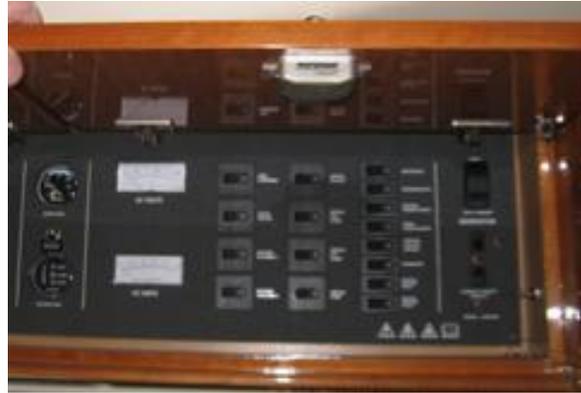
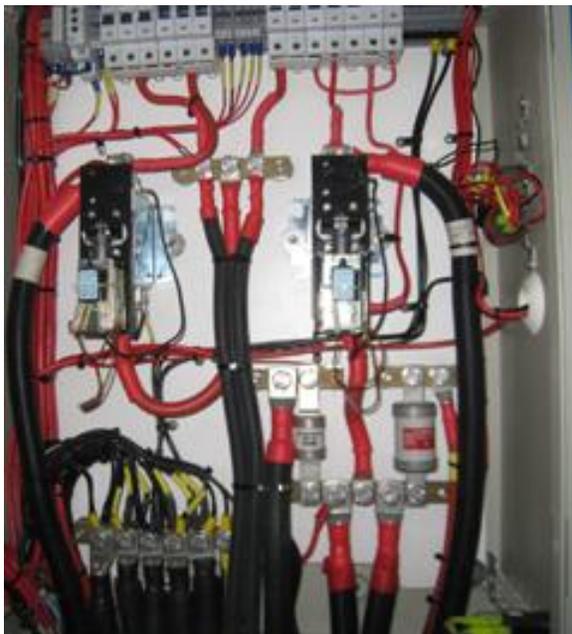
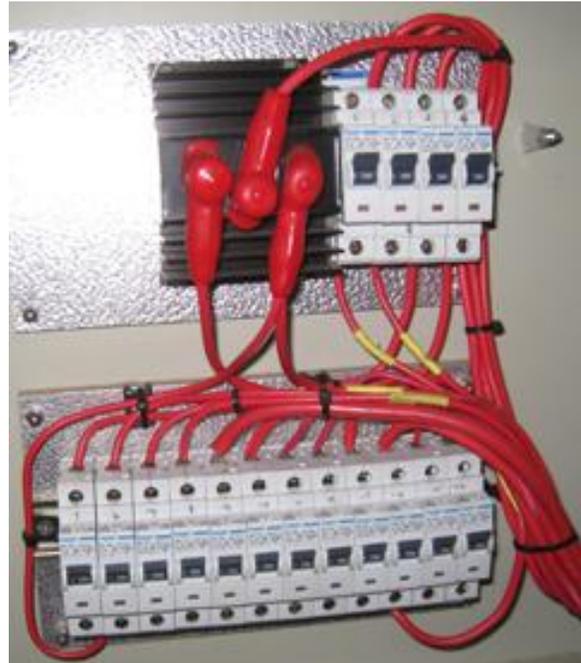
Electrical and Electronics

The electrical panels are in good shape. The 3 position battery disconnect switches mounted are in good condition and properly wired. All DC circuits were rung out and found to be in good condition. The 120 Volt power panel, breakers, and circuits were found to be in operating and in safe condition. All wiring is properly harnessed and secure, as can it be observed through out the vessel. Cable circuits and receptacles are installed. Two shore power cables (fifty feet) are on board and in good condition. The 230 V shore power inlet appears in good condition. The running lights conform to the CFR . Electronics includes, Raytheon Autopilot, New (2009) Garmin 5212 Radar, Horn and Intercom, GPS with chart plotters, and Auto pilot. There are two VHF transceivers, a depth finder, knot log and wind speed indicators installed and operating. The electric motors which operate the toilet pump and fresh water system are in good working order . The Side Power bow thruster is in good condition.
